# Manhole Inspection Report

Date:	<b>05/14/2018</b>	Weather:		Coding:	<b>RZMACP</b>
MH#:	<b>M-504-134</b>	Owner:	<b>NA</b>	Len. Surveyed:	<b>4.7</b>
P.O.#:		Surveyor:	<b>Jen Costello</b>	Rim to Invert:	<b>5.5</b>
Customer:		Cert. #:	<b>U-907-5518</b>	Wall Material:	<b>Concrete (reinforced)</b>

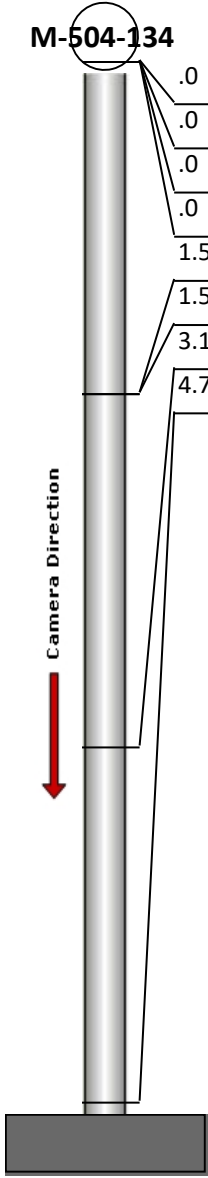
.0	MGO	General Observation	10	NA
	.0	IW	Infil Weeper	21	M 2
	.0	MGO	General Observation	32	NA
	.0	IS	Infil Stain	43	NA
	1.5	MGO	General Observation	60	NA
	1.5	DAE	Deposits Attached Encrustation	73	M 2
	3.1	DSF	Deposits Settled Fine	87	M 2
	4.7	MGO	General Observation	102	NA

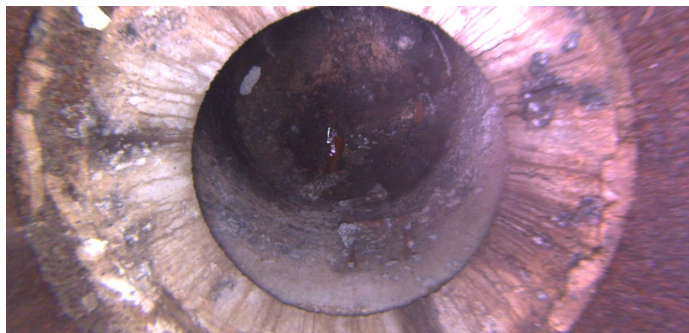
Code: **MGO**  
Description: **General Observation**

Distance (ft): **.0**  
Structural Grade: **0**  
O&M Grade: **0**  
Clock Start/From:  
Clock To:  
1st Value:  
2nd Value:  
Value Percent:  
Step: **NO**  
Remarks: **ACCESS MH**

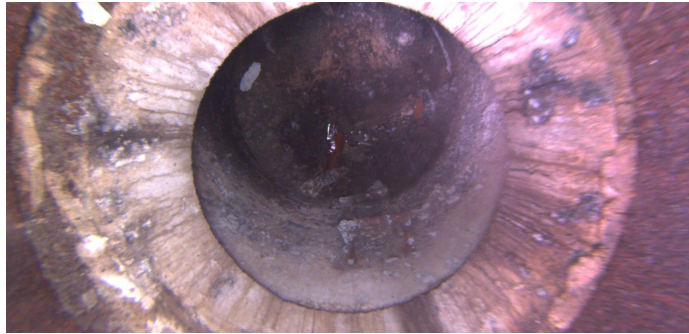
Code: **IW**  
Description: **Infil Weeper**

Distance (ft): **.0**  
Structural Grade: **0**  
O&M Grade: **2**  
Clock Start/From: **12**  
Clock To: **12**  
1st Value:  
2nd Value:  
Value Percent:  
Step: **NO**  
Remarks:

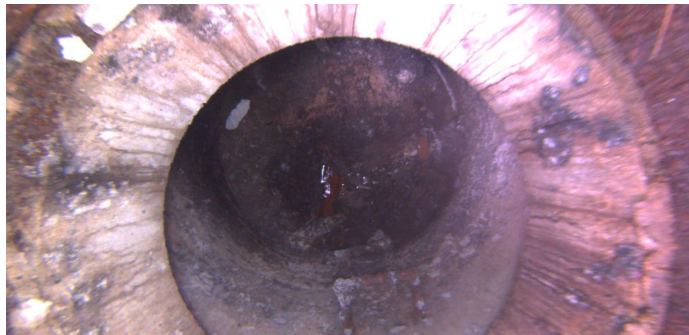
Code: **MGO**  
Description: **General Observation**

Distance (ft): **.0**  
Structural Grade: **0**  
O&M Grade: **0**  
Clock Start/From:  
Clock To:  
1st Value:  
2nd Value:  
Value Percent:  
Step: **NO**  
Remarks: **ACCESS MH**

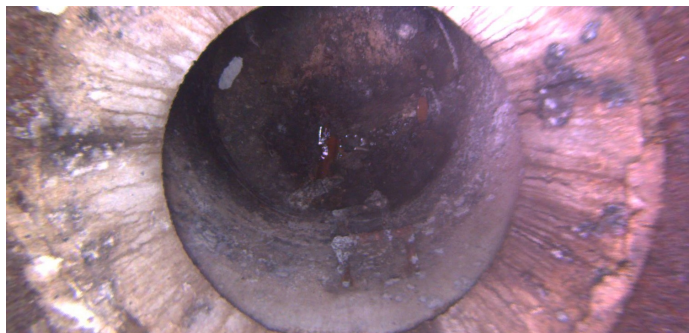
Code: **IS**  
Description: **Infil Stain**

Distance (ft): **.0**  
Structural Grade: **0**  
O&M Grade: **0**  
Clock Start/From: **12**  
Clock To: **12**  
1st Value:  
2nd Value:  
Value Percent:  
Step: **NO**  
Remarks:

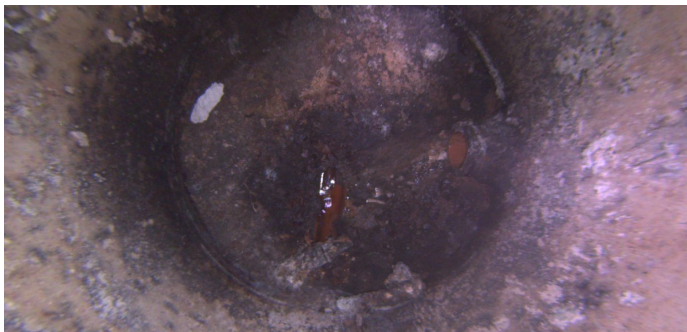
Code: **DAE**  
Description: **Deposits Attached Encrustation**

Distance (ft): **1.5**  
Structural Grade: **0**  
O&M Grade: **2**  
Clock Start/From: **12**  
Clock To: **12**  
1st Value:  
2nd Value:  
Value Percent: **5.000**  
Step: **NO**  
Remarks:

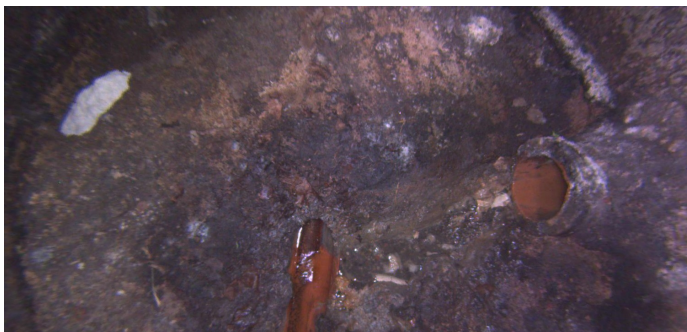
Code: **DSF**  
Description: **Deposits Settled Fine**

Distance (ft): **3.1**  
Structural Grade: **0**  
O&M Grade: **2**  
Clock Start/From: **12**  
Clock To: **12**  
1st Value:  
2nd Value:  
Value Percent: **5.000**  
Step: **NO**  
Remarks:

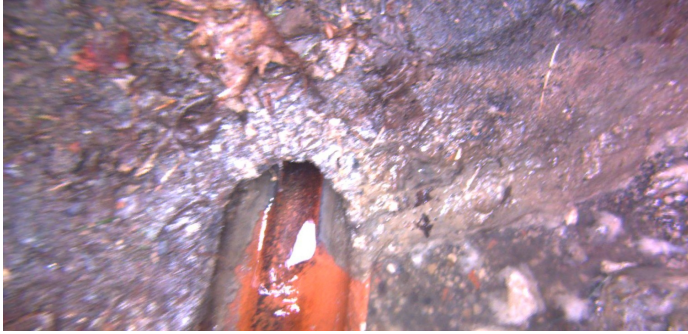
Code:	<b>MGO</b>
Description:	<b>General Observation</b>
Distance (ft):	<b>4.7</b>
Structural Grade:	<b>0</b>
O&M Grade:	<b>0</b>
Clock Start/From:	
Clock To:	
1st Value:	
2nd Value:	
Value Percent:	
Step:	<b>NO</b>
Remarks:	<b>END SURVEY</b>
