# Manhole Inspection Report

Date:	<b>04/30/2018</b>	Weather:		Coding:	<b>RZMACP</b>
MH#:	<b>M-505-006</b>	Owner:	<b>NA</b>	Len. Surveyed:	<b>6.0</b>
P.O.#:		Surveyor:	<b>Jen Costello</b>	Rim to Invert:	<b>6.2</b>
Customer:		Cert. #:	<b>U-907-5518</b>	Wall Material:	<b>Brick</b>

Street:	<b>Lake George Dr. 520' East of Virginia</b>	Project:	<b>Hobart, IN</b>
City:	<b>Hobart, IN</b>	GPS Northing:	<b>2901528.525</b>
Location:		GPS Easting:	<b>2901528.525</b>
Drain Area:	<b>West</b>	GPS Accuracy:	<b>Sub-Meter</b>
Cover Shape:	<b>Circular</b>	Evidence of Surcharge:	<b>No</b>
Cover Size:	<b>22.5</b>	Potential for Runoff:	<b>None</b>
Comments:

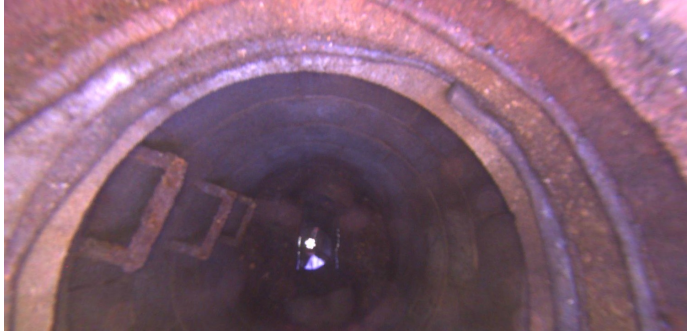
Code:	<b>SAV</b>
Description:	<b>Surface Aggregate Visible</b>
Distance (ft):	<b>.0</b>
Structural Grade:	<b>3</b>
O&M Grade:	<b>0</b>
Clock Start/From:	<b>12</b>
Clock To:	<b>12</b>
1st Value:	
2nd Value:	
Value Percent:	
Step:	<b>NO</b>
Remarks:

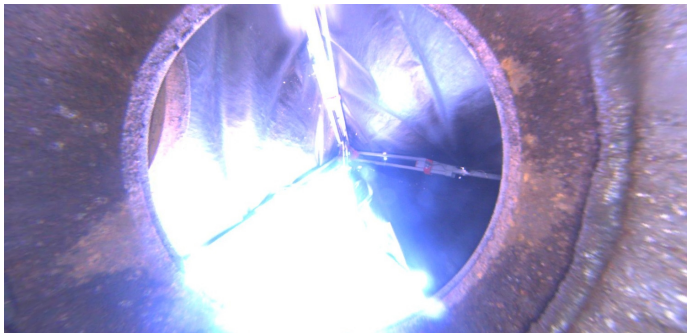
Code:	<b>MGO</b>
Description:	<b>General Observation</b>
Distance (ft):	<b>1.5</b>
Structural Grade:	<b>0</b>
O&M Grade:	<b>0</b>
Clock Start/From:	
Clock To:	
1st Value:	
2nd Value:	
Value Percent:	
Step:	<b>NO</b>
Remarks:	<b>underside of frame</b>

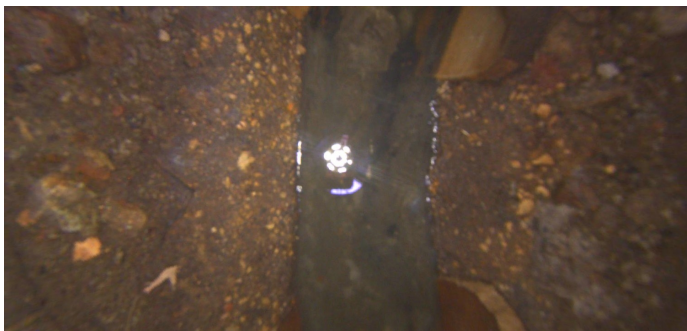
Code:	<b>OBR</b>
Description:	<b>Obstacle Rocks</b>
Distance (ft):	<b>4.8</b>
Structural Grade:	<b>0</b>
O&M Grade:	<b>2</b>
Clock Start/From:	<b>12</b>
Clock To:	<b>12</b>
1st Value:	
2nd Value:	
Value Percent:	<b>5.000</b>
Step:	<b>NO</b>
Remarks:

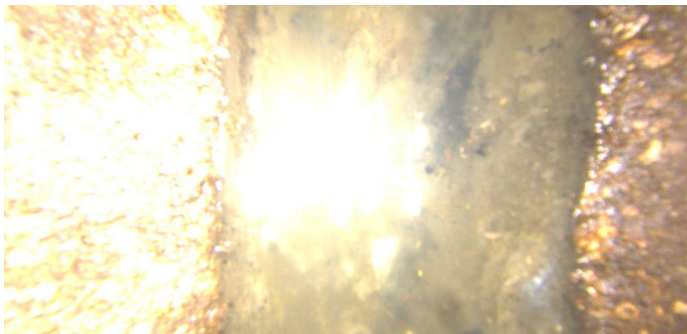
Code: **MGO**  
Description: **General Observation**

Distance (ft): **6.0**  
Structural Grade: **0**  
O&M Grade: **0**  
Clock Start/From:  
Clock To:  
1st Value:  
2nd Value:  
Value Percent:  
Step: **NO**  
Remarks: **end survey**
