Manhole Inspection Report

Date:	04/30/2018	Weather:		Coding:	RZMACP
MH#:	M-505-007	Owner:	NA	Len. Surveyed:	8.9
P.O.#:		Surveyor:	Jen Costello	Rim to Invert:	9.4
Customer:		Cert. #:	U-907-5518	Wall Material:	Brick

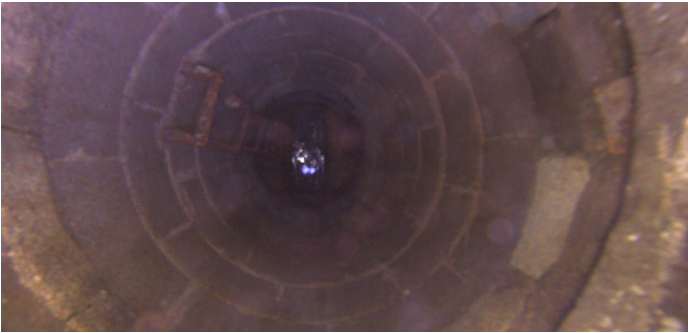
Position	Code	Observation	Video (sec)	Grade
	.0	MGP	General Photo	10	NA
	2.1	MGO	General Observation	28	NA
	2.1	FM	Fracture Multiple	39	S 4
	4.4	IS	Infil Stain	57	NA
	4.4	SAV	Surface Aggregate Visible	68	S 3
	7.0	RFB	Roots Fine Barrel	86	M 2
	7.0	DSGV	Deposits Settled Gravel	97	M 2
	8.9	MGO	General Observation	112	NA

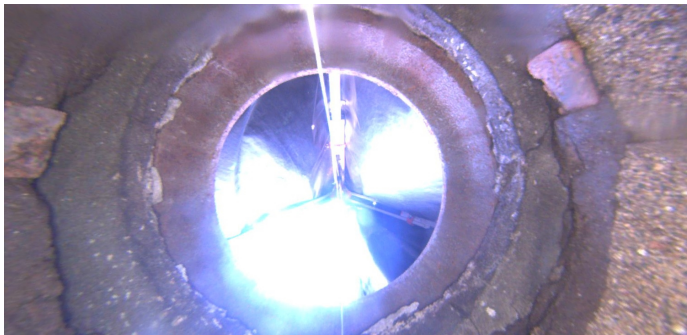
Code:	FM
Description:	Fracture Multiple
Distance (ft):	2.1
Structural Grade:	4
O&M Grade:	0
Clock Start/From:	12
Clock To:	12
1st Value:	
2nd Value:	
Value Percent:	
Step:	NO
Remarks:

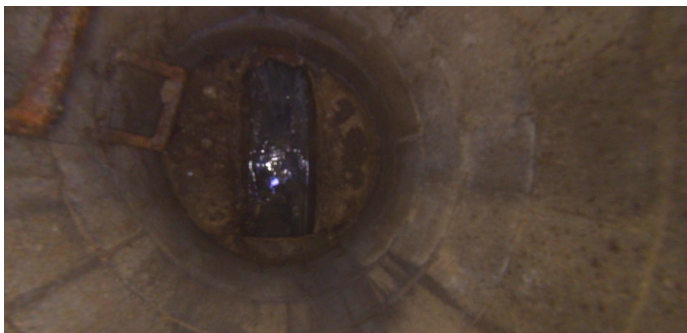
Code:	IS
Description:	Infil Stain
Distance (ft):	4.4
Structural Grade:	0
O&M Grade:	0
Clock Start/From:	4
Clock To:	6
1st Value:	
2nd Value:	
Value Percent:	
Step:	NO
Remarks:

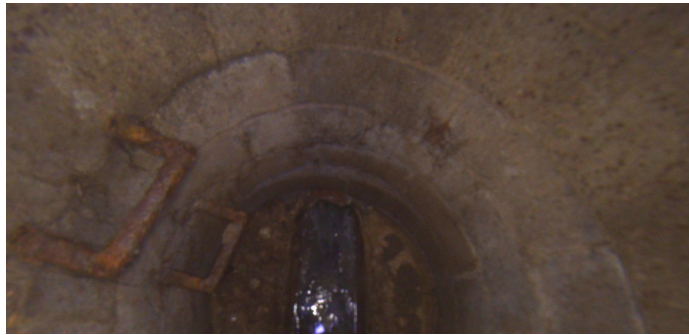
Code:	SAV
Description:	Surface Aggregate Visible
Distance (ft):	4.4
Structural Grade:	3
O&M Grade:	0
Clock Start/From:	12
Clock To:	12
1st Value:	
2nd Value:	
Value Percent:	
Step:	NO
Remarks:
