Manhole Inspection Report

Date:	04/30/2018	Weather:		Coding:	RZMACP
MH#:	M-505-008	Owner:	NA	Len. Surveyed:	8.5
P.O.#:		Surveyor:	Jen Costello	Rim to Invert:	8.4
Customer:		Cert. #:	U-907-5518	Wall Material:	Brick

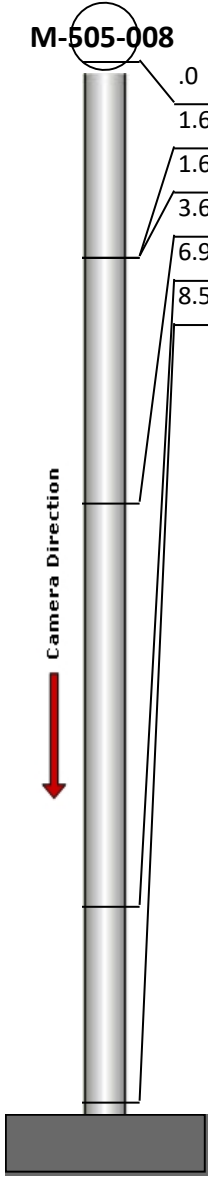
.0	MGO	General Observation	10	NA
	1.6	MGO	General Observation	27	NA
	1.6	SAV	Surface Aggregate Visible	39	S 3
	3.6	CS	Crack Spiral	54	S 2
	6.9	DSF	Deposits Settled Fine	71	M 2
	8.5	MGO	General Observation	85	NA

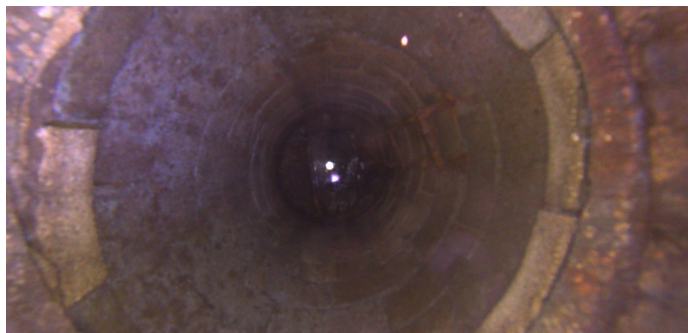
Code: **MGO**
Description: **General Observation**

Distance (ft): **.0**
Structural Grade: **0**
O&M Grade: **0**
Clock Start/From:
Clock To:
1st Value:
2nd Value:
Value Percent:
Step: **NO**
Remarks: **access mh**

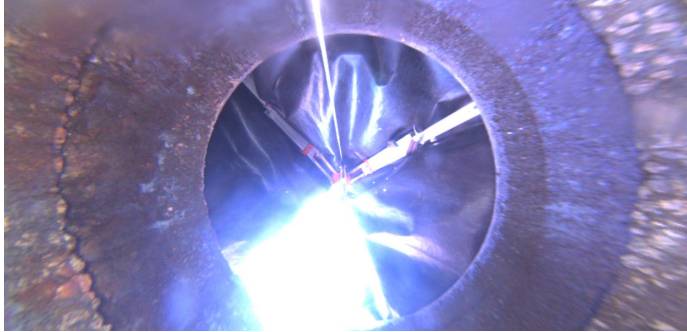
Code: **MGO**
Description: **General Observation**

Distance (ft): **1.6**
Structural Grade: **0**
O&M Grade: **0**
Clock Start/From:
Clock To:
1st Value:
2nd Value:
Value Percent:
Step: **NO**
Remarks: **underside of frame**

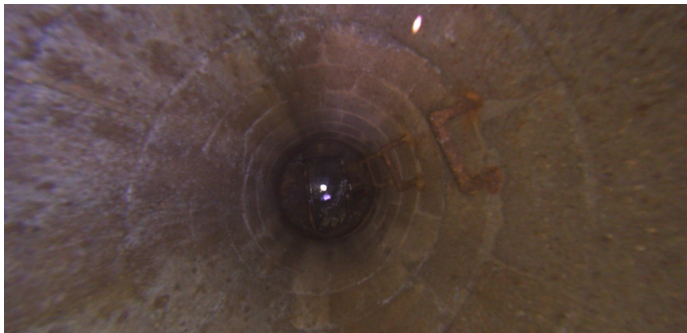
Code: **SAV**
Description: **Surface Aggregate Visible**

Distance (ft): **1.6**
Structural Grade: **3**
O&M Grade: **0**
Clock Start/From: **12**
Clock To: **12**
1st Value:
2nd Value:
Value Percent:
Step: **NO**
Remarks:

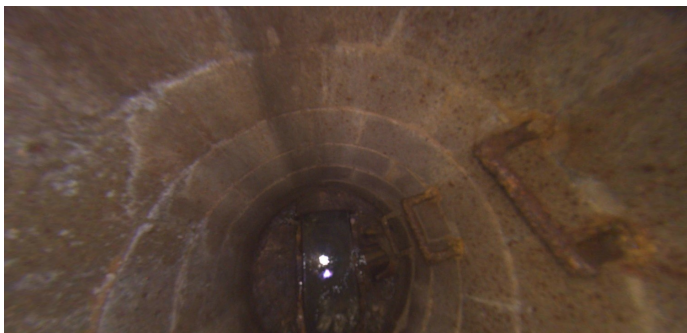
Code: **CS**
Description: **Crack Spiral**

Distance (ft): **3.6**
Structural Grade: **2**
O&M Grade: **0**
Clock Start/From: **10**
Clock To: **11**
1st Value:
2nd Value:
Value Percent:
Step: **NO**
Remarks:

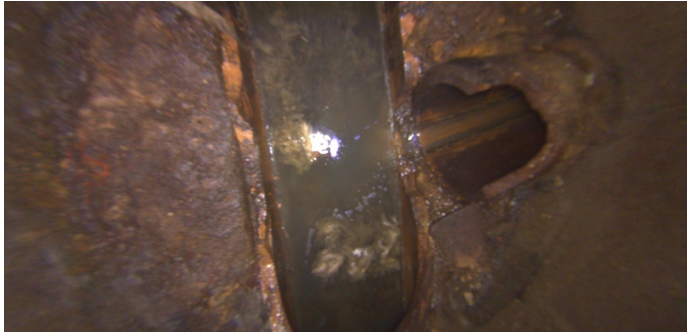
Code:	DSF
Description:	Deposits Settled Fine
Distance (ft):	6.9
Structural Grade:	0
O&M Grade:	2
Clock Start/From:	12
Clock To:	12
1st Value:	
2nd Value:	
Value Percent:	5.000
Step:	NO
Remarks:

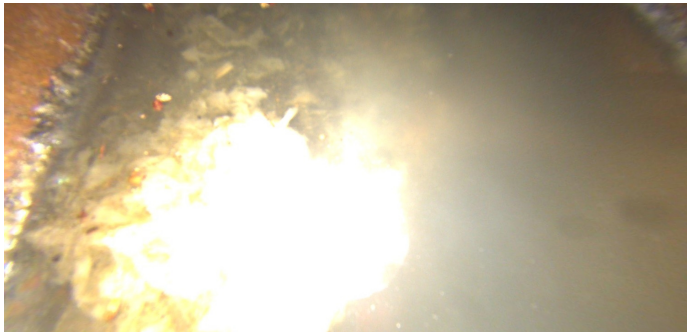
Code:	MGO
Description:	General Observation
Distance (ft):	8.5
Structural Grade:	0
O&M Grade:	0
Clock Start/From:	
Clock To:	
1st Value:	
2nd Value:	
Value Percent:	
Step:	NO
Remarks:	end survey
