# Manhole Inspection Report

Date:	<b>04/30/2018</b>	Weather:		Coding:	<b>RZMACP</b>
MH#:	<b>M-505-009</b>	Owner:	<b>NA</b>	Len. Surveyed:	<b>7.7</b>
P.O.#:		Surveyor:	<b>Jen Costello</b>	Rim to Invert:	<b>8.3</b>
Customer:		Cert. #:	<b>U-907-5518</b>	Wall Material:	<b>Brick</b>

Street:	<b>Virginia St. 136' South of W. 3rd Pl.</b>	Project:	<b>Hobart, IN</b>
City:	<b>Hobart, IN</b>	GPS Northing:	<b>2901039.092</b>
Location:		GPS Easting:	<b>2901039.092</b>
Drain Area:	<b>West</b>	GPS Accuracy:	<b>Sub-Meter</b>
Cover Shape:	<b>Circular</b>	Evidence of Surcharge:	<b>No</b>
Cover Size:	<b>24.0</b>	Potential for Runoff:	<b>None</b>
Comments:

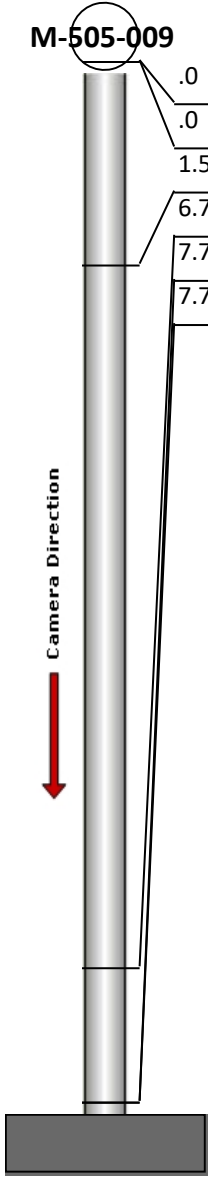
.0	MGP	General Photo	10	NA
	.0	SAP	Surface Aggregate Projecting	22	S 3
	1.5	MGP	General Photo	38	NA
	6.7	DSGV	Deposits Settled Gravel	61	M 2
	7.7	DSF	Deposits Settled Fine	73	M 2
	7.7	MGO	General Observation	83	NA

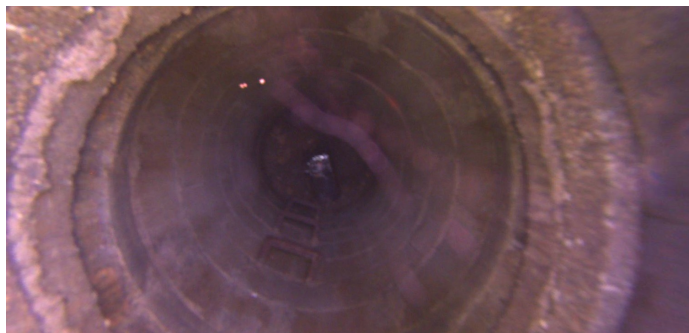
Code: **MGP**  
Description: **General Photo**

Distance (ft): **.0**  
Structural Grade: **0**  
O&M Grade: **0**  
Clock Start/From:  
Clock To:  
1st Value:  
2nd Value:  
Value Percent:  
Step: **NO**  
Remarks: **ACCESS MH**

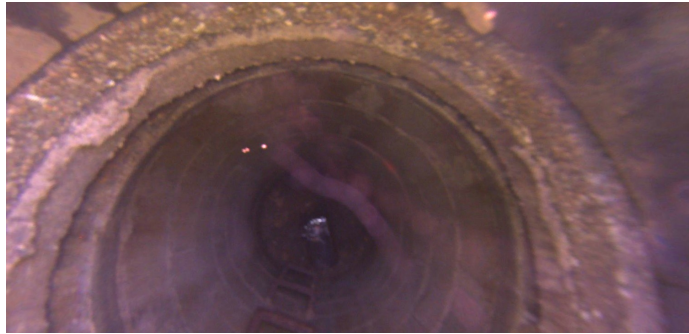
Code: **SAP**  
Description: **Surface Aggregate Projecting**

Distance (ft): **.0**  
Structural Grade: **3**  
O&M Grade: **0**  
Clock Start/From: **12**  
Clock To: **12**  
1st Value:  
2nd Value:  
Value Percent:  
Step: **NO**  
Remarks:

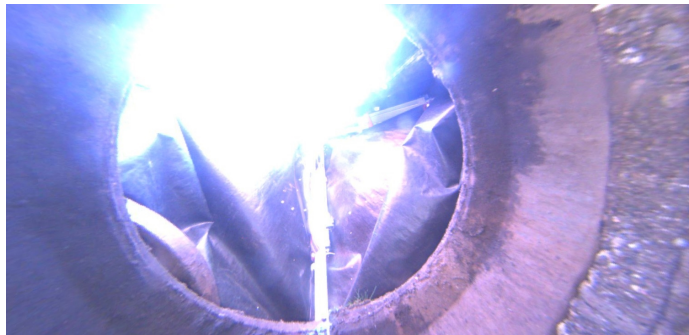
Code: **MGP**  
Description: **General Photo**

Distance (ft): **1.5**  
Structural Grade: **0**  
O&M Grade: **0**  
Clock Start/From:  
Clock To:  
1st Value:  
2nd Value:  
Value Percent:  
Step: **NO**  
Remarks: **underside of frame**

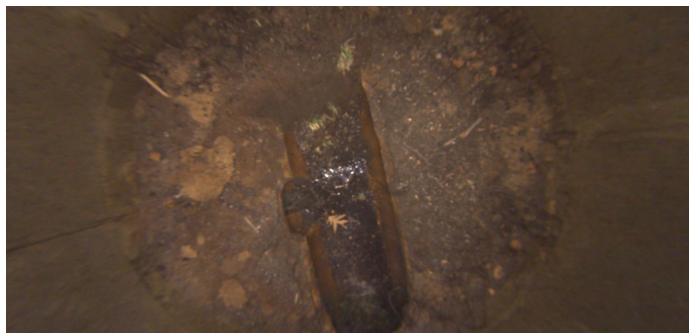
Code: **DSGV**  
Description: **Deposits Settled Gravel**

Distance (ft): **6.7**  
Structural Grade: **0**  
O&M Grade: **2**  
Clock Start/From: **12**  
Clock To: **12**  
1st Value:  
2nd Value:  
Value Percent: **5.000**  
Step: **NO**  
Remarks:

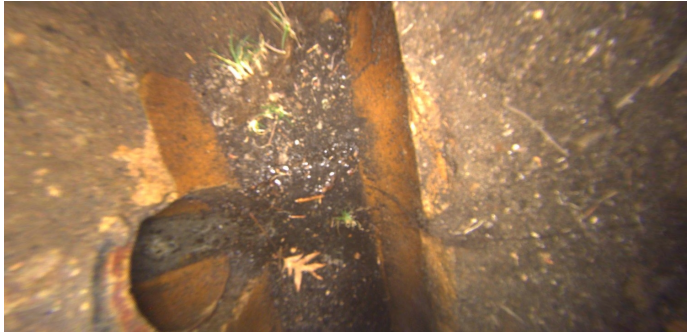
Code: **DSF**  
Description: **Deposits Settled Fine**

Distance (ft): **7.7**  
Structural Grade: **0**  
O&M Grade: **2**  
Clock Start/From: **5**  
Clock To: **7**  
1st Value:  
2nd Value:  
Value Percent: **10.000**  
Step: **NO**  
Remarks:

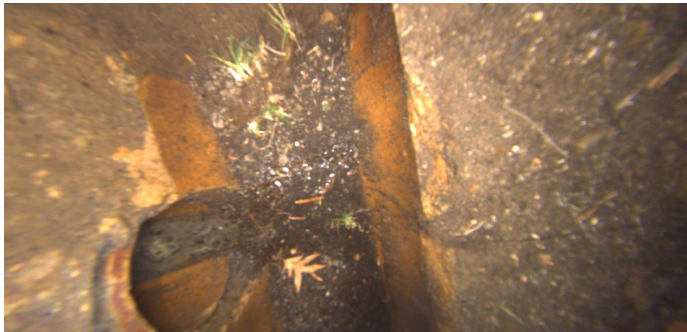
Code: **MGO**  
Description: **General Observation**

Distance (ft): **7.7**  
Structural Grade: **0**  
O&M Grade: **0**  
Clock Start/From:  
Clock To:  
1st Value:  
2nd Value:  
Value Percent:  
Step: **NO**  
Remarks: **end survey**
