Manhole Inspection Report

Date:	04/30/2018	Weather:		Coding:	RZMACP
MH#:	M-505-015	Owner:	NA	Len. Surveyed:	13.1
P.O.#:		Surveyor:	Jen Costello	Rim to Invert:	14.7
Customer:		Cert. #:	U-907-5518	Wall Material:	Brick

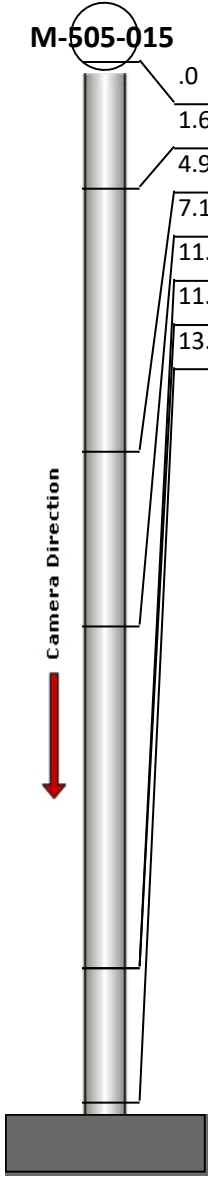
.0	MGP	General Photo	10	NA
	1.6	MGO	General Observation	26	NA
	4.9	IS	Infil Stain	46	NA
	7.1	IS	Infil Stain	62	NA
	11.4	IW	Infil Weeper	81	M 2
	11.4	SAP	Surface Aggregate Projecting	92	S 3
	13.1	MGO	General Observation	107	NA

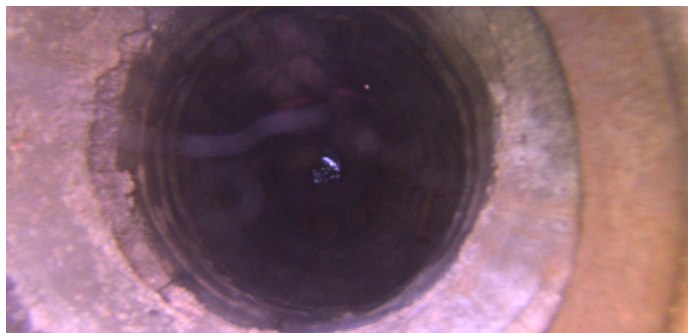
Code: **MGP**
Description: **General Photo**

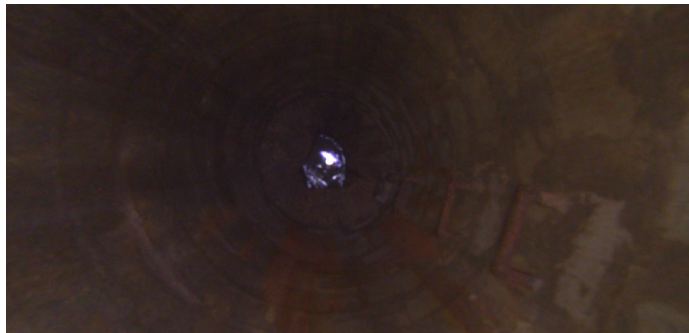
Code:	IS
Description:	Infil Stain
Distance (ft):	4.9
Structural Grade:	0
O&M Grade:	0
Clock Start/From:	4
Clock To:	8
1st Value:	
2nd Value:	
Value Percent:	
Step:	NO
Remarks:

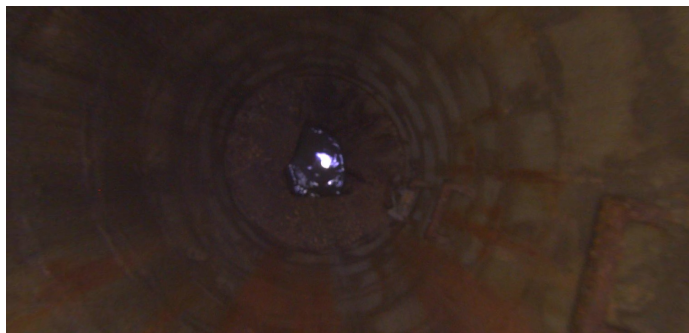
Code:	IS
Description:	Infil Stain
Distance (ft):	7.1
Structural Grade:	0
O&M Grade:	0
Clock Start/From:	4
Clock To:	8
1st Value:	
2nd Value:	
Value Percent:	
Step:	NO
Remarks:

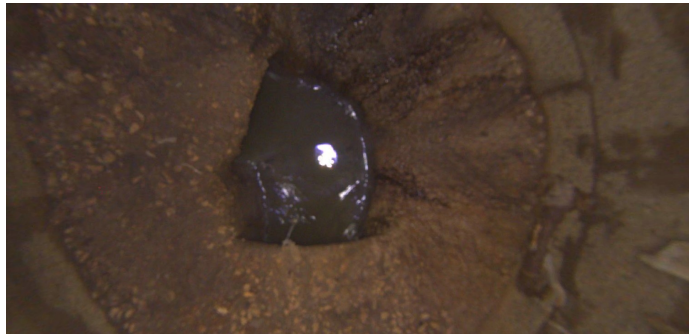
Code: **IW**
Description: **Infil Weeper**
