Manhole Inspection Report

Date:	04/29/2018	Weather:		Coding:	RZMACP
MH#:	M-505-037	Owner:	NA	Len. Surveyed:	12.2
P.O.#:		Surveyor:	Jen Costello	Rim to Invert:	12.5
Customer:		Cert. #:	U-907-5518	Wall Material:	Brick

Street:	Intersection of 2nd St. and California	Project:	Hobart, IN
City:	Hobart, IN	GPS Northing:	2901497.507
Location:		GPS Easting:	2901497.507
Drain Area:	West	GPS Accuracy:	Sub-Meter
Cover Shape:	Circular	Evidence of Surcharge:	No
Cover Size:	22.5	Potential for Runoff:	None
Comments:

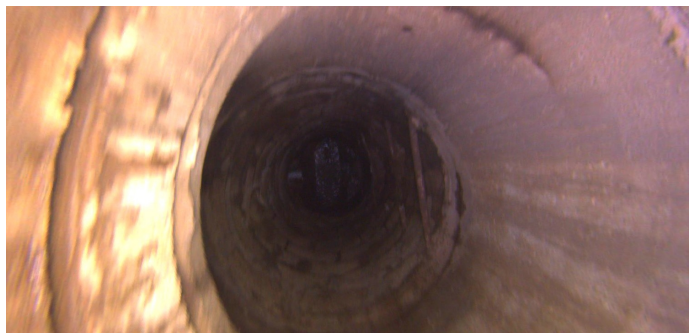
Code: **MGP**
Description: **General Photo**

Distance (ft): **.0**
Structural Grade: **0**
O&M Grade: **0**
Clock Start/From:
Clock To:
1st Value:
2nd Value:
Value Percent:
Step: **NO**
Remarks: **ACCESS MH**

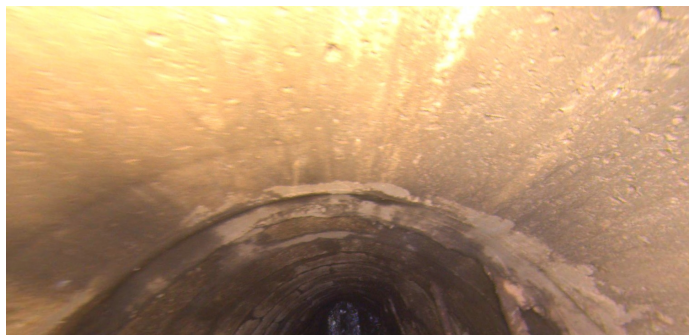
Code: **SSS**
Description: **Surface Spalling**

Distance (ft): **1.8**
Structural Grade: **2**
O&M Grade: **0**
Clock Start/From: **12**
Clock To: **12**
1st Value:
2nd Value:
Value Percent:
Step: **NO**
Remarks:

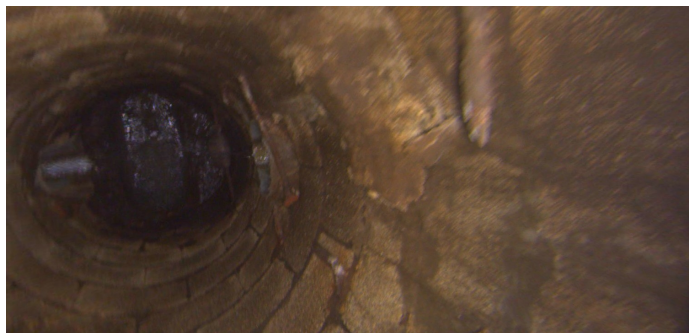
Code: **MGO**
Description: **General Observation**

Distance (ft): **4.5**
Structural Grade: **0**
O&M Grade: **0**
Clock Start/From:
Clock To:
1st Value:
2nd Value:
Value Percent:
Step: **NO**
Remarks: **MISSING AND BROKEN STEPS**

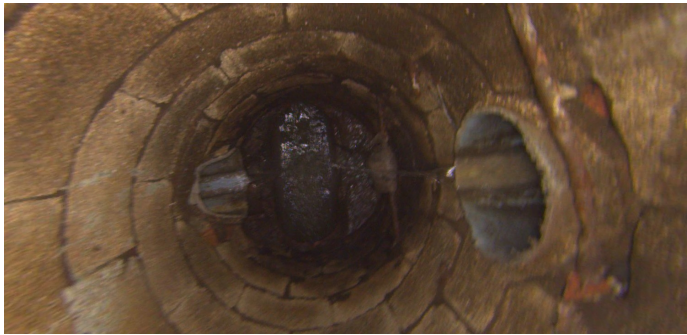
Code: **SAV**
Description: **Surface Aggregate Visible**

Distance (ft): **6.5**
Structural Grade: **3**
O&M Grade: **0**
Clock Start/From: **12**
Clock To: **12**
1st Value:
2nd Value:
Value Percent:
Step: **NO**
Remarks:

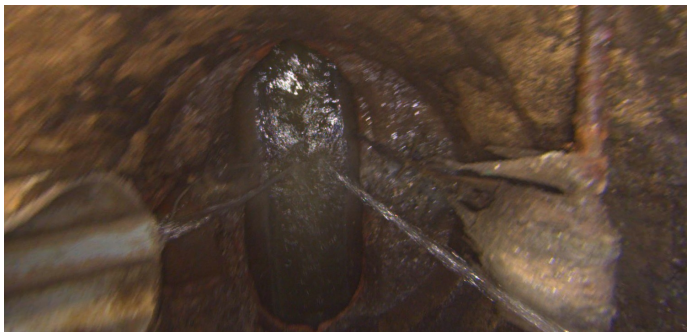
Code: **DAR**
Description: **Deposits Attached Ragging**

Distance (ft): **9.7**
Structural Grade: **0**
O&M Grade: **2**
Clock Start/From: **3**
Clock To: **4**
1st Value:
2nd Value:
Value Percent: **10.000**
Step: **YES**
Remarks:

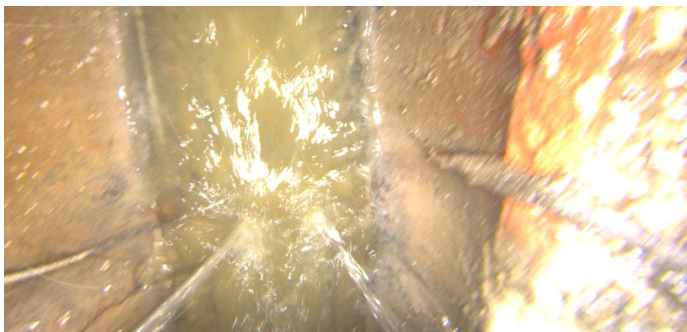
Code: **MGO**
Description: **General Observation**

Distance (ft): **12.2**
Structural Grade: **0**
O&M Grade: **0**
Clock Start/From:
Clock To:
1st Value:
2nd Value:
Value Percent:
Step: **NO**
Remarks: **END SURVEY**
