Manhole Inspection Report

Date:	04/30/2018	Weather:		Coding:	RZMACP
MH#:	M-505-038	Owner:	NA	Len. Surveyed:	6.4
P.O.#:		Surveyor:	Jen Costello	Rim to Invert:	6.8
Customer:		Cert. #:	U-907-5518	Wall Material:	Brick

Street:	California St. 325' South of Clevelan	Project:	Hobart, IN
City:	Hobart, IN	GPS Northing:	2901498.365
Location:		GPS Easting:	2901498.365
Drain Area:	West	GPS Accuracy:	Sub-Meter
Cover Shape:	Circular	Evidence of Surcharge:	No
Cover Size:	22.5	Potential for Runoff:	None
Comments:

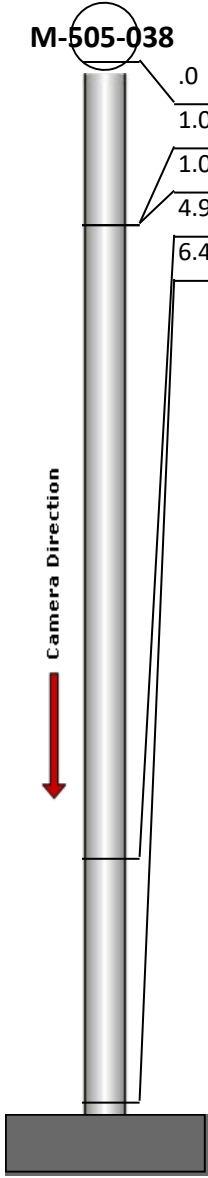
.0	MGP	General Photo	10	NA
	1.0	IS	Infil Stain	23	NA
	1.0	MGO	General Observation	36	NA
	4.9	DSGV	Deposits Settled Gravel	57	M 2
	6.4	MGO	General Observation	71	NA

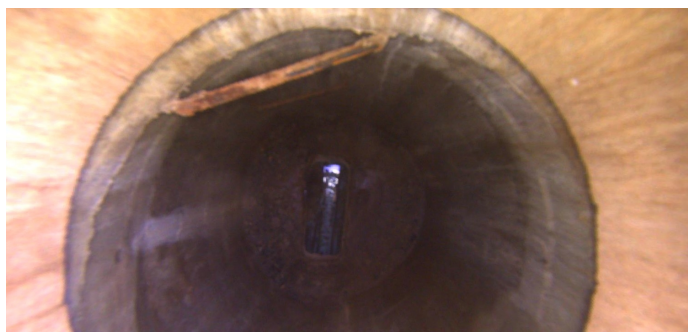
Code: **MGP**
Description: **General Photo**

Distance (ft): **.0**
Structural Grade: **0**
O&M Grade: **0**
Clock Start/From:
Clock To:
1st Value:
2nd Value:
Value Percent:
Step: **NO**
Remarks: **ACCESS MH**

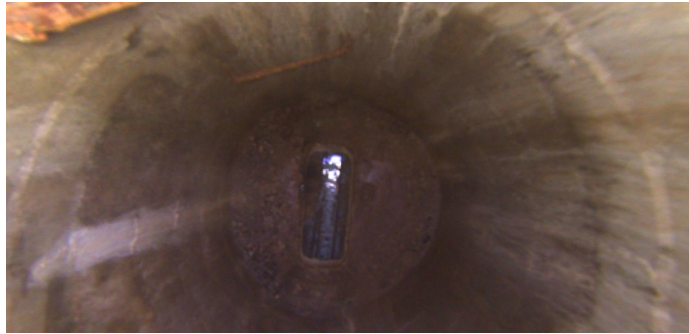
Code: **IS**
Description: **Infil Stain**

Distance (ft): **1.0**
Structural Grade: **0**
O&M Grade: **0**
Clock Start/From: **12**
Clock To: **12**
1st Value:
2nd Value:
Value Percent:
Step: **NO**
Remarks:

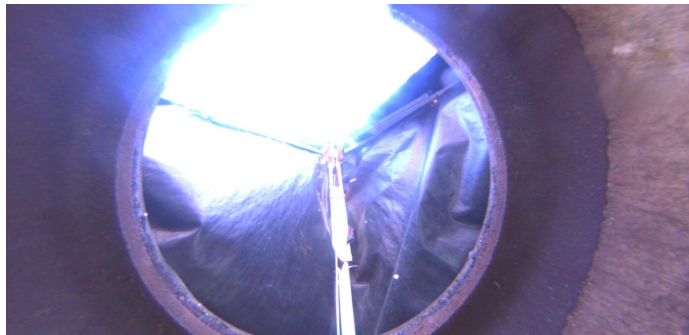
Code: **MGO**
Description: **General Observation**

Distance (ft): **1.0**
Structural Grade: **0**
O&M Grade: **0**
Clock Start/From:
Clock To:
1st Value:
2nd Value:
Value Percent:
Step: **NO**
Remarks: **UNDERSIDE OF FRAME**

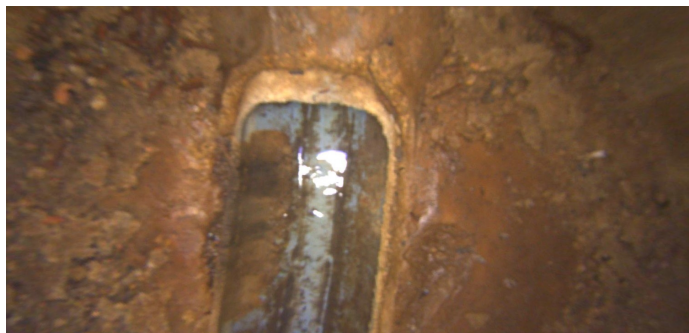
Code: **DSGV**
Description: **Deposits Settled Gravel**

Distance (ft): **4.9**
Structural Grade: **0**
O&M Grade: **2**
Clock Start/From: **12**
Clock To: **12**
1st Value:
2nd Value:
Value Percent: **5.000**
Step: **NO**
Remarks:

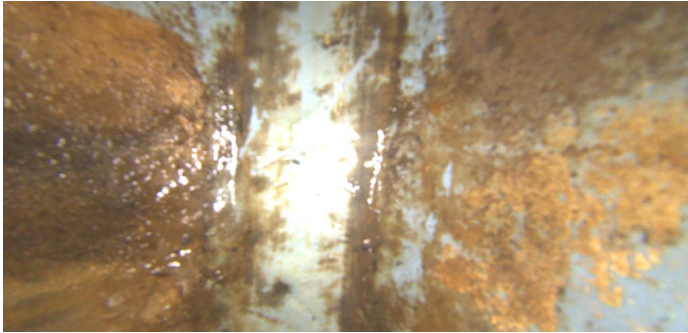
Code:	MGO
Description:	General Observation
Distance (ft):	6.4
Structural Grade:	0
O&M Grade:	0
Clock Start/From:	
Clock To:	
1st Value:	
2nd Value:	
Value Percent:	
Step:	NO
Remarks:	END SURVEY
