Manhole Inspection Report

Date:	04/30/2018	Weather:		Coding:	RZMACP
MH#:	M-505-039	Owner:	NA	Len. Surveyed:	5.5
P.O.#:		Surveyor:	Jen Costello	Rim to Invert:	6.1
Customer:		Cert. #:	U-907-5518	Wall Material:	Brick

Street:	Intersection of Cleveland Ave. and C	Project:	Hobart, IN
City:	Hobart, IN	GPS Northing:	2901491.36
Location:		GPS Easting:	2901491.36
Drain Area:	West	GPS Accuracy:	Sub-Meter
Cover Shape:	Circular	Evidence of Surcharge:	No
Cover Size:	22.5	Potential for Runoff:	None
Comments:

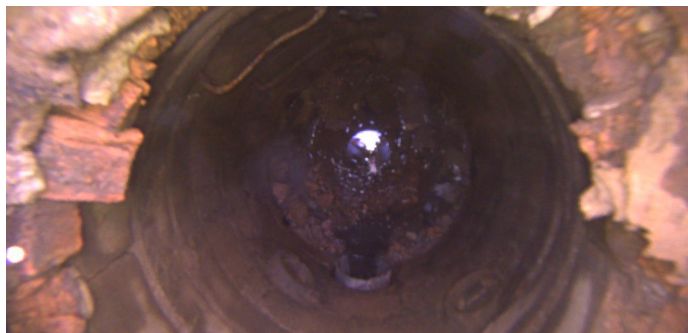
Code: **MGO**
Description: **General Observation**

Distance (ft): **.0**
Structural Grade: **0**
O&M Grade: **0**
Clock Start/From:
Clock To:
1st Value:
2nd Value:
Value Percent:
Step: **NO**
Remarks: **access MH**

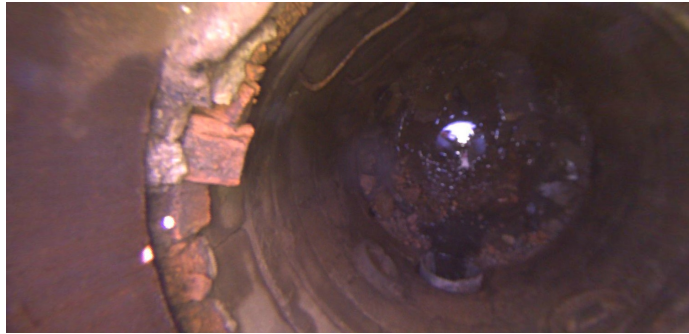
Code: **DB**
Description: **Displaced Brick**

Distance (ft): **.0**
Structural Grade: **3**
O&M Grade: **0**
Clock Start/From: **9**
Clock To:
1st Value:
2nd Value:
Value Percent:
Step: **NO**
Remarks:

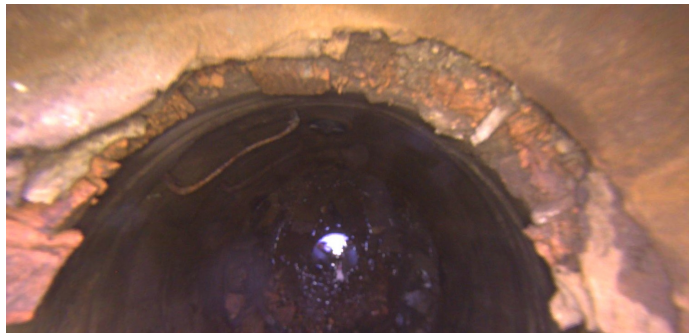
Code: **DAE**
Description: **Deposits Attached Encrustation**

Distance (ft): **.0**
Structural Grade: **0**
O&M Grade: **2**
Clock Start/From: **9**
Clock To: **3**
1st Value:
2nd Value:
Value Percent: **5.000**
Step: **NO**
Remarks:

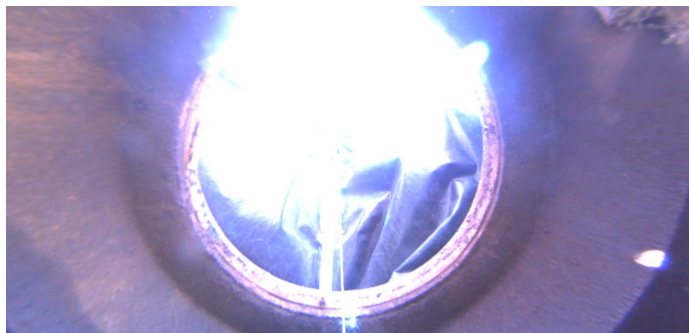
Code: **MGO**
Description: **General Observation**

Distance (ft): **1.2**
Structural Grade: **0**
O&M Grade: **0**
Clock Start/From:
Clock To:
1st Value:
2nd Value:
Value Percent:
Step: **NO**
Remarks: **UNDERSIDE OF FRAME**

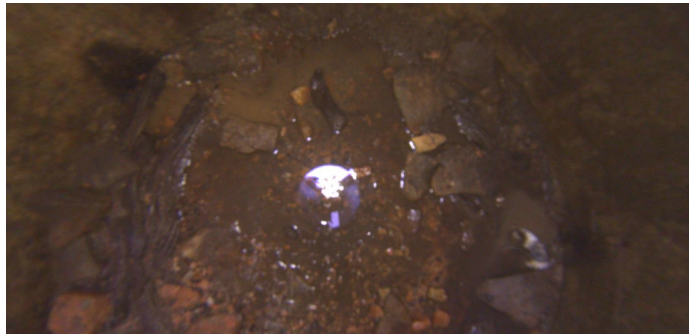
Code:	OBM
Description:	Obstacle Pipe Material
Distance (ft):	3.4
Structural Grade:	0
O&M Grade:	2
Clock Start/From:	12
Clock To:	12
1st Value:	
2nd Value:	
Value Percent:	10.000
Step:	NO
Remarks:

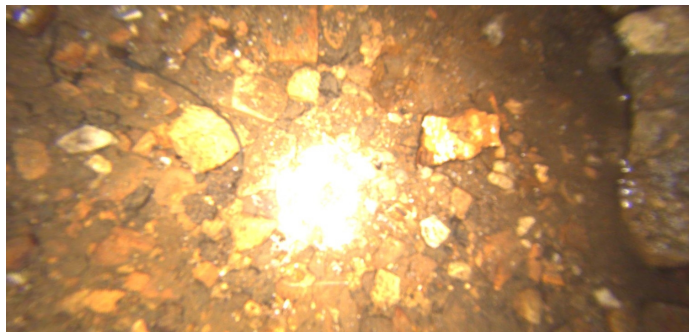
Code:	MGO
Description:	General Observation
Distance (ft):	5.5
Structural Grade:	0
O&M Grade:	0
Clock Start/From:	
Clock To:	
1st Value:	
2nd Value:	
Value Percent:	
Step:	NO
Remarks:	END SURVEY
