Manhole Inspection Report

Date:	05/14/2018	Weather:		Coding:	RZMACP
MH#:	M-505-042	Owner:	NA	Len. Surveyed:	13.7
P.O.#:		Surveyor:	Jen Costello	Rim to Invert:	14.0
Customer:		Cert. #:	U-907-5518	Wall Material:	Brick

Street:	Virginia St. 281' South of 2nd St.	Project:	Hobart, IN
City:	Hobart, IN	GPS Northing:	41.53455353
Location:		GPS Easting:	-87.27243042
Drain Area:	West	GPS Accuracy:	Nearest Meter
Cover Shape:	Circular	Evidence of Surcharge:	No
Cover Size:	22.5	Potential for Runoff:	None
Comments:

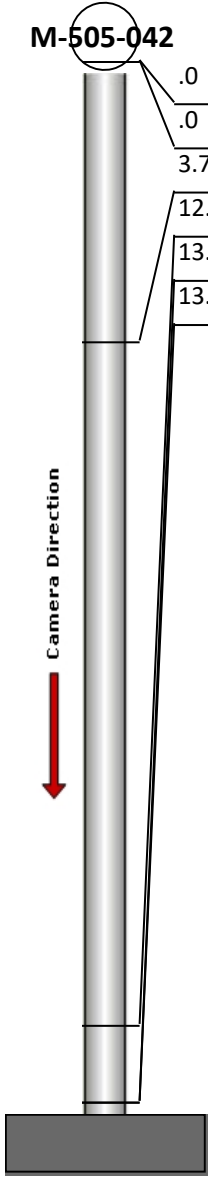
.0	MGO	General Observation	10	NA
	.0	SRI	Surface Roughness Increased	21	S 1
	3.7	MGO	General Observation	42	NA
	12.7	DSC	Deposits Settled Compacted	74	M 2
	13.7	MGO	General Observation	87	NA
	13.7	SRI	Surface Roughness Increased	99	S 1

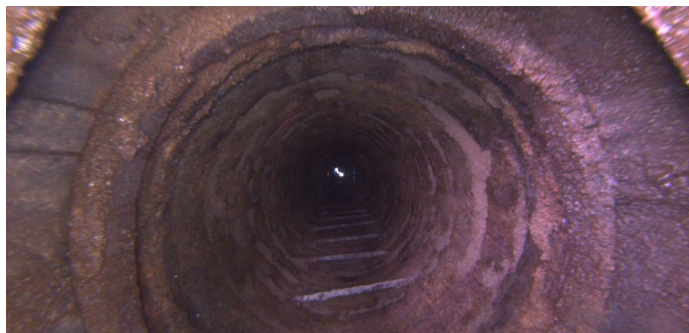
Code: **MGO**
Description: **General Observation**

Distance (ft): **.0**
Structural Grade: **0**
O&M Grade: **0**
Clock Start/From:
Clock To:
1st Value:
2nd Value:
Value Percent:
Step: **NO**
Remarks: **ACCESS MH**

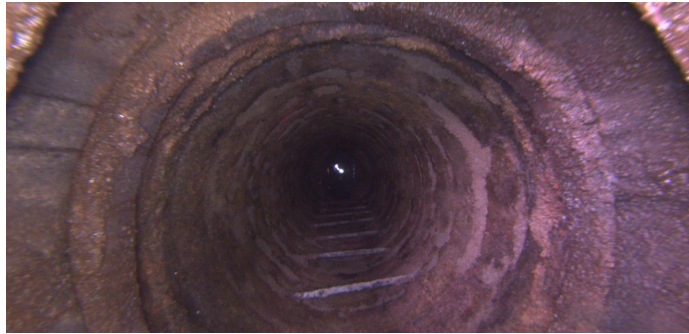
Code: **SRI**
Description: **Surface Roughness Increased**

Distance (ft): **.0**
Structural Grade: **1**
O&M Grade: **0**
Clock Start/From: **12**
Clock To: **12**
1st Value:
2nd Value:
Value Percent:
Step: **NO**
Remarks:

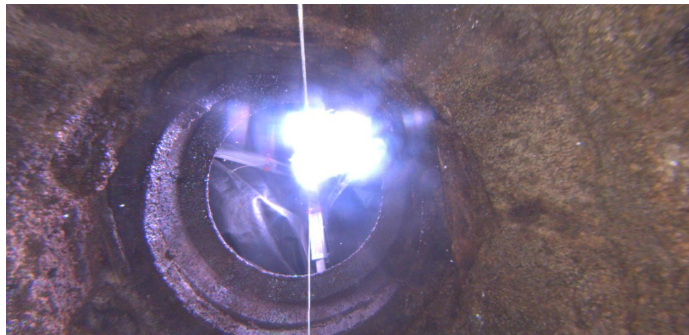
Code: **MGO**
Description: **General Observation**

Distance (ft): **3.7**
Structural Grade: **0**
O&M Grade: **0**
Clock Start/From:
Clock To:
1st Value:
2nd Value:
Value Percent:
Step: **NO**
Remarks: **UNDERSIDE OF FRAME**

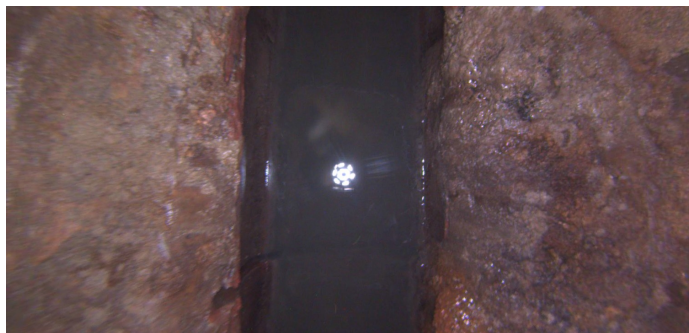
Code: **DSC**
Description: **Deposits Settled Compacted**

Distance (ft): **12.7**
Structural Grade: **0**
O&M Grade: **2**
Clock Start/From: **12**
Clock To: **12**
1st Value:
2nd Value:
Value Percent: **5.000**
Step: **NO**
Remarks:

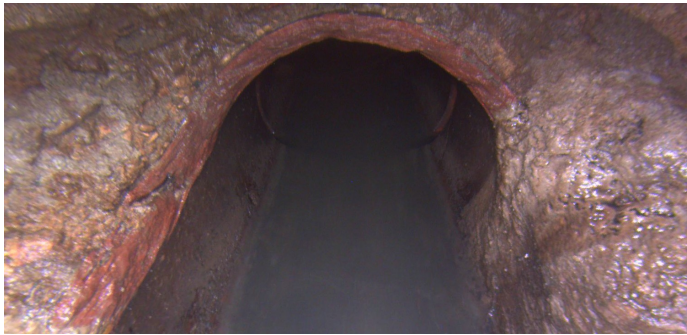
Code: **MGO**
Description: **General Observation**

Distance (ft): **13.7**
Structural Grade: **0**
O&M Grade: **0**
Clock Start/From:
Clock To:
1st Value:
2nd Value:
Value Percent:
Step: **NO**
Remarks: **END SURVEY**

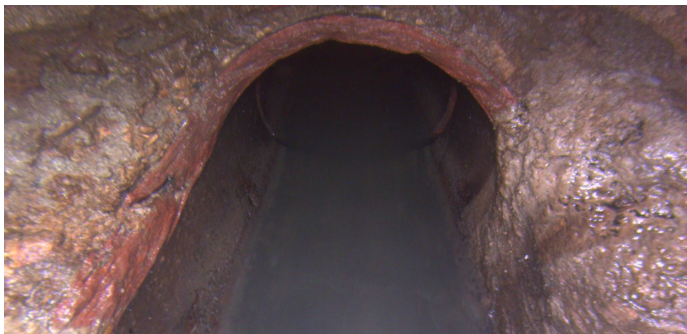
Code: **SRI**
Description: **Surface Roughness Increased**

Distance (ft): **13.7**
Structural Grade: **1**
O&M Grade: **0**
Clock Start/From: **12**
Clock To: **12**
1st Value:
2nd Value:
Value Percent:
Step: **NO**
Remarks:
