Manhole Inspection Report

Date:	10/03/2022	Weather:		Coding:	RZMACP
MH#:	M-505-044	Owner:	NA	Len. Surveyed:	8.1
P.O.#:		Surveyor:	Jen Costello	Rim to Invert:	8.8
Customer:		Cert. #:	U-907-5518	Wall Material:	Concrete (cast in place)

Street:	Virginia St. 300' North of 2nd St.	Project:	Hobart, IN
City:	Hobart, IN	GPS Northing:	2290134.453
Location:	Local Rural Streets	GPS Easting:	2901171.895
Drain Area:	West	GPS Accuracy:	Sub-Meter
Cover Shape:	Circular	Evidence of Surcharge:	No
Cover Size:	24.0	Potential for Runoff:	None
Comments:

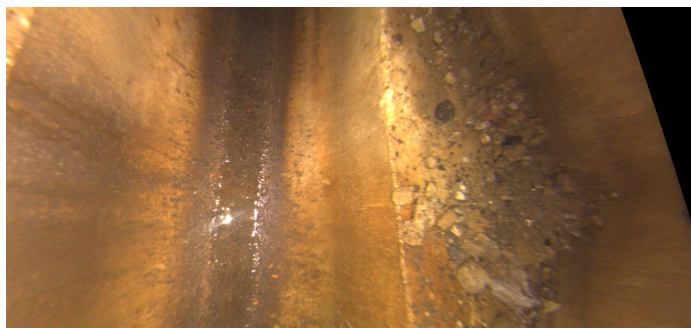
Code: **DSGV**
Description: **Deposits Settled Gravel**

Distance (ft): **7.1**
Structural Grade: **0**
O&M Grade: **2**
Clock Start/From: **12**
Clock To: **12**
1st Value:
2nd Value:
Value Percent: **5.000**
Step: **NO**
Remarks:

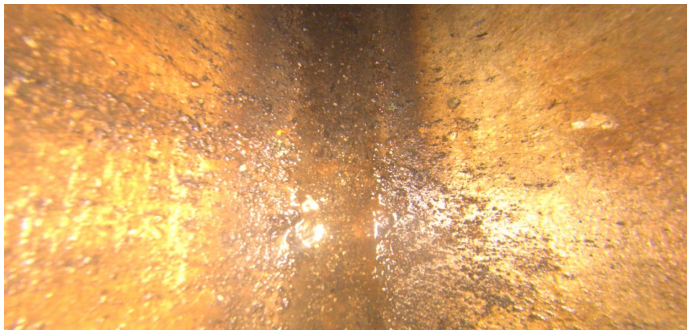
Code: **MGO**
Description: **General Observation**

Distance (ft): **8.1**
Structural Grade: **0**
O&M Grade: **0**
Clock Start/From:
Clock To:
1st Value:
2nd Value:
Value Percent:
Step: **NO**
Remarks: **end of survey**
