Manhole Inspection Report

Date:	10/03/2022	Weather:		Coding:	RZMACP
MH#:	M-505-046	Owner:	NA	Len. Surveyed:	13.5
P.O.#:		Surveyor:	Jen Costello	Rim to Invert:	14.8
Customer:		Cert. #:	U-907-5518	Wall Material:	Concrete (cast in place)

Street:	2nd St. 166' West of Virginia St.	Project:	Hobart, IN
City:	Hobart, IN	GPS Northing:	2289841.226
Location:	Local Rural Streets	GPS Easting:	2901007.644
Drain Area:	West	GPS Accuracy:	Sub-Meter
Cover Shape:	Circular	Evidence of Surcharge:	No
Cover Size:	24.0	Potential for Runoff:	None
Comments:

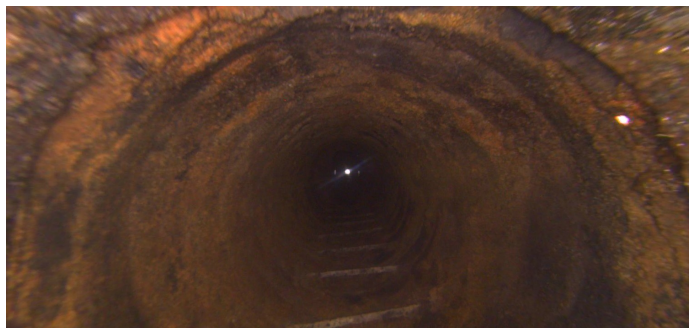
Code: **MGO**
Description: **General Observation**

Distance (ft): **.0**
Structural Grade: **0**
O&M Grade: **0**
Clock Start/From:
Clock To:
1st Value:
2nd Value:
Value Percent:
Step: **NO**
Remarks: **access mh**

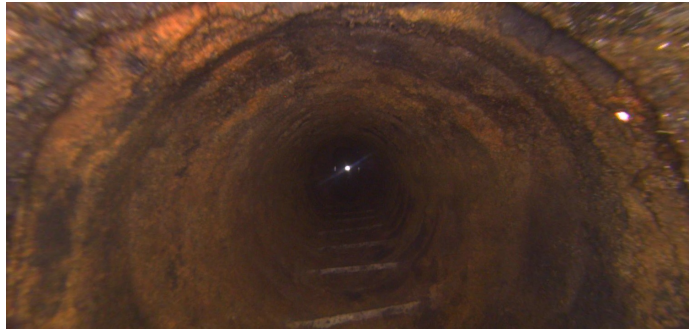
Code: **SAV**
Description: **Surface Aggregate Visible**

Distance (ft): **.0**
Structural Grade: **3**
O&M Grade: **0**
Clock Start/From: **12**
Clock To: **12**
1st Value:
2nd Value:
Value Percent:
Step: **NO**
Remarks:

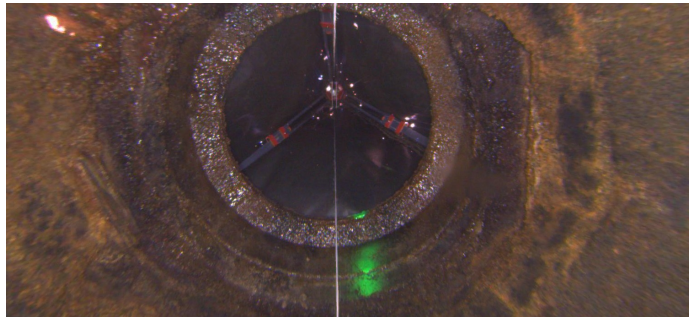
Code: **MGO**
Description: **General Observation**

Distance (ft): **2.6**
Structural Grade: **0**
O&M Grade: **0**
Clock Start/From:
Clock To:
1st Value:
2nd Value:
Value Percent:
Step: **NO**
Remarks: **underside of frame**

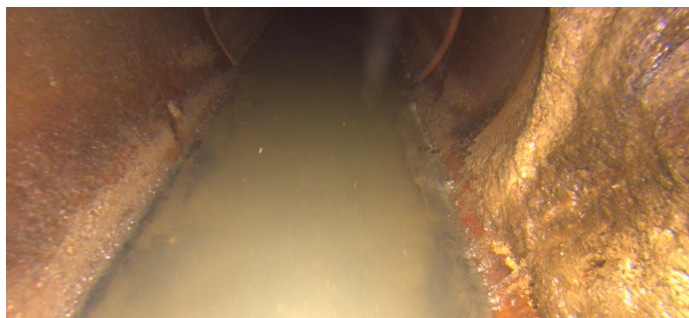
Code: **DAE**
Description: **Deposits Attached Encrustation**

Distance (ft): **13.5**
Structural Grade: **0**
O&M Grade: **2**
Clock Start/From: **3**
Clock To: **5**
1st Value:
2nd Value:
Value Percent: **10.000**
Step: **NO**
Remarks:

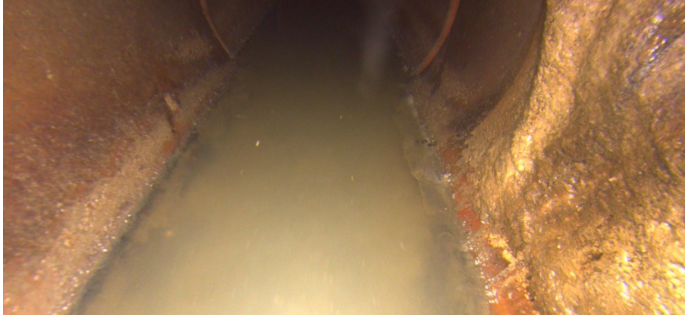
Code:	SAV
Description:	Surface Aggregate Visible

Distance (ft):	13.5
Structural Grade:	3
O&M Grade:	0
Clock Start/From:	12
Clock To:	12
1st Value:	
2nd Value:	
Value Percent:	
Step:	NO
Remarks:

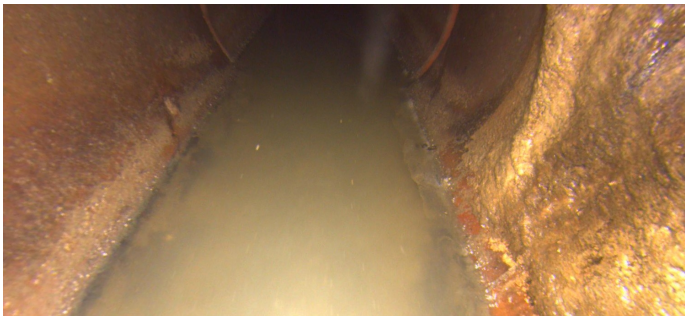
Code:	MGO
Description:	General Observation

Distance (ft):	13.5
Structural Grade:	0
O&M Grade:	0
Clock Start/From:	
Clock To:	
1st Value:	
2nd Value:	
Value Percent:	
Step:	NO
Remarks:	end of survey
