Manhole Inspection Report

Date:	05/13/2018	Weather:		Coding:	RZMACP
MH#:	M-505-054	Owner:	NA	Len. Surveyed:	13.6
P.O.#:		Surveyor:	Jen Costello	Rim to Invert:	15.2
Customer:		Cert. #:	U-907-5518	Wall Material:	Brick

Street:	Intersection of Colorado St. and 2nd	Project:	Hobart, IN
City:	Hobart, IN	GPS Northing:	41.53455353
Location:		GPS Easting:	-87.27412415
Drain Area:	West	GPS Accuracy:	Nearest Meter
Cover Shape:	Circular	Evidence of Surcharge:	No
Cover Size:	22.5	Potential for Runoff:	None
Comments:

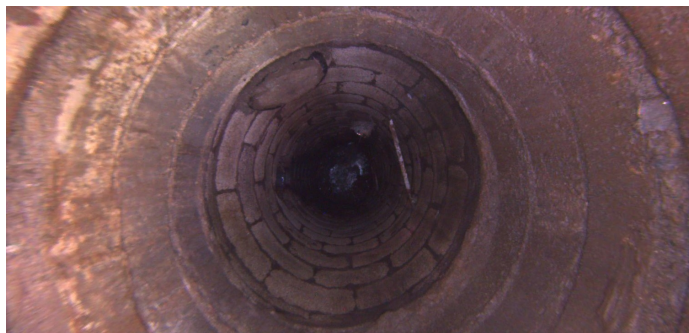
Code: **MGO**
Description: **General Observation**

Distance (ft): **.0**
Structural Grade: **0**
O&M Grade: **0**
Clock Start/From:
Clock To:
1st Value:
2nd Value:
Value Percent:
Step: **NO**
Remarks: **ACCESS MH**

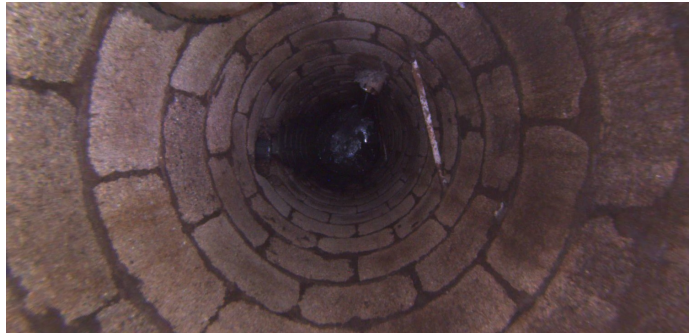
Code: **SAV**
Description: **Surface Aggregate Visible**

Distance (ft): **1.7**
Structural Grade: **3**
O&M Grade: **0**
Clock Start/From: **12**
Clock To: **12**
1st Value:
2nd Value:
Value Percent:
Step: **NO**
Remarks:

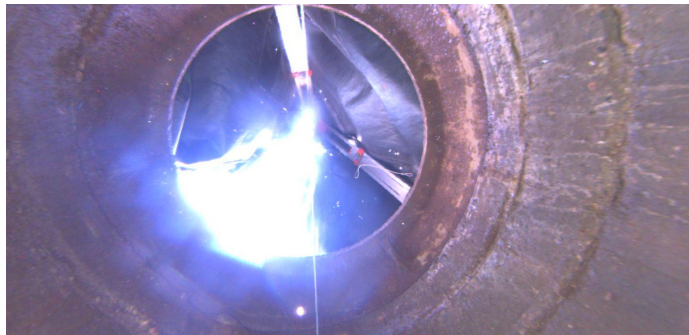
Code: **MGO**
Description: **General Observation**

Distance (ft): **2.6**
Structural Grade: **0**
O&M Grade: **0**
Clock Start/From:
Clock To:
1st Value:
2nd Value:
Value Percent:
Step: **NO**
Remarks: **UNDERSIDE OF FRAME**

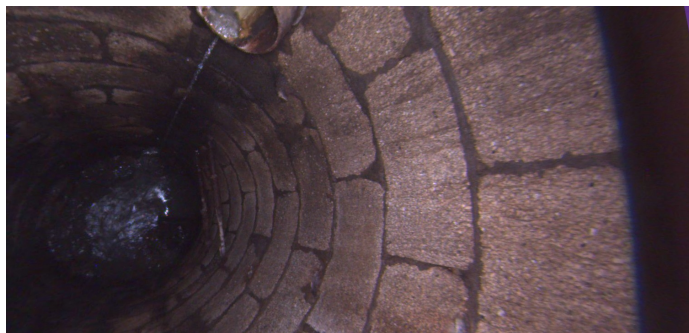
Code: **MGO**
Description: **General Observation**

Distance (ft): **6.0**
Structural Grade: **0**
O&M Grade: **0**
Clock Start/From:
Clock To:
1st Value:
2nd Value:
Value Percent:
Step: **NO**
Remarks: **MISSING AND BROKEN STEP**

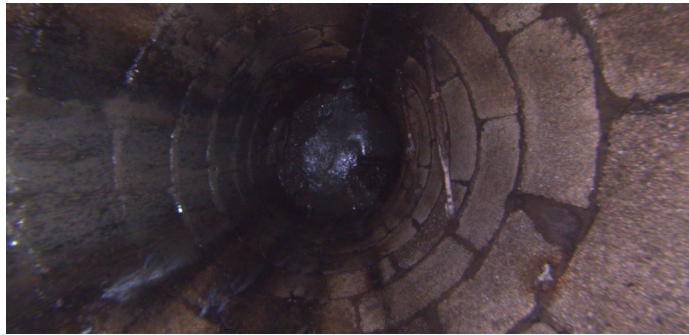
Code: **IW**
Description: **Infil Weeper**

Distance (ft): **8.1**
Structural Grade: **0**
O&M Grade: **2**
Clock Start/From: **6**
Clock To: **12**
1st Value:
2nd Value:
Value Percent:
Step: **NO**
Remarks:

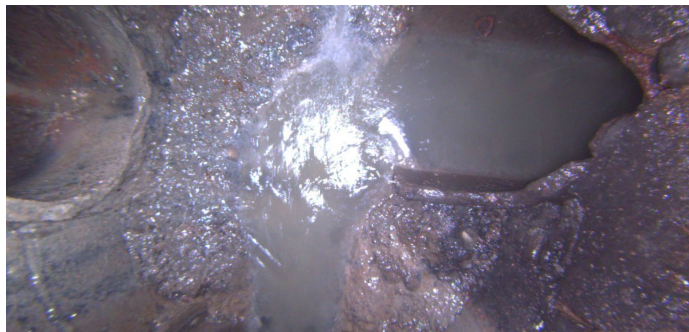
Code: **MGO**
Description: **General Observation**

Distance (ft): **13.6**
Structural Grade: **0**
O&M Grade: **0**
Clock Start/From:
Clock To:
1st Value:
2nd Value:
Value Percent:
Step: **NO**
Remarks: **END SURVEY**

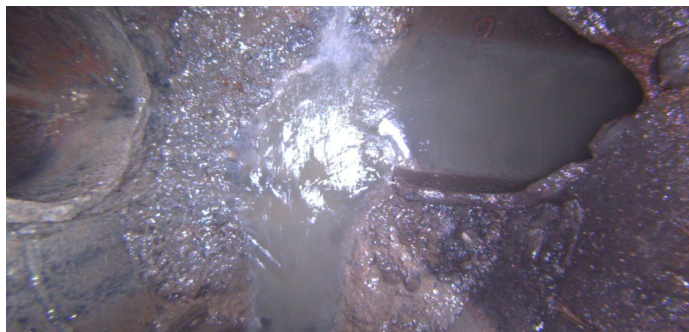
Code: **SAV**
Description: **Surface Aggregate Visible**

Distance (ft): **13.6**
Structural Grade: **3**
O&M Grade: **0**
Clock Start/From: **12**
Clock To: **12**
1st Value:
2nd Value:
Value Percent:
Step: **NO**
Remarks:
