Manhole Inspection Report

Date:	05/13/2018	Weather:		Coding:	RZMACP
MH#:	M-505-055	Owner:	NA	Len. Surveyed:	14.8
P.O.#:		Surveyor:	Jen Costello	Rim to Invert:	15.0
Customer:		Cert. #:	U-907-5518	Wall Material:	Brick

Street:	Colorado St. 165' North of 2nd St.	Project:	Hobart, IN
City:	Hobart, IN	GPS Northing:	41.53502655
Location:		GPS Easting:	-87.27410126
Drain Area:	West	GPS Accuracy:	Nearest Meter
Cover Shape:	Circular	Evidence of Surcharge:	No
Cover Size:	22.5	Potential for Runoff:	None
Comments:

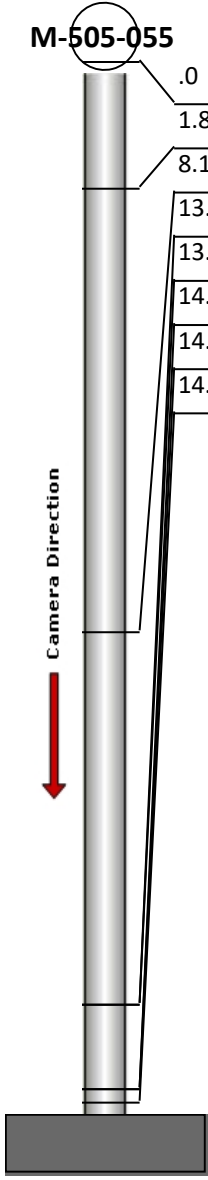
.0	MGO	General Observation	10	NA
	1.8	SAV	Surface Aggregate Visible	25	S 3
	8.1	RFB	Roots Fine Barrel	50	M 2
	13.4	RFB	Roots Fine Barrel	71	M 2
	13.4	RMB	Roots Medium Barrel	82	M 4
	14.6	DSGV	Deposits Settled Gravel	95	M 2
	14.6	SAV	Surface Aggregate Visible	105	S 3
	14.8	MGO	General Observation	117	NA

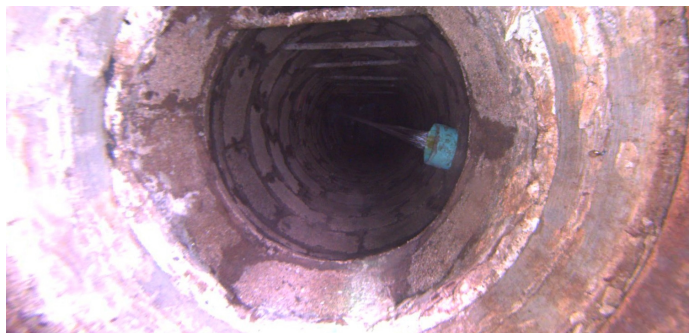
Code: **MGO**
Description: **General Observation**

Distance (ft): **.0**
Structural Grade: **0**
O&M Grade: **0**
Clock Start/From:
Clock To:
1st Value:
2nd Value:
Value Percent:
Step: **NO**
Remarks: **ACCESS MH**

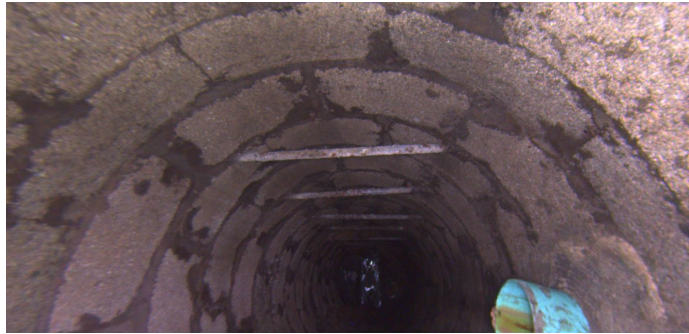
Code: **SAV**
Description: **Surface Aggregate Visible**

Distance (ft): **1.8**
Structural Grade: **3**
O&M Grade: **0**
Clock Start/From: **12**
Clock To: **12**
1st Value:
2nd Value:
Value Percent:
Step: **NO**
Remarks:

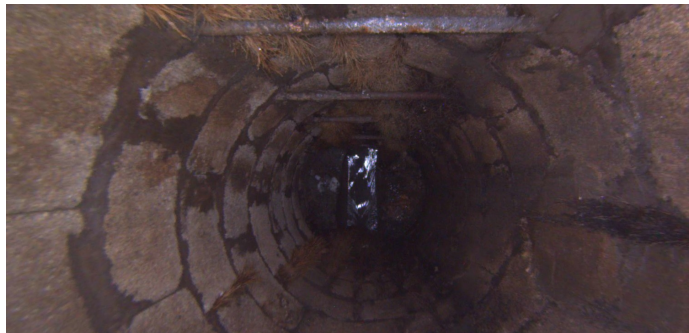
Code: **RFB**
Description: **Roots Fine Barrel**

Distance (ft): **8.1**
Structural Grade: **0**
O&M Grade: **2**
Clock Start/From: **12**
Clock To: **12**
1st Value:
2nd Value:
Value Percent:
Step: **NO**
Remarks:

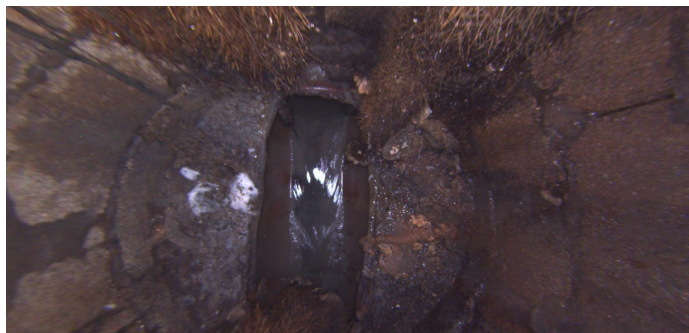
Code: **RFB**
Description: **Roots Fine Barrel**

Distance (ft): **13.4**
Structural Grade: **0**
O&M Grade: **2**
Clock Start/From: **12**
Clock To: **12**
1st Value:
2nd Value:
Value Percent:
Step: **NO**
Remarks:

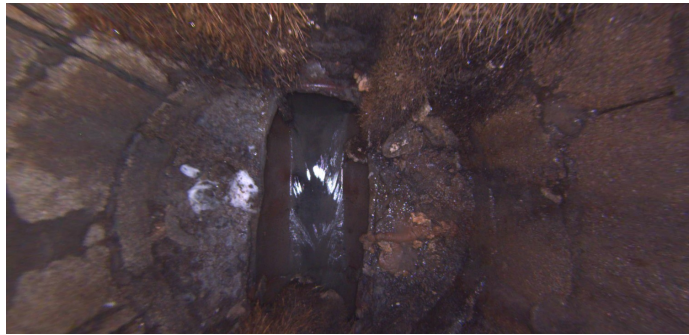
Code: **RMB**
Description: **Roots Medium Barrel**

Distance (ft): **13.4**
Structural Grade: **0**
O&M Grade: **4**
Clock Start/From: **12**
Clock To: **12**
1st Value:
2nd Value:
Value Percent: **10.000**
Step: **NO**
Remarks:

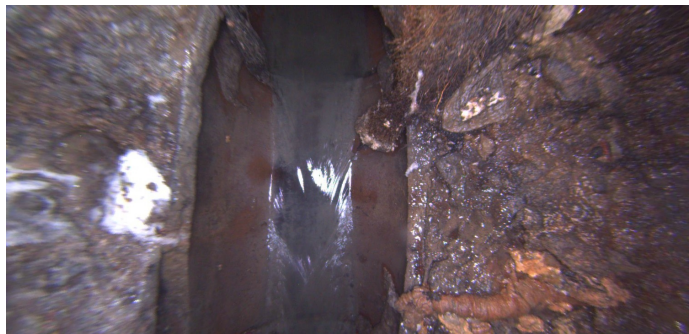
Code: **DSGV**
Description: **Deposits Settled Gravel**

Distance (ft): **14.6**
Structural Grade: **0**
O&M Grade: **2**
Clock Start/From: **12**
Clock To: **12**
1st Value:
2nd Value:
Value Percent: **10.000**
Step: **NO**
Remarks:

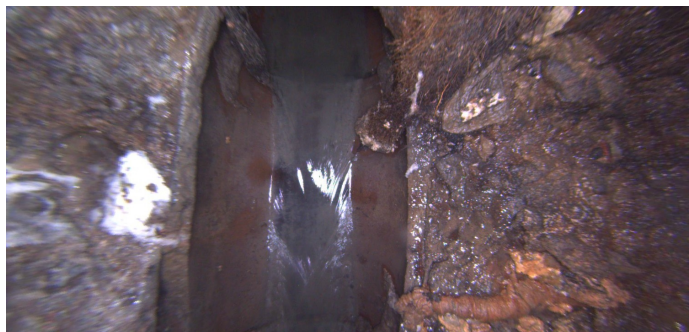
Code: **SAV**
Description: **Surface Aggregate Visible**

Distance (ft): **14.6**
Structural Grade: **3**
O&M Grade: **0**
Clock Start/From: **12**
Clock To: **12**
1st Value:
2nd Value:
Value Percent:
Step: **NO**
Remarks:

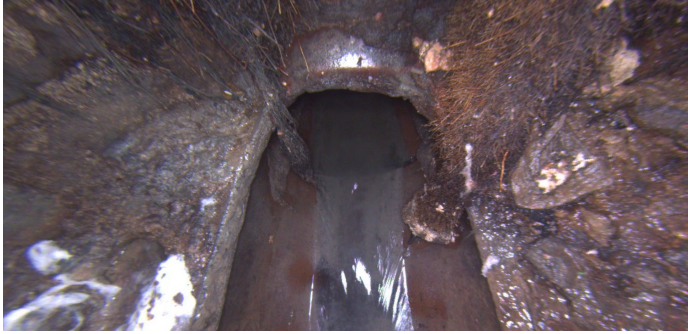
Code:	MGO
Description:	General Observation
Distance (ft):	14.8
Structural Grade:	0
O&M Grade:	0
Clock Start/From:	
Clock To:	
1st Value:	
2nd Value:	
Value Percent:	
Step:	NO
Remarks:	END SURVEY
