# Manhole Inspection Report

Date:	<b>05/13/2018</b>	Weather:		Coding:	<b>RZMACP</b>
MH#:	<b>M-505-056</b>	Owner:	<b>NA</b>	Len. Surveyed:	<b>15.4</b>
P.O.#:		Surveyor:	<b>Jen Costello</b>	Rim to Invert:	<b>16.5</b>
Customer:		Cert. #:	<b>U-907-5518</b>	Wall Material:	<b>Brick</b>

Street:	<b>Intersection of 1st Pl. and Colorado</b>	Project:	<b>Hobart, IN</b>
City:	<b>Hobart, IN</b>	GPS Northing:	<b>41.53541565</b>
Location:		GPS Easting:	<b>-87.274086</b>
Drain Area:	<b>West</b>	GPS Accuracy:	<b>Nearest Meter</b>
Cover Shape:	<b>Circular</b>	Evidence of Surcharge:	<b>No</b>
Cover Size:	<b>22.5</b>	Potential for Runoff:	<b>None</b>
Comments:

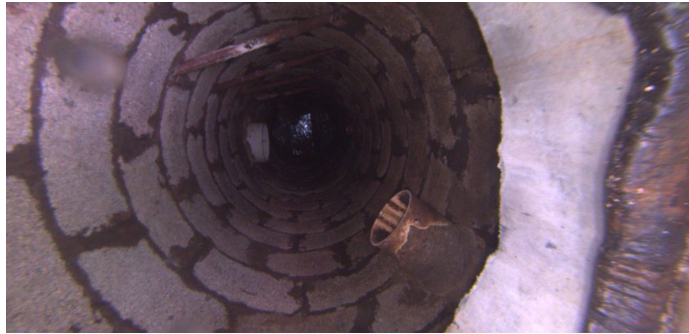
Code: **SAV**  
Description: **Surface Aggregate Visible**

Distance (ft): **1.3**  
Structural Grade: **3**  
O&M Grade: **0**  
Clock Start/From: **12**  
Clock To: **12**  
1st Value:  
2nd Value:  
Value Percent:  
Step: **NO**  
Remarks:

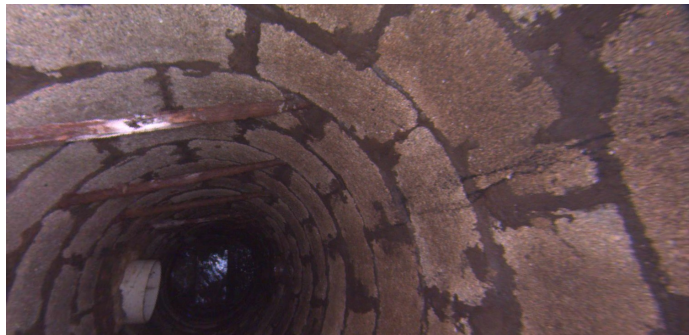
Code: **RFJ**  
Description: **Roots Fine Joint**

Distance (ft): **2.6**  
Structural Grade: **0**  
O&M Grade: **1**  
Clock Start/From: **2**  
Clock To:  
1st Value:  
2nd Value:  
Value Percent:  
Step: **NO**  
Remarks:

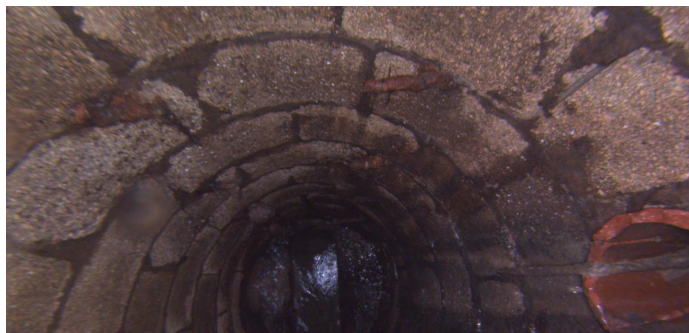
Code: **IW**  
Description: **Infil Weeper**

Distance (ft): **8.8**  
Structural Grade: **0**  
O&M Grade: **2**  
Clock Start/From: **1**  
Clock To: **4**  
1st Value:  
2nd Value:  
Value Percent:  
Step: **NO**  
Remarks:

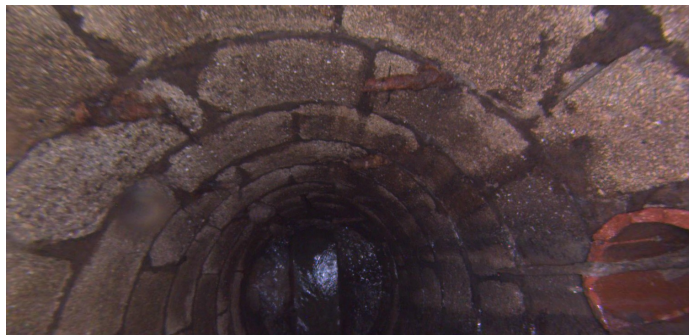
Code: **MGO**  
Description: **General Observation**

Distance (ft): **8.8**  
Structural Grade: **0**  
O&M Grade: **0**  
Clock Start/From:  
Clock To:  
1st Value:  
2nd Value:  
Value Percent:  
Step: **NO**  
Remarks: **MISSING AND BROKEN STEPS**

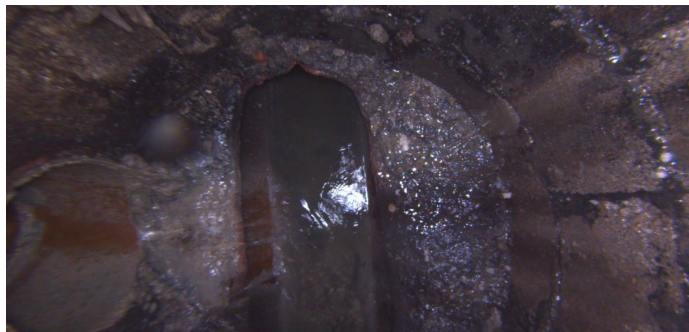
Code: **IW**  
Description: **Infil Weeper**

Distance (ft): **13.8**  
Structural Grade: **0**  
O&M Grade: **2**  
Clock Start/From: **12**  
Clock To: **12**  
1st Value:  
2nd Value:  
Value Percent:  
Step: **NO**  
Remarks:

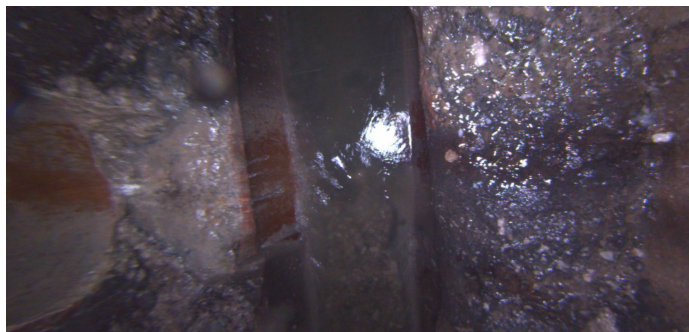
Code: **DSF**  
Description: **Deposits Settled Fine**

Distance (ft): **14.7**  
Structural Grade: **0**  
O&M Grade: **2**  
Clock Start/From: **12**  
Clock To: **12**  
1st Value:  
2nd Value:  
Value Percent: **5.000**  
Step: **NO**  
Remarks:
