# Manhole Inspection Report

Date:	<b>05/13/2018</b>	Weather:		Coding:	<b>RZMACP</b>
MH#:	<b>M-505-059</b>	Owner:	<b>NA</b>	Len. Surveyed:	<b>11.3</b>
P.O.#:		Surveyor:	<b>Jen Costello</b>	Rim to Invert:	<b>12.0</b>
Customer:		Cert. #:	<b>U-907-5518</b>	Wall Material:	<b>Brick</b>

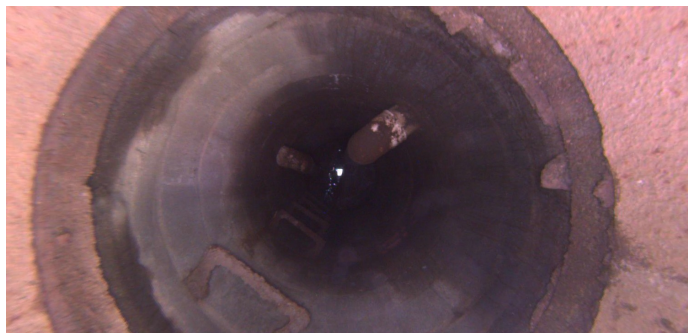
Code: **MGO**  
Description: **General Observation**

Distance (ft): **.0**  
Structural Grade: **0**  
O&M Grade: **0**  
Clock Start/From:  
Clock To:  
1st Value:  
2nd Value:  
Value Percent:  
Step: **NO**  
Remarks: **access MH**

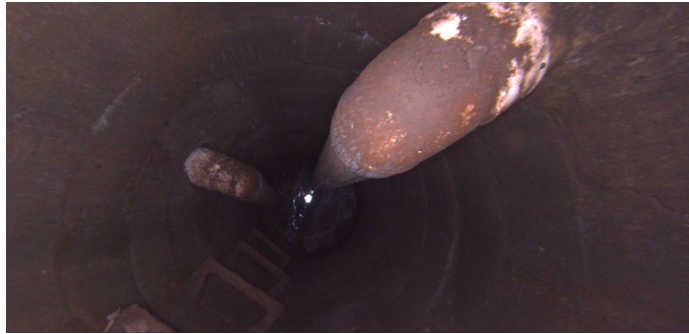
Code: **OBP**  
Description: **Obstacle External Pipe or Cable**

Distance (ft): **3.3**  
Structural Grade: **0**  
O&M Grade: **2**  
Clock Start/From: **2**  
Clock To:  
1st Value:  
2nd Value:  
Value Percent: **10.000**  
Step: **NO**  
Remarks:

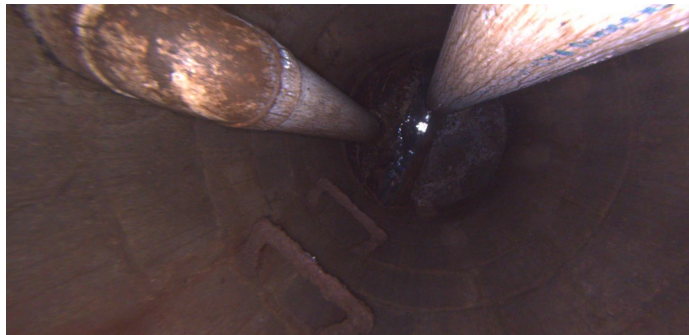
Code: **OBP**  
Description: **Obstacle External Pipe or Cable**

Distance (ft): **6.5**  
Structural Grade: **0**  
O&M Grade: **2**  
Clock Start/From: **10**  
Clock To:  
1st Value:  
2nd Value:  
Value Percent: **10.000**  
Step: **NO**  
Remarks:

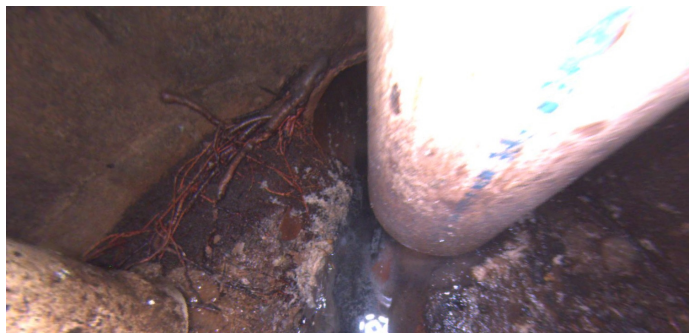
Code: **RFB**  
Description: **Roots Fine Barrel**

Distance (ft): **10.8**  
Structural Grade: **0**  
O&M Grade: **2**  
Clock Start/From: **9**  
Clock To: **12**  
1st Value:  
2nd Value:  
Value Percent:  
Step: **NO**  
Remarks:

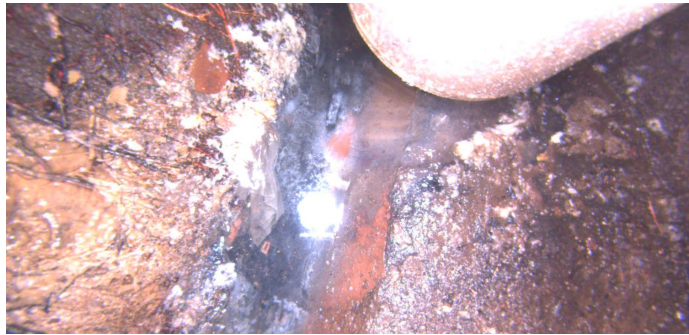
Code: **DSF**  
Description: **Deposits Settled Fine**

Distance (ft): **11.3**  
Structural Grade: **0**  
O&M Grade: **2**  
Clock Start/From: **12**  
Clock To: **12**  
1st Value:  
2nd Value:  
Value Percent: **5.000**  
Step: **NO**  
Remarks:

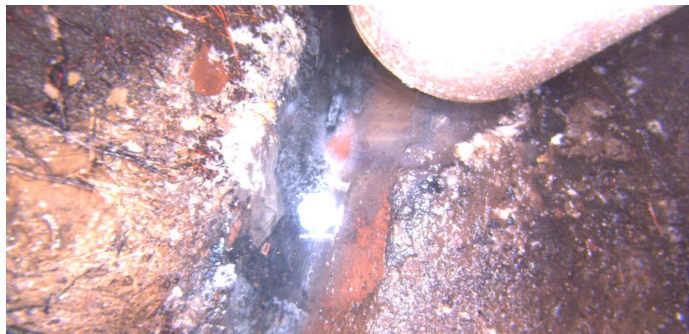
Code: **MGO**  
Description: **General Observation**

Distance (ft): **11.3**  
Structural Grade: **0**  
O&M Grade: **0**  
Clock Start/From:  
Clock To:  
1st Value:  
2nd Value:  
Value Percent:  
Step: **NO**  
Remarks: **END SURVEY**

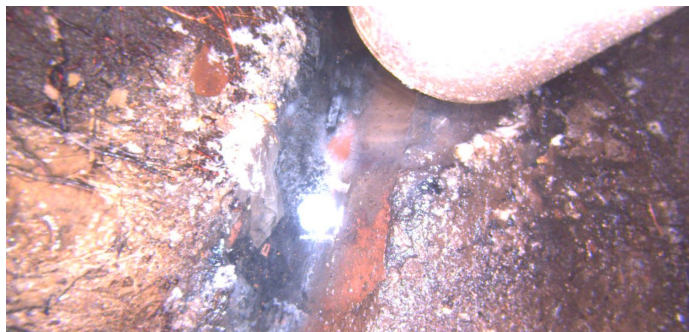
Code: **OBP**  
Description: **Obstacle External Pipe or Cable**

Distance (ft): **11.3**  
Structural Grade: **0**  
O&M Grade: **2**  
Clock Start/From: **2**  
Clock To:  
1st Value:  
2nd Value:  
Value Percent: **10.000**  
Step: **NO**  
Remarks:

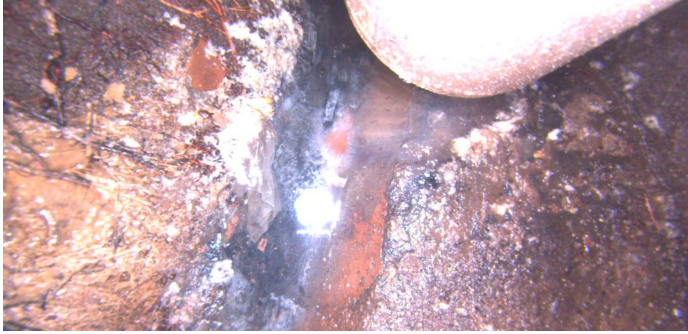
Code:	<b>OBP</b>
Description:	<b>Obstacle External Pipe or Cable</b>
Distance (ft):	<b>11.3</b>
Structural Grade:	<b>0</b>
O&M Grade:	<b>2</b>
Clock Start/From:	<b>10</b>
Clock To:	
1st Value:	
2nd Value:	
Value Percent:	<b>10.000</b>
Step:	<b>NO</b>
Remarks:
