Manhole Inspection Report

Date:	05/13/2018	Weather:		Coding:	RZMACP
MH#:	M-505-067	Owner:	NA	Len. Surveyed:	5.7
P.O.#:		Surveyor:	Jen Costello	Rim to Invert:	5.8
Customer:		Cert. #:	U-907-5518	Wall Material:	Brick

Street:	Wilson St. 162' South of 1st Pl.	Project:	Hobart, IN
City:	Hobart, IN	GPS Northing:	41.53509903
Location:		GPS Easting:	-87.2782135
Drain Area:	West	GPS Accuracy:	Nearest Meter
Cover Shape:	Circular	Evidence of Surcharge:	No
Cover Size:	22.5	Potential for Runoff:	None
Comments:

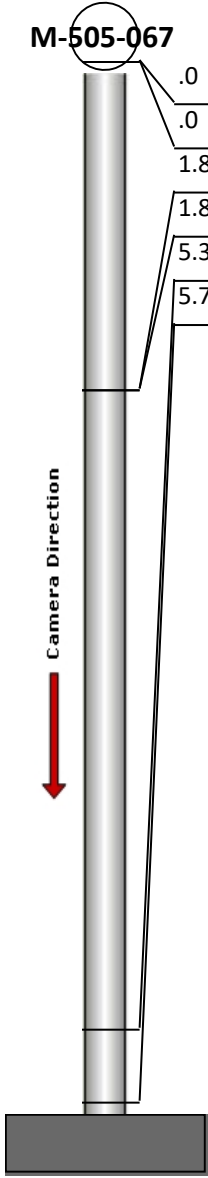
.0	MGO	General Observation	10	NA
	.0	RFJ	Roots Fine Joint	21	M 1
	1.8	MGO	General Observation	38	NA
	1.8	DB	Displaced Brick	48	S 3
	5.3	DSF	Deposits Settled Fine	68	M 2
	5.7	MGO	General Observation	81	NA

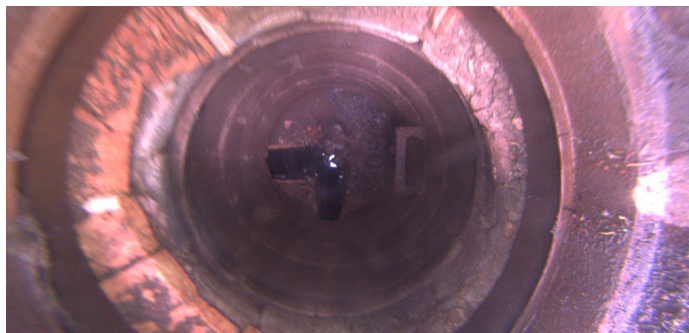
Code: **MGO**
Description: **General Observation**

Distance (ft): **.0**
Structural Grade: **0**
O&M Grade: **0**
Clock Start/From:
Clock To:
1st Value:
2nd Value:
Value Percent:
Step: **NO**
Remarks: **ACCESS MH**

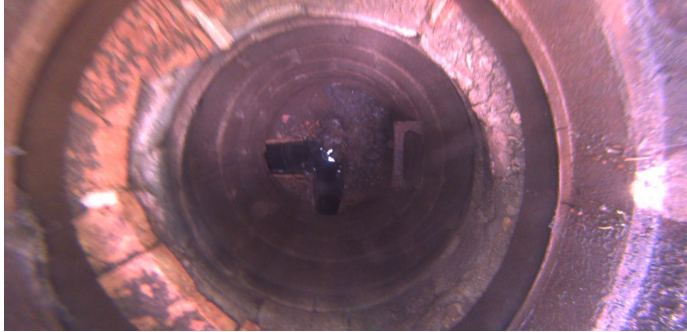
Code: **RFJ**
Description: **Roots Fine Joint**

Distance (ft): **.0**
Structural Grade: **0**
O&M Grade: **1**
Clock Start/From: **3**
Clock To: **4**
1st Value:
2nd Value:
Value Percent:
Step: **NO**
Remarks:

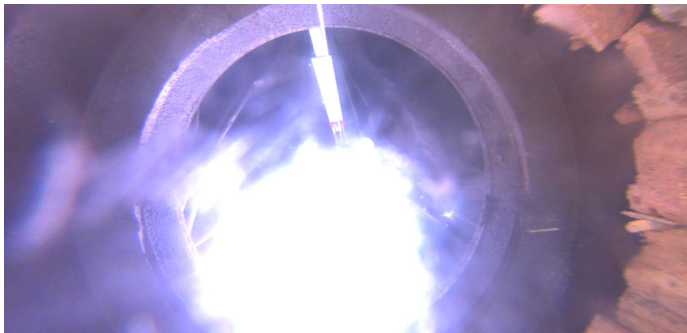
Code: **MGO**
Description: **General Observation**

Distance (ft): **1.8**
Structural Grade: **0**
O&M Grade: **0**
Clock Start/From:
Clock To:
1st Value:
2nd Value:
Value Percent:
Step: **NO**
Remarks: **UNDERSIDE OF FRAME**

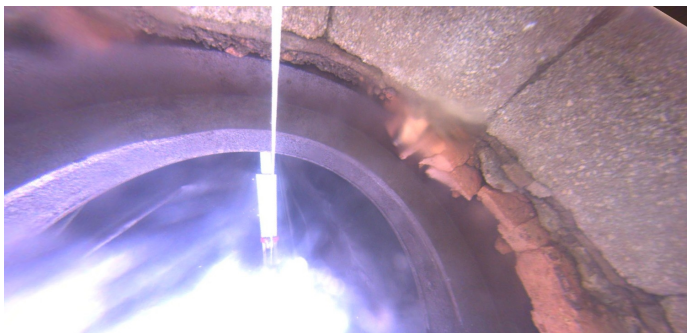
Code: **DB**
Description: **Displaced Brick**

Distance (ft): **1.8**
Structural Grade: **3**
O&M Grade: **0**
Clock Start/From: **10**
Clock To: **12**
1st Value:
2nd Value:
Value Percent:
Step: **NO**
Remarks:

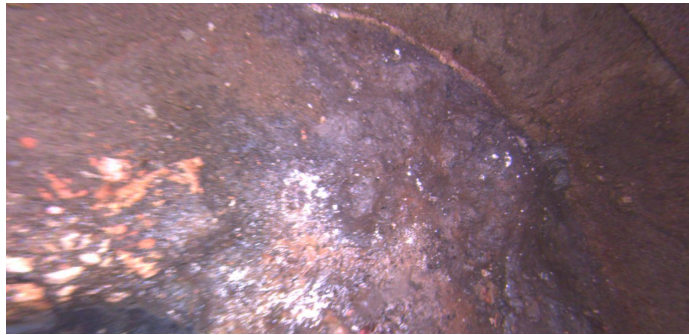
Code:	DSF
Description:	Deposits Settled Fine
Distance (ft):	5.3
Structural Grade:	0
O&M Grade:	2
Clock Start/From:	12
Clock To:	12
1st Value:	
2nd Value:	
Value Percent:	5.000
Step:	NO
Remarks:

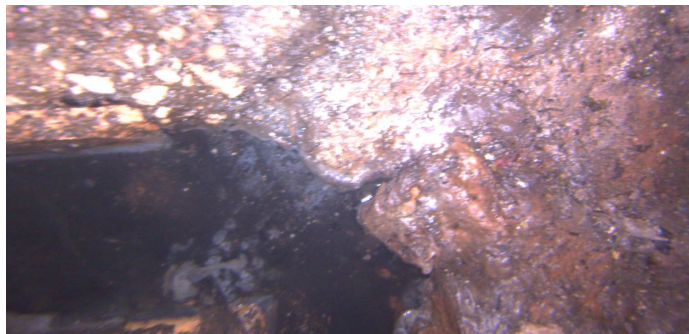
Code:	MGO
Description:	General Observation
Distance (ft):	5.7
Structural Grade:	0
O&M Grade:	0
Clock Start/From:	
Clock To:	
1st Value:	
2nd Value:	
Value Percent:	
Step:	NO
Remarks:	END SURVEY
