Manhole Inspection Report

Date:	04/28/2018	Weather:		Coding:	RZMACP
MH#:	M-505-085	Owner:	NA	Len. Surveyed:	10.2
P.O.#:		Surveyor:	Jen Costello	Rim to Invert:	10.7
Customer:		Cert. #:	U-907-5518	Wall Material:	Concrete (reinforced)

Street:	4th Pl. 5 Manholes East of Liftstatio	Project:	Hobart, IN
City:	Hobart, IN	GPS Northing:	41.52945709
Location:		GPS Easting:	-87.27523041
Drain Area:	West	GPS Accuracy:	Nearest Meter
Cover Shape:	Circular	Evidence of Surcharge:	No
Cover Size:	22.5	Potential for Runoff:	None
Comments:

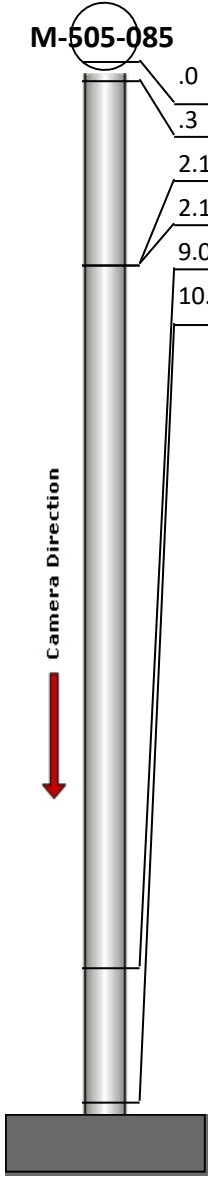
.0	MGO	General Observation	10	NA
	.3	DAE	Deposits Attached Encrustation	22	M 2
	2.1	MGP	General Photo	39	NA
	2.1	DAE	Deposits Attached Encrustation	53	M 2
	9.0	DSF	Deposits Settled Fine	78	M 2
	10.2	MGO	General Observation	91	NA

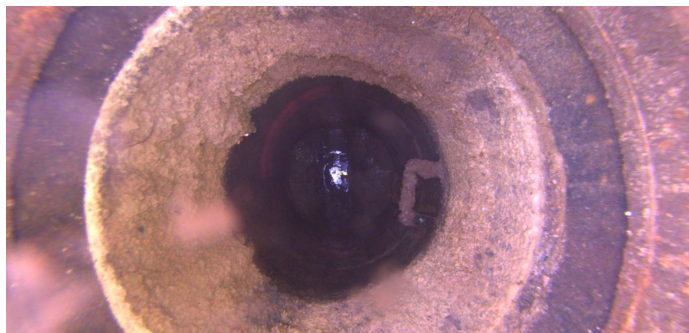
Code: **MGO**
Description: **General Observation**

Distance (ft): **.0**
Structural Grade: **0**
O&M Grade: **0**
Clock Start/From:
Clock To:
1st Value:
2nd Value:
Value Percent:
Step: **NO**
Remarks: **ACCESS MH**

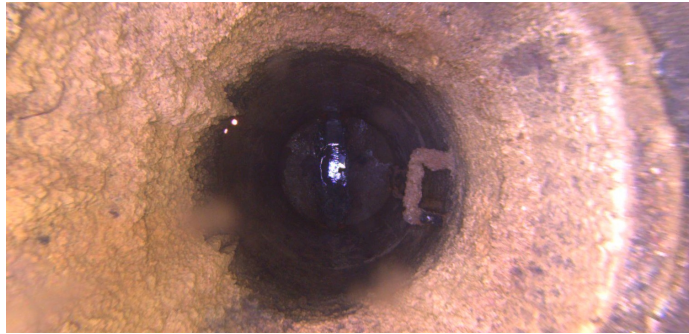
Code: **DAE**
Description: **Deposits Attached Encrustation**

Distance (ft): **.3**
Structural Grade: **0**
O&M Grade: **2**
Clock Start/From: **12**
Clock To: **12**
1st Value:
2nd Value:
Value Percent: **5.000**
Step: **NO**
Remarks:

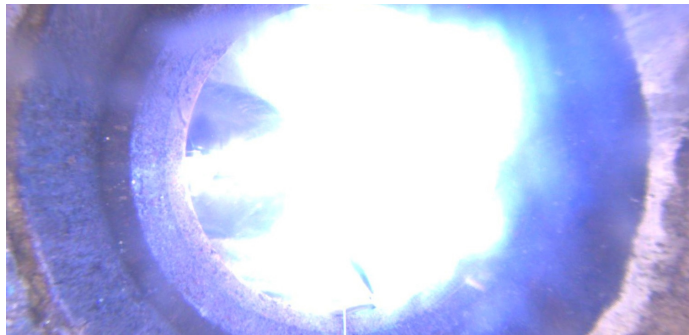
Code: **MGP**
Description: **General Photo**

Distance (ft): **2.1**
Structural Grade: **0**
O&M Grade: **0**
Clock Start/From:
Clock To:
1st Value:
2nd Value:
Value Percent:
Step: **NO**
Remarks: **UNDERSIDE OF FRAME**

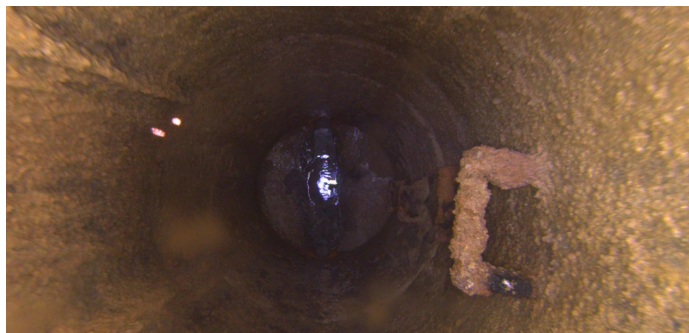
Code: **DAE**
Description: **Deposits Attached Encrustation**

Distance (ft): **2.1**
Structural Grade: **0**
O&M Grade: **2**
Clock Start/From: **12**
Clock To: **12**
1st Value:
2nd Value:
Value Percent: **5.000**
Step: **NO**
Remarks:

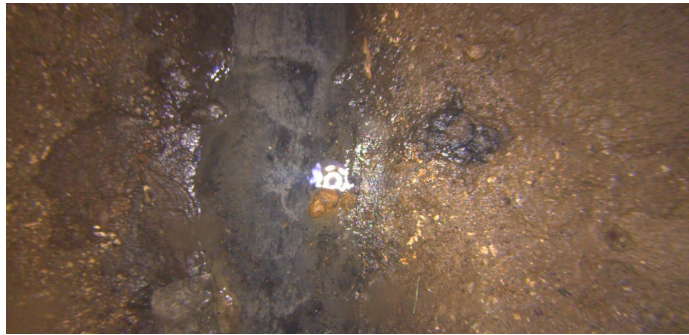
Code: **DSF**
Description: **Deposits Settled Fine**

Distance (ft): **9.0**
Structural Grade: **0**
O&M Grade: **2**
Clock Start/From: **12**
Clock To: **12**
1st Value:
2nd Value:
Value Percent: **5.000**
Step: **NO**
Remarks:

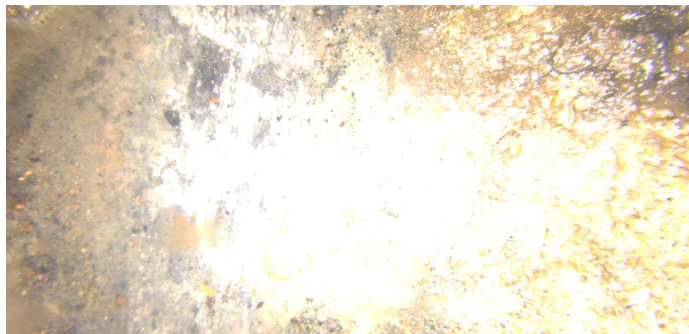
Code: **MGO**
Description: **General Observation**

Distance (ft): **10.2**
Structural Grade: **0**
O&M Grade: **0**
Clock Start/From:
Clock To:
1st Value:
2nd Value:
Value Percent:
Step: **NO**
Remarks: **END SURVEY**
