Manhole Inspection Report

Date:	04/30/2018	Weather:		Coding:	RZMACP
MH#:	M-505-093	Owner:	NA	Len. Surveyed:	10.1
P.O.#:		Surveyor:	Jen Costello	Rim to Invert:	10.1
Customer:		Cert. #:	U-907-5518	Wall Material:	Brick

Street:	3rd St. 445' West of Cherry Ln.	Project:	Hobart, IN
City:	Hobart, IN	GPS Northing:	2900236.917
Location:		GPS Easting:	2900236.917
Drain Area:	West	GPS Accuracy:	Sub-Meter
Cover Shape:	Circular	Evidence of Surcharge:	No
Cover Size:	24.0	Potential for Runoff:	None
Comments:

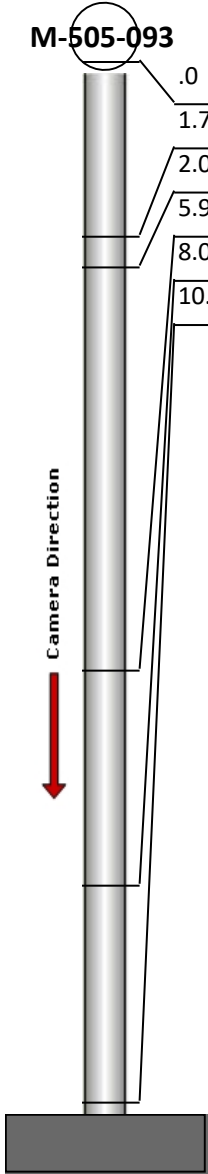
.0	MGP	General Photo	10	NA
	1.7	MGO	General Observation	27	NA
	2.0	DSGV	Deposits Settled Gravel	41	M 2
	5.9	SAV	Surface Aggregate Visible	61	S 3
	8.0	DSF	Deposits Settled Fine	76	M 2
	10.1	MGO	General Observation	92	NA

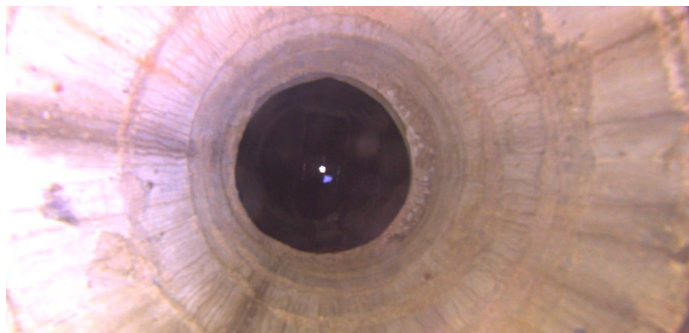
Code: **MGP**
 Description: **General Photo**

Distance (ft): **.0**
 Structural Grade: **0**
 O&M Grade: **0**
 Clock Start/From:
 Clock To:
 1st Value:
 2nd Value:
 Value Percent:
 Step: **NO**
 Remarks: **ACCESS MH**

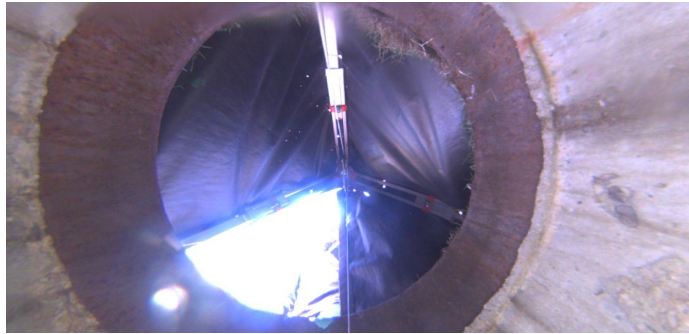
Code: **MGO**
Description: **General Observation**

Distance (ft): **1.7**
Structural Grade: **0**
O&M Grade: **0**
Clock Start/From:
Clock To:
1st Value:
2nd Value:
Value Percent:
Step: **NO**
Remarks: **UNDERSIDE OF FRAME**

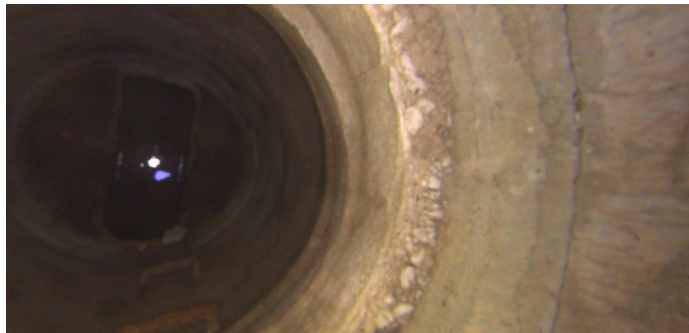
Code: **DSGV**
Description: **Deposits Settled Gravel**

Distance (ft): **2.0**
Structural Grade: **0**
O&M Grade: **2**
Clock Start/From: **1**
Clock To: **3**
1st Value:
2nd Value:
Value Percent: **5.000**
Step: **NO**
Remarks:

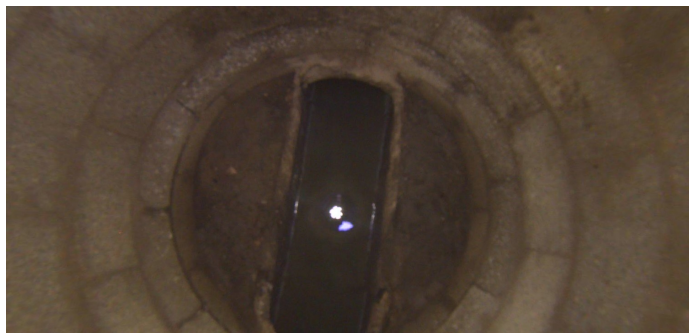
Code: **SAV**
Description: **Surface Aggregate Visible**

Distance (ft): **5.9**
Structural Grade: **3**
O&M Grade: **0**
Clock Start/From: **12**
Clock To: **12**
1st Value:
2nd Value:
Value Percent:
Step: **NO**
Remarks:

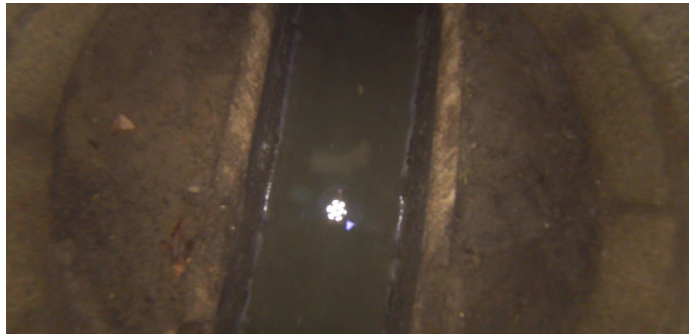
Code: **DSF**
Description: **Deposits Settled Fine**

Distance (ft): **8.0**
Structural Grade: **0**
O&M Grade: **2**
Clock Start/From: **12**
Clock To: **12**
1st Value:
2nd Value:
Value Percent: **5.000**
Step: **NO**
Remarks:

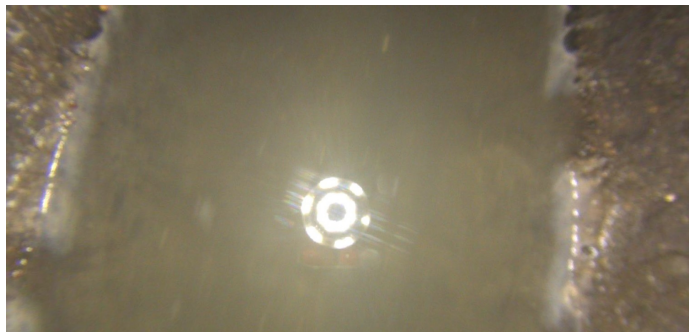
Code: **MGO**
Description: **General Observation**

Distance (ft): **10.1**
Structural Grade: **0**
O&M Grade: **0**
Clock Start/From:
Clock To:
1st Value:
2nd Value:
Value Percent:
Step: **NO**
Remarks: **END SURVEY**
