Manhole Inspection Report

Date:	04/27/2018	Weather:		Coding:	RZMACP
MH#:	M-506-001A	Owner:	NA	Len. Surveyed:	17.6
P.O.#:		Surveyor:	Jen Costello	Rim to Invert:	18.1
Customer:		Cert. #:	U-907-5518	Wall Material:	Concrete (reinforced)

Street:	Intersection of 8th St. and Wisconsi	Project:	Hobart, IN
City:	Hobart, IN	GPS Northing:	41.52542877
Location:		GPS Easting:	-87.26909637
Drain Area:	Southwest	GPS Accuracy:	Nearest Meter
Cover Shape:	Circular	Evidence of Surcharge:	No
Cover Size:	22.5	Potential for Runoff:	None
Comments:

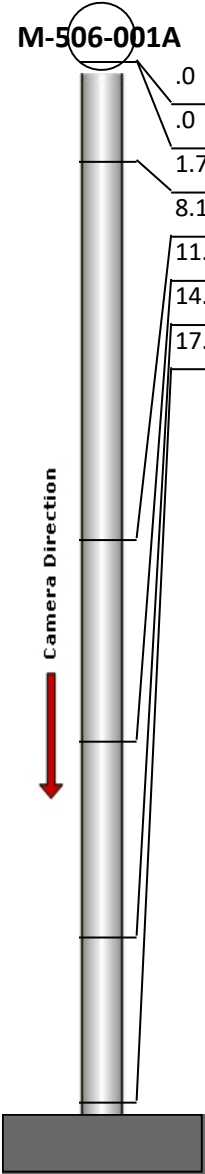
Position	Code	Observation	Video (sec)	Grade
M-506-001A

0.0	MGO	General Observation	10	NA
	0.0	MB	Missing Brick	20	S 4
	1.7	MGO	General Observation	37	NA
	8.1	IW	Infil Weeper	63	M 2
	11.5	SAV	Surface Aggregate Visible	81	S 3
	14.8	MGO	General Observation	99	NA
	17.6	MGO	General Observation	116	NA

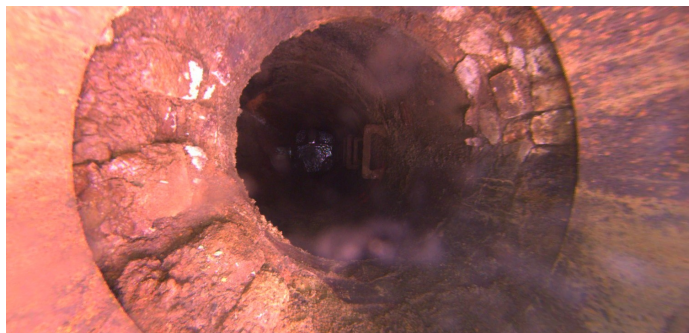
Code: **MGO**
Description: **General Observation**

Distance (ft): **.0**
Structural Grade: **0**
O&M Grade: **0**
Clock Start/From:
Clock To:
1st Value:
2nd Value:
Value Percent:
Step: **NO**
Remarks: **ACCESS MH**

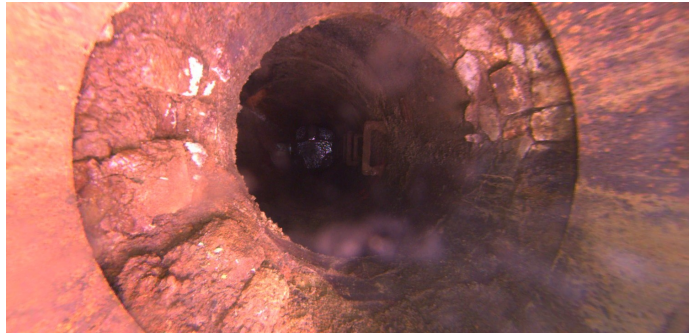
Code: **MB**
Description: **Missing Brick**

Distance (ft): **.0**
Structural Grade: **4**
O&M Grade: **0**
Clock Start/From: **12**
Clock To: **12**
1st Value:
2nd Value:
Value Percent:
Step: **NO**
Remarks:

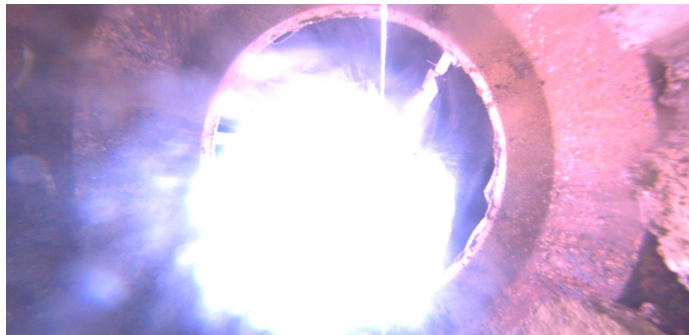
Code: **MGO**
Description: **General Observation**

Distance (ft): **1.7**
Structural Grade: **0**
O&M Grade: **0**
Clock Start/From:
Clock To:
1st Value:
2nd Value:
Value Percent:
Step: **NO**
Remarks: **UNDERSIDE OF FRAME**

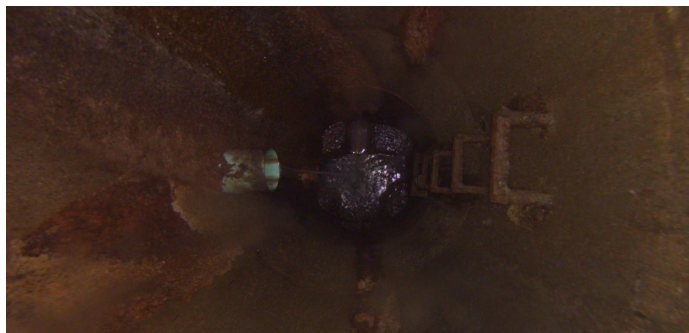
Code: **IW**
Description: **Infil Weeper**

Distance (ft): **8.1**
Structural Grade: **0**
O&M Grade: **2**
Clock Start/From: **12**
Clock To: **12**
1st Value:
2nd Value:
Value Percent:
Step: **NO**
Remarks:

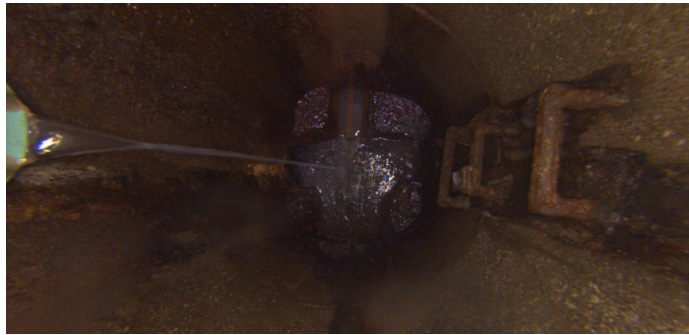
Code: **SAV**
Description: **Surface Aggregate Visible**

Distance (ft): **11.5**
Structural Grade: **3**
O&M Grade: **0**
Clock Start/From: **12**
Clock To: **12**
1st Value:
2nd Value:
Value Percent:
Step: **NO**
Remarks:

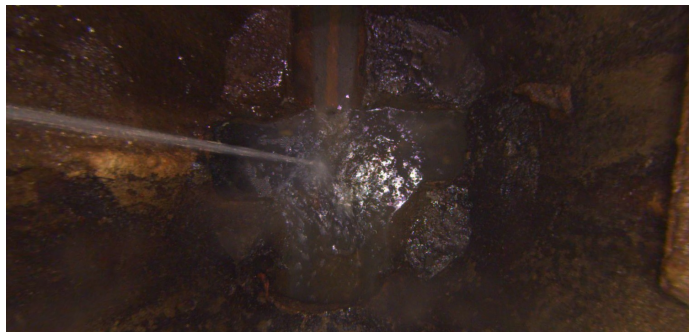
Code: **MGO**
Description: **General Observation**

Distance (ft): **14.8**
Structural Grade: **0**
O&M Grade: **0**
Clock Start/From:
Clock To:
1st Value:
2nd Value:
Value Percent:
Step: **NO**
Remarks: **BROKEN STEP**

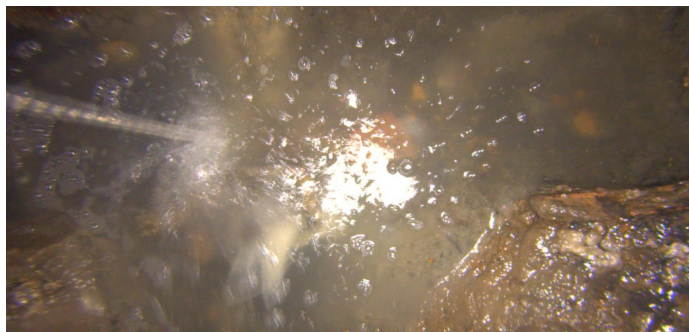
Code: **MGO**
Description: **General Observation**

Distance (ft): **17.6**
Structural Grade: **0**
O&M Grade: **0**
Clock Start/From:
Clock To:
1st Value:
2nd Value:
Value Percent:
Step: **NO**
Remarks: **END SURVEY**
