Manhole Inspection Report

Date:	09/28/2022	Weather:		Coding:	RZMACP
MH#:	M-506-004	Owner:	NA	Len. Surveyed:	15.5
P.O.#:		Surveyor:	Jen Costello	Rim to Invert:	17.1
Customer:		Cert. #:	U-907-5518	Wall Material:	Concrete (cast in place)

Street:	8th St. 482' East of Colorado St.	Project:	Hobart, IN
City:	Hobart, IN	GPS Northing:	2286514.351
Location:	Yard	GPS Easting:	2901027.041
Drain Area:	Southwest	GPS Accuracy:	Sub-Meter
Cover Shape:	Circular	Evidence of Surcharge:	No
Cover Size:	24.0	Potential for Runoff:	None
Comments:

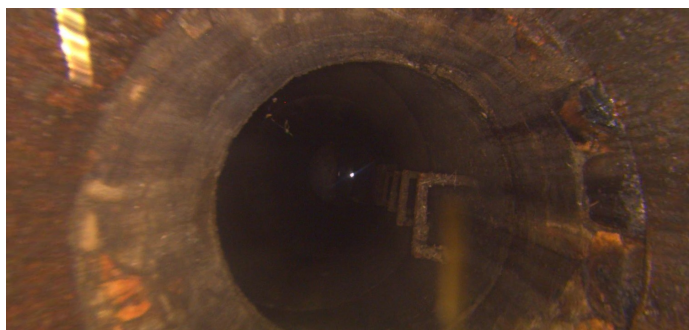
Code: **MGO**
Description: **General Observation**

Distance (ft): **.0**
Structural Grade: **0**
O&M Grade: **0**
Clock Start/From:
Clock To:
1st Value:
2nd Value:
Value Percent:
Step: **NO**
Remarks: **access mh**

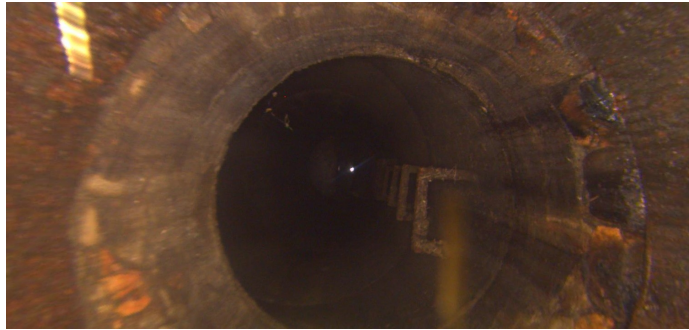
Code: **SRI**
Description: **Surface Roughness Increased**

Distance (ft): **.0**
Structural Grade: **1**
O&M Grade: **0**
Clock Start/From: **12**
Clock To: **12**
1st Value:
2nd Value:
Value Percent:
Step: **NO**
Remarks:

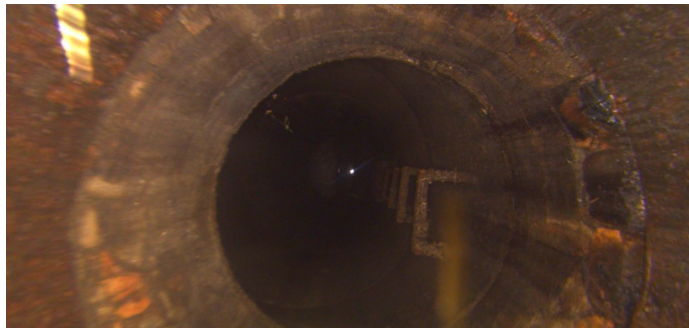
Code: **IW**
Description: **Infil Weeper**

Distance (ft): **.0**
Structural Grade: **0**
O&M Grade: **2**
Clock Start/From: **1**
Clock To: **4**
1st Value:
2nd Value:
Value Percent:
Step: **NO**
Remarks:

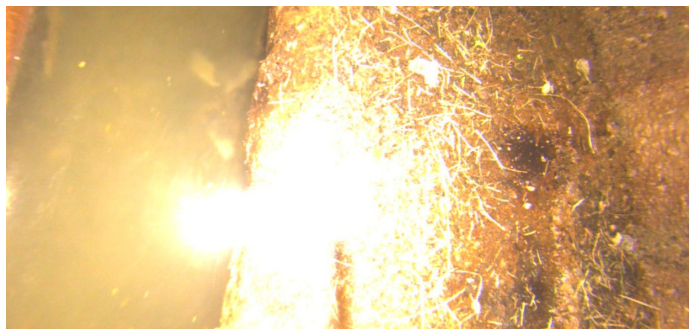
Code: **DSF**
Description: **Deposits Settled Fine**

Distance (ft): **15.5**
Structural Grade: **0**
O&M Grade: **2**
Clock Start/From: **12**
Clock To: **12**
1st Value:
2nd Value:
Value Percent: **5.000**
Step: **NO**
Remarks:

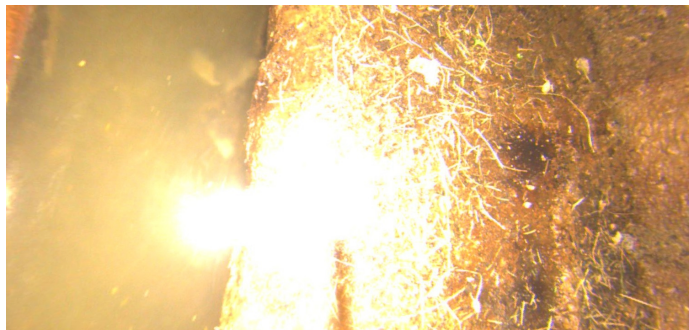
Code: **SRI**
Description: **Surface Roughness Increased**

Distance (ft): **15.5**
Structural Grade: **1**
O&M Grade: **0**
Clock Start/From: **12**
Clock To: **12**
1st Value:
2nd Value:
Value Percent:
Step: **NO**
Remarks:

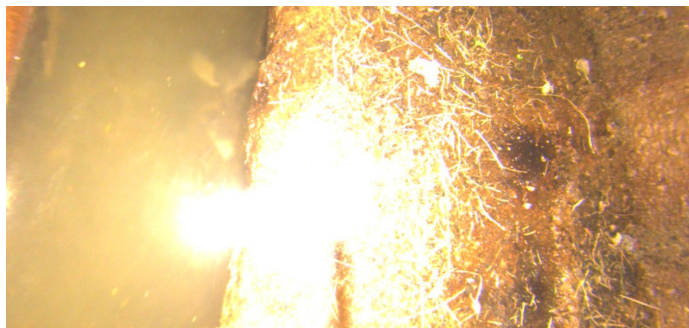
Code: **MGO**
Description: **General Observation**

Distance (ft): **15.5**
Structural Grade: **0**
O&M Grade: **0**
Clock Start/From:
Clock To:
1st Value:
2nd Value:
Value Percent:
Step: **NO**
Remarks: **end of survey**
