# Manhole Inspection Report

Date:	<b>09/28/2022</b>	Weather:		Coding:	<b>RZMACP</b>
MH#:	<b>M-506-005</b>	Owner:	<b>NA</b>	Len. Surveyed:	<b>15.3</b>
P.O.#:		Surveyor:	<b>Jen Costello</b>	Rim to Invert:	<b>16.9</b>
Customer:		Cert. #:	<b>U-907-5518</b>	Wall Material:	<b>Concrete (cast in place)</b>

Street:	<b>8th St. 277' East of Colorado St.</b>	Project:	<b>Hobart, IN</b>
City:	<b>Hobart, IN</b>	GPS Northing:	<b>2286508.681</b>
Location:	<b>Yard</b>	GPS Easting:	<b>2900815.372</b>
Drain Area:	<b>Southwest</b>	GPS Accuracy:	<b>Sub-Meter</b>
Cover Shape:	<b>Circular</b>	Evidence of Surcharge:	<b>No</b>
Cover Size:	<b>24.0</b>	Potential for Runoff:	<b>None</b>
Comments:

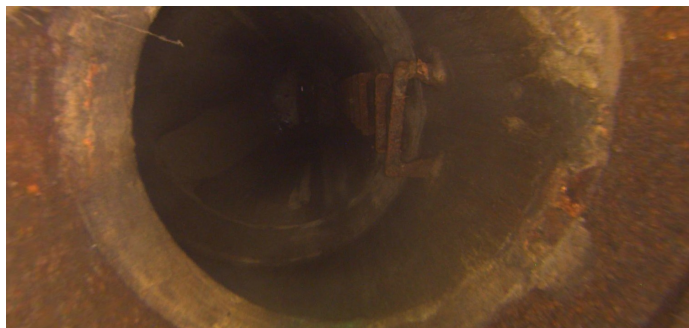
Code: **MGO**  
Description: **General Observation**

Distance (ft): **.0**  
Structural Grade: **0**  
O&M Grade: **0**  
Clock Start/From:  
Clock To:  
1st Value:  
2nd Value:  
Value Percent:  
Step: **NO**  
Remarks: **access mh**

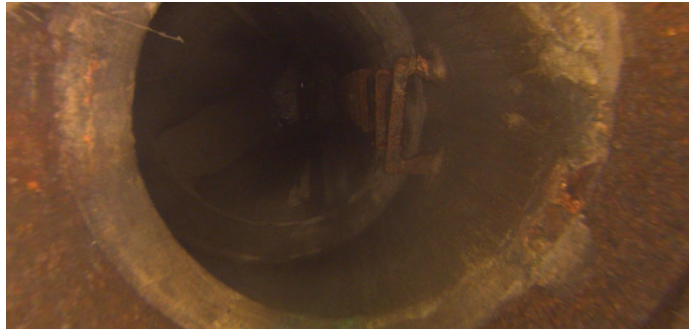
Code: **SRI**  
Description: **Surface Roughness Increased**

Distance (ft): **.0**  
Structural Grade: **1**  
O&M Grade: **0**  
Clock Start/From: **12**  
Clock To: **12**  
1st Value:  
2nd Value:  
Value Percent:  
Step: **NO**  
Remarks:

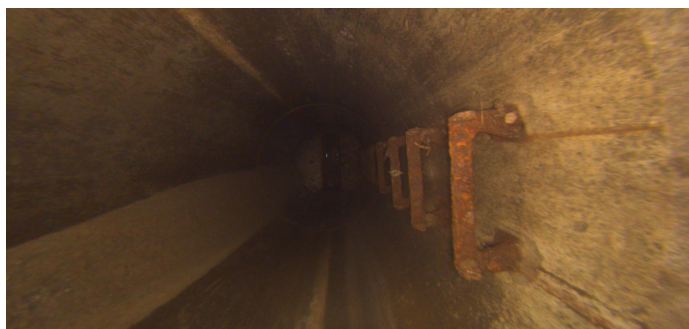
Code: **IW**  
Description: **Infil Weeper**

Distance (ft): **3.9**  
Structural Grade: **0**  
O&M Grade: **2**  
Clock Start/From: **6**  
Clock To: **12**  
1st Value:  
2nd Value:  
Value Percent:  
Step: **NO**  
Remarks:

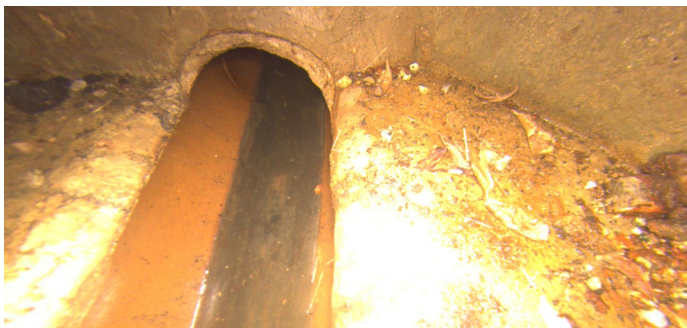
Code: **SRI**  
Description: **Surface Roughness Increased**

Distance (ft): **15.3**  
Structural Grade: **1**  
O&M Grade: **0**  
Clock Start/From: **12**  
Clock To: **12**  
1st Value:  
2nd Value:  
Value Percent:  
Step: **NO**  
Remarks:

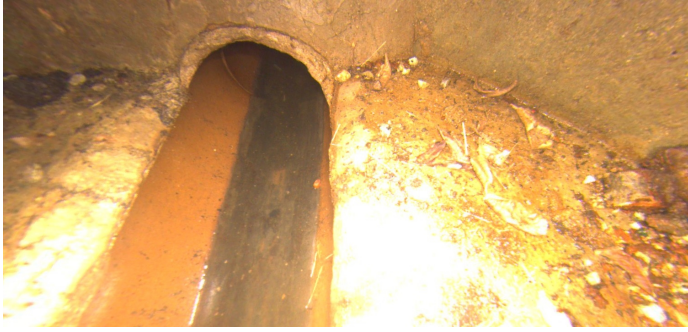
Code:	<b>MGO</b>
Description:	<b>General Observation</b>
Distance (ft):	<b>15.3</b>
Structural Grade:	<b>0</b>
O&M Grade:	<b>0</b>
Clock Start/From:	
Clock To:	
1st Value:	
2nd Value:	
Value Percent:	
Step:	<b>NO</b>
Remarks:	<b>end of survey</b>
