Manhole Inspection Report

Date:	04/24/2018	Weather:		Coding:	RZMACP
MH#:	M-506-006	Owner:	NA	Len. Surveyed:	14.5
P.O.#:		Surveyor:	Jen Costello	Rim to Invert:	15.9
Customer:		Cert. #:	U-907-5518	Wall Material:	Concrete (reinforced)

Street:	Intersection of 8th St. and Colorado	Project:	Hobart, IN
City:	Hobart, IN	GPS Northing:	2900540.533
Location:		GPS Easting:	2900540.533
Drain Area:	Southwest	GPS Accuracy:	Sub-Meter
Cover Shape:	Circular	Evidence of Surcharge:	No
Cover Size:	22.5	Potential for Runoff:	None
Comments:

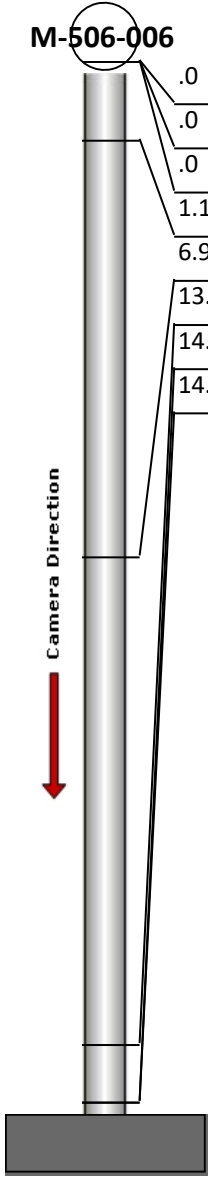
.0	MGO	General Observation	10	NA
	.0	RFJ	Roots Fine Joint	20	M 1
	.0	SRV	Surface Reinforcement Visible	30	S 5
	1.1	SAV	Surface Aggregate Visible	43	S 3
	6.9	RFJ	Roots Fine Joint	65	M 1
	13.7	RMB	Roots Medium Barrel	89	M 4
	14.5	MGO	General Observation	102	NA
	14.5	SAV	Surface Aggregate Visible	112	S 3

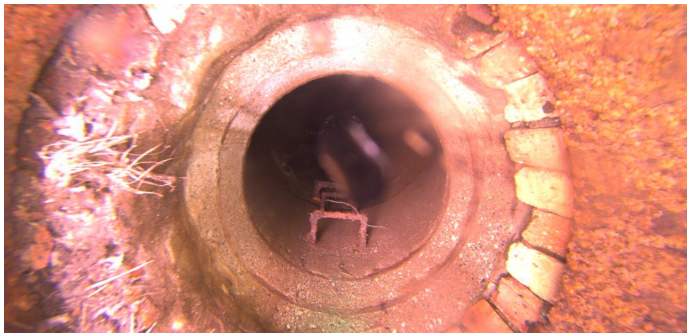
Code: **MGO**
Description: **General Observation**

Distance (ft): **.0**
Structural Grade: **0**
O&M Grade: **0**
Clock Start/From:
Clock To:
1st Value:
2nd Value:
Value Percent:
Step: **NO**
Remarks: **access MH**

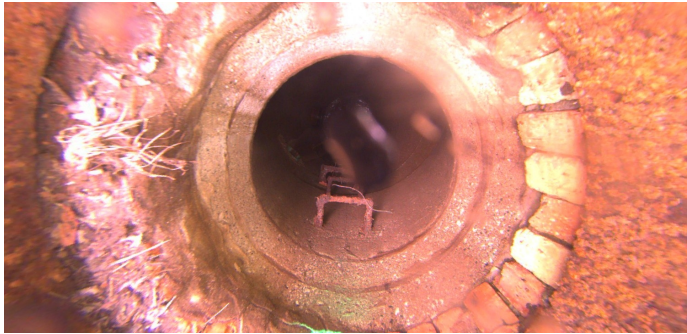
Code: **RFJ**
Description: **Roots Fine Joint**

Distance (ft): **.0**
Structural Grade: **0**
O&M Grade: **1**
Clock Start/From: **8**
Clock To: **9**
1st Value:
2nd Value:
Value Percent:
Step: **NO**
Remarks:

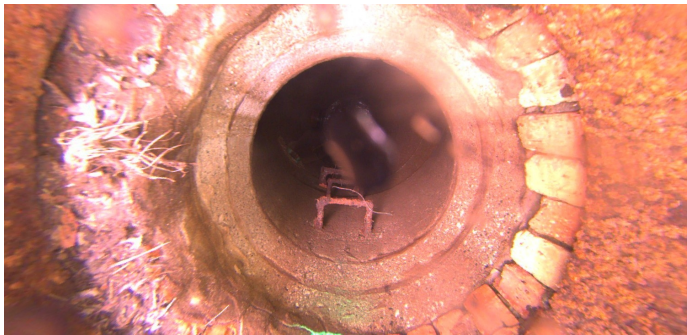
Code: **SRV**
Description: **Surface Reinforcement Visible**

Distance (ft): **.0**
Structural Grade: **5**
O&M Grade: **0**
Clock Start/From: **12**
Clock To: **12**
1st Value:
2nd Value:
Value Percent:
Step: **NO**
Remarks:

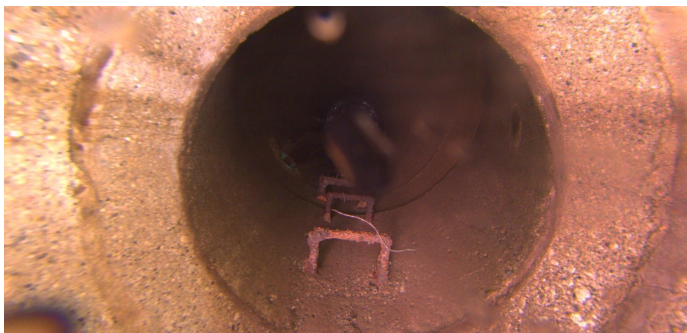
Code: **SAV**
Description: **Surface Aggregate Visible**

Distance (ft): **1.1**
Structural Grade: **3**
O&M Grade: **0**
Clock Start/From: **12**
Clock To: **12**
1st Value:
2nd Value:
Value Percent:
Step: **NO**
Remarks:

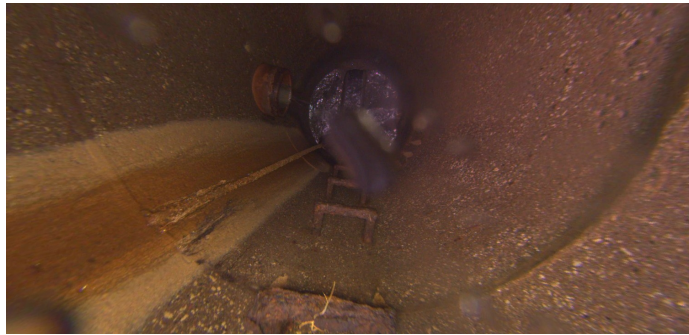
Code: **RFJ**
Description: **Roots Fine Joint**

Distance (ft): **6.9**
Structural Grade: **0**
O&M Grade: **1**
Clock Start/From: **8**
Clock To:
1st Value:
2nd Value:
Value Percent:
Step: **NO**
Remarks:

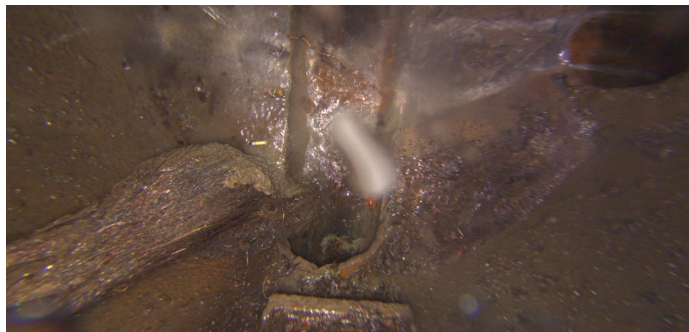
Code: **RMB**
Description: **Roots Medium Barrel**

Distance (ft): **13.7**
Structural Grade: **0**
O&M Grade: **4**
Clock Start/From: **7**
Clock To: **8**
1st Value:
2nd Value:
Value Percent: **10.000**
Step: **NO**
Remarks:

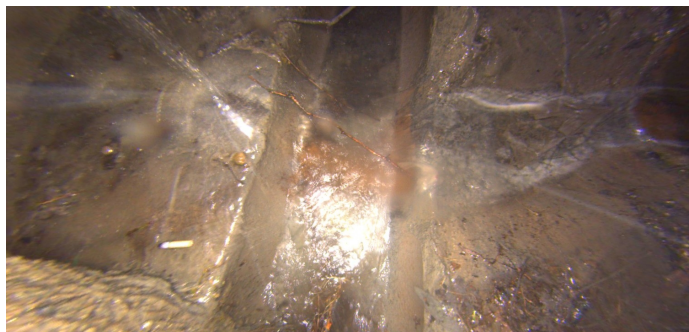
Code: **MGO**
Description: **General Observation**

Distance (ft): **14.5**
Structural Grade: **0**
O&M Grade: **0**
Clock Start/From:
Clock To:
1st Value:
2nd Value:
Value Percent:
Step: **NO**
Remarks: **END SURVEY**

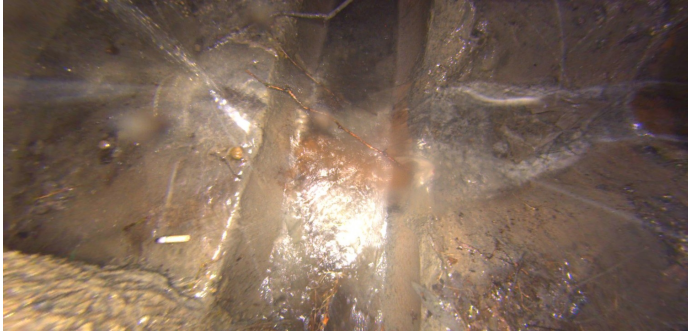
Code:	SAV
Description:	Surface Aggregate Visible
Distance (ft):	14.5
Structural Grade:	3
O&M Grade:	0
Clock Start/From:	12
Clock To:	12
1st Value:	
2nd Value:	
Value Percent:	
Step:	NO
Remarks:
