Manhole Inspection Report

Date:	04/24/2018	Weather:		Coding:	RZMACP
MH#:	M-506-007	Owner:	NA	Len. Surveyed:	10.0
P.O.#:		Surveyor:	Jen Costello	Rim to Invert:	10.3
Customer:		Cert. #:	U-907-5518	Wall Material:	Concrete (reinforced)

Street:	Intersection of Cardinal Ct. and 8th	Project:	Hobart, IN
City:	Hobart, IN	GPS Northing:	41.52548218
Location:		GPS Easting:	-87.2746048
Drain Area:	Southwest	GPS Accuracy:	Nearest Meter
Cover Shape:	Circular	Evidence of Surcharge:	No
Cover Size:	22.5	Potential for Runoff:	None
Comments:

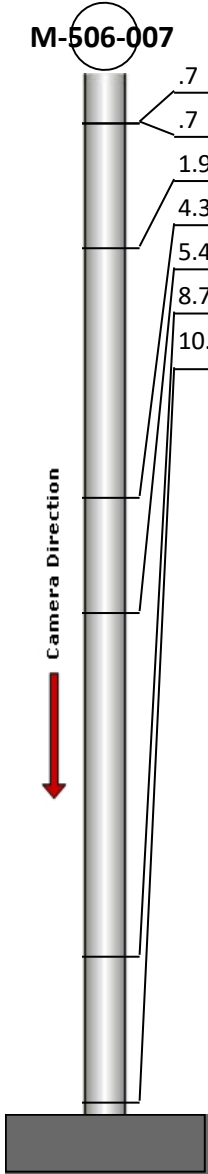
.7	MGO	General Observation	12	NA
	.7	DAE	Deposits Attached Encrustation	23	M 2
	1.9	MGP	General Photo	39	NA
	4.3	IS	Infil Stain	57	NA
	5.4	OBZ	Obstacle Other	71	M 2
	8.7	DSGV	Deposits Settled Gravel	88	M 2
	10.0	MGO	General Observation	102	NA

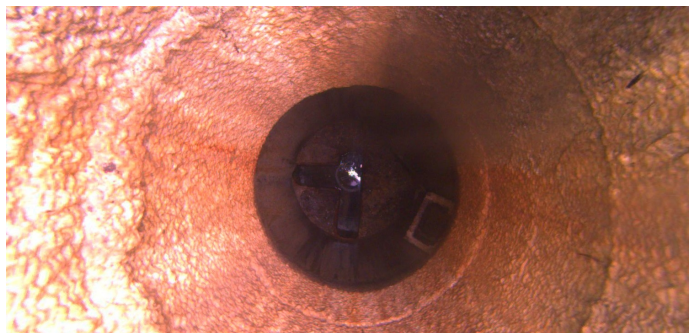
Code: **MGO**
Description: **General Observation**

Distance (ft): **.7**
Structural Grade: **0**
O&M Grade: **0**
Clock Start/From:
Clock To:
1st Value:
2nd Value:
Value Percent:
Step: **NO**
Remarks: **ACCESS MH**

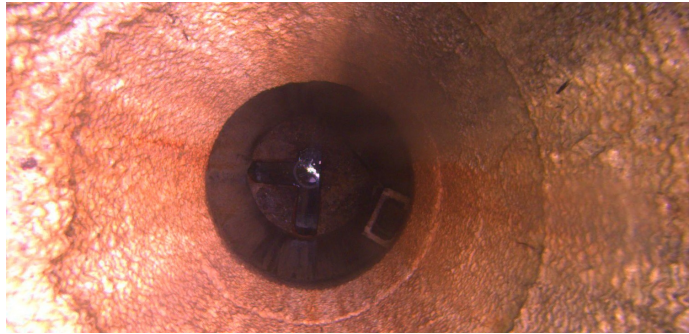
Code:	DAE
Description:	Deposits Attached Encrustation
Distance (ft):	.7
Structural Grade:	0
O&M Grade:	2
Clock Start/From:	12
Clock To:	12
1st Value:	
2nd Value:	
Value Percent:	5.000
Step:	NO
Remarks:

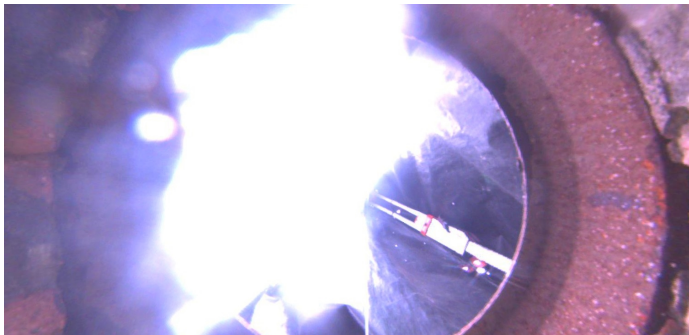
Code:	MGP
Description:	General Photo
Distance (ft):	1.9
Structural Grade:	0
O&M Grade:	0
Clock Start/From:	
Clock To:	
1st Value:	
2nd Value:	
Value Percent:	
Step:	NO
Remarks:	UNDERSIDE OF FRAME

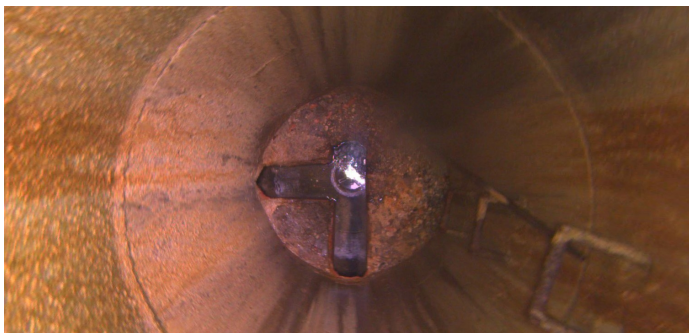
Code:	IS
Description:	Infil Stain
Distance (ft):	4.3
Structural Grade:	0
O&M Grade:	0
Clock Start/From:	12
Clock To:	12
1st Value:	
2nd Value:	
Value Percent:	
Step:	NO
Remarks:

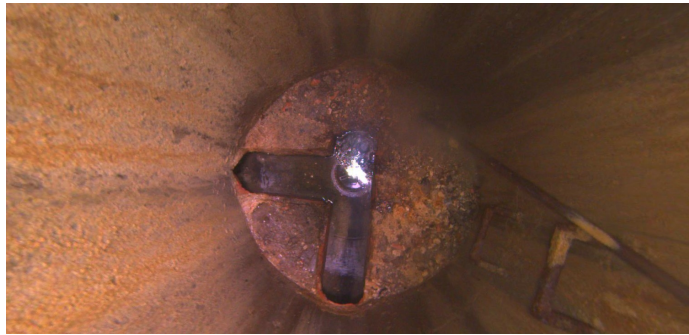
Code: **OBZ**
Description: **Obstacle Other**

Distance (ft): **5.4**
Structural Grade: **0**
O&M Grade: **2**
Clock Start/From: **2**
Clock To: **4**
1st Value:
2nd Value:
Value Percent: **5.000**
Step: **NO**
Remarks: **STICK**

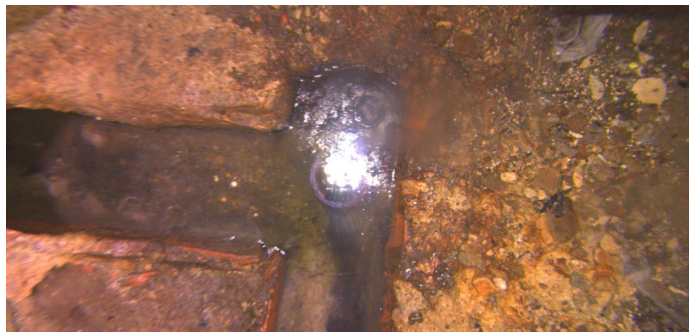
Code: **DSGV**
Description: **Deposits Settled Gravel**

Distance (ft): **8.7**
Structural Grade: **0**
O&M Grade: **2**
Clock Start/From: **12**
Clock To: **12**
1st Value:
2nd Value:
Value Percent: **5.000**
Step: **NO**
Remarks:

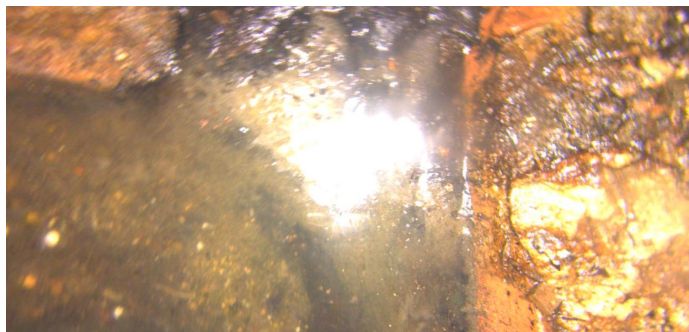
Code: **MGO**
Description: **General Observation**

Distance (ft): **10.0**
Structural Grade: **0**
O&M Grade: **0**
Clock Start/From:
Clock To:
1st Value:
2nd Value:
Value Percent:
Step: **NO**
Remarks: **END SURVEY**
