# Manhole Inspection Report

Date:	<b>04/24/2018</b>	Weather:		Coding:	<b>RZMACP</b>
MH#:	<b>M-506-007</b>	Owner:	<b>NA</b>	Len. Surveyed:	<b>9.9</b>
P.O.#:		Surveyor:	<b>Jen Costello</b>	Rim to Invert:	<b>10.3</b>
Customer:		Cert. #:	<b>U-907-5518</b>	Wall Material:	<b>Brick</b>

Street:	<b>Intersection of Cardinal Ct. and 8th</b>	Project:	<b>Hobart, IN</b>
City:	<b>Hobart, IN</b>	GPS Northing:	<b>41.52554321</b>
Location:		GPS Easting:	<b>-87.27456665</b>
Drain Area:	<b>Southwest</b>	GPS Accuracy:	<b>Nearest Meter</b>
Cover Shape:	<b>Circular</b>	Evidence of Surcharge:	<b>No</b>
Cover Size:	<b>22.5</b>	Potential for Runoff:	<b>None</b>
Comments:

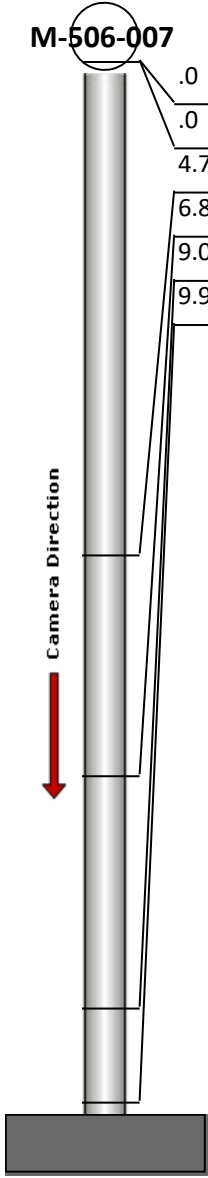
.0	MGO	General Observation	10	NA
	.0	DAE	Deposits Attached Encrustation	21	M 2
	4.7	IS	Infil Stain	42	NA
	6.8	OBZ	Obstacle Other	57	M 2
	9.0	DSGV	Deposits Settled Gravel	72	M 2
	9.9	MGO	General Observation	84	NA

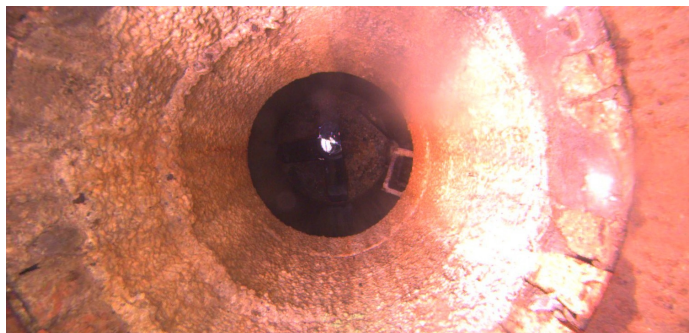
Code: **MGO**  
Description: **General Observation**

Distance (ft): **.0**  
Structural Grade: **0**  
O&M Grade: **0**  
Clock Start/From:  
Clock To:  
1st Value:  
2nd Value:  
Value Percent:  
Step: **NO**  
Remarks: **ACCESS MH**

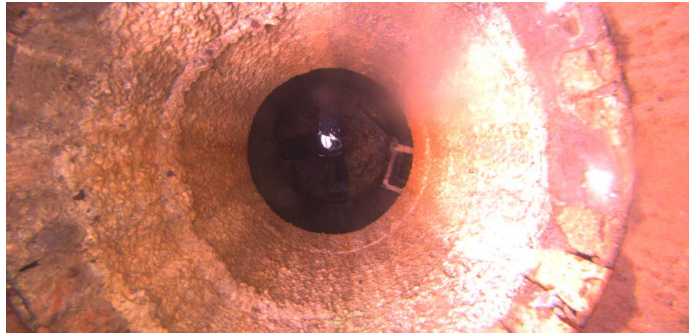
Code:	<b>DAE</b>
Description:	<b>Deposits Attached Encrustation</b>
Distance (ft):	<b>.0</b>
Structural Grade:	<b>0</b>
O&M Grade:	<b>2</b>
Clock Start/From:	<b>12</b>
Clock To:	<b>12</b>
1st Value:	
2nd Value:	
Value Percent:	<b>5.000</b>
Step:	<b>NO</b>
Remarks:

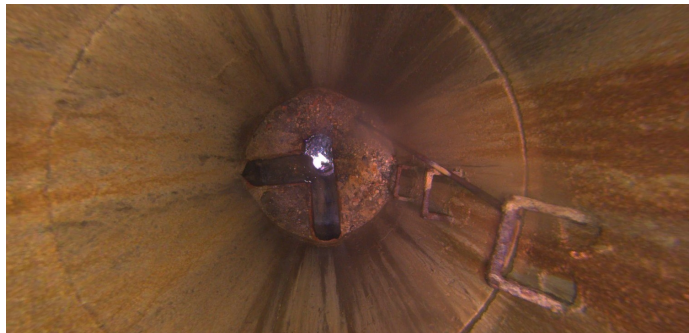
Code:	<b>IS</b>
Description:	<b>Infil Stain</b>
Distance (ft):	<b>4.7</b>
Structural Grade:	<b>0</b>
O&M Grade:	<b>0</b>
Clock Start/From:	<b>12</b>
Clock To:	<b>12</b>
1st Value:	
2nd Value:	
Value Percent:	
Step:	<b>NO</b>
Remarks:

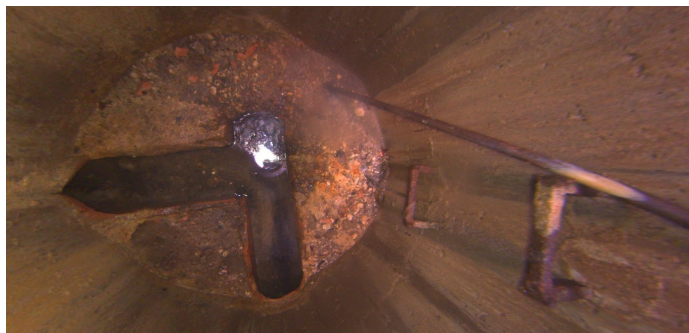
Code:	<b>OBZ</b>
Description:	<b>Obstacle Other</b>
Distance (ft):	<b>6.8</b>
Structural Grade:	<b>0</b>
O&M Grade:	<b>2</b>
Clock Start/From:	<b>1</b>
Clock To:	<b>3</b>
1st Value:	
2nd Value:	
Value Percent:	<b>5.000</b>
Step:	<b>NO</b>
Remarks:	<b>STICK</b>

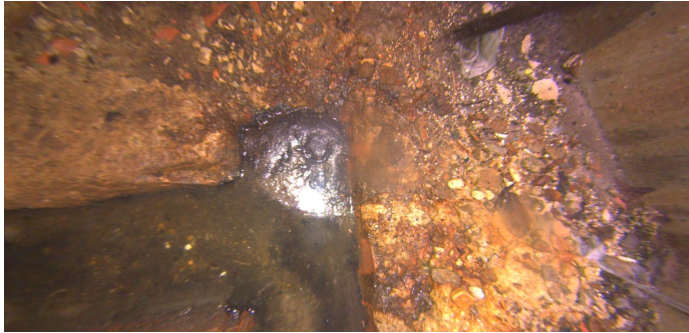
Code: **DSGV**  
Description: **Deposits Settled Gravel**

Distance (ft): **9.0**  
Structural Grade: **0**  
O&M Grade: **2**  
Clock Start/From: **12**  
Clock To: **12**  
1st Value:  
2nd Value:  
Value Percent: **5.000**  
Step: **NO**  
Remarks:

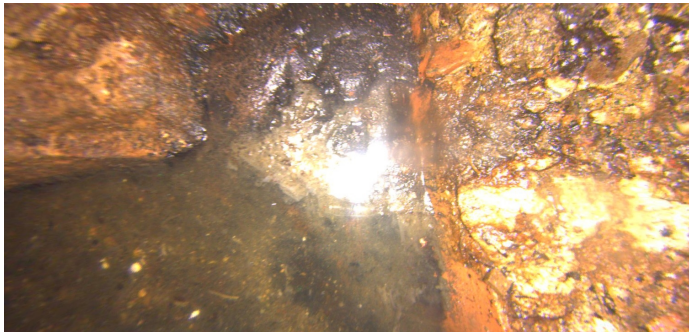
Code: **MGO**  
Description: **General Observation**

Distance (ft): **9.9**  
Structural Grade: **0**  
O&M Grade: **0**  
Clock Start/From:  
Clock To:  
1st Value:  
2nd Value:  
Value Percent:  
Step: **NO**  
Remarks: **END SURVEY**
