Manhole Inspection Report

Date:	04/24/2018	Weather:		Coding:	RZMACP
MH#:	M-506-012	Owner:	NA	Len. Surveyed:	9.4
P.O.#:		Surveyor:	Jen Costello	Rim to Invert:	10.0
Customer:		Cert. #:	U-907-5518	Wall Material:	Concrete (reinforced)

Street:	7th Pl. 204' East of Colorado St.	Project:	Hobart, IN
City:	Hobart, IN	GPS Northing:	2900745.126
Location:		GPS Easting:	2900745.126
Drain Area:	Southwest	GPS Accuracy:	Sub-Meter
Cover Shape:	Circular	Evidence of Surcharge:	No
Cover Size:	22.5	Potential for Runoff:	None
Comments:

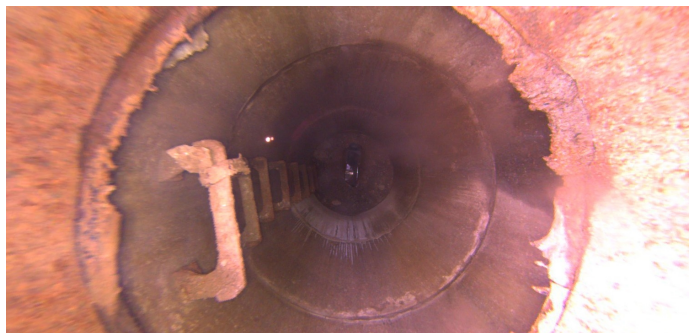
Code: **MGO**
Description: **General Observation**

Distance (ft): **.0**
Structural Grade: **0**
O&M Grade: **0**
Clock Start/From:
Clock To:
1st Value:
2nd Value:
Value Percent:
Step: **NO**
Remarks: **ACCESS MH**

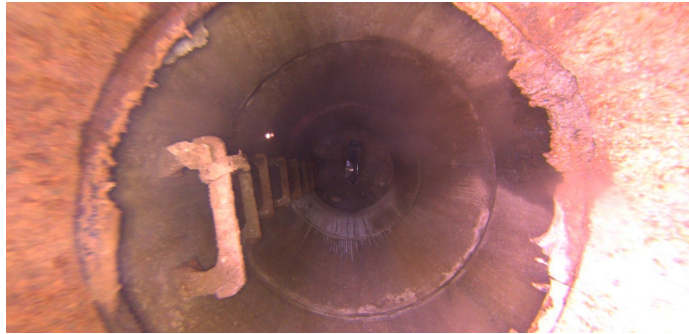
Code:	DAE
Description:	Deposits Attached Encrustation
Distance (ft):	.0
Structural Grade:	0
O&M Grade:	2
Clock Start/From:	12
Clock To:	12
1st Value:	
2nd Value:	
Value Percent:	5.000
Step:	NO
Remarks:

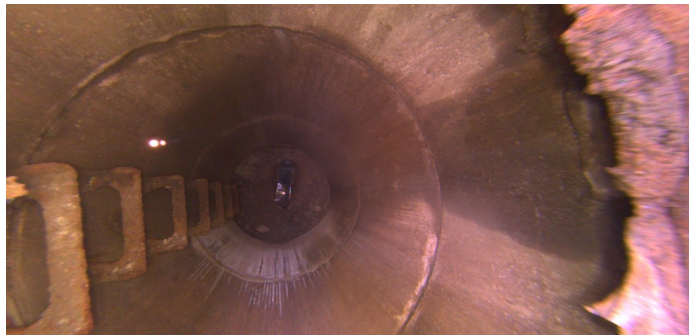
Code:	IW
Description:	Infil Weeper
Distance (ft):	.7
Structural Grade:	0
O&M Grade:	2
Clock Start/From:	2
Clock To:	3
1st Value:	
2nd Value:	
Value Percent:	
Step:	NO
Remarks:

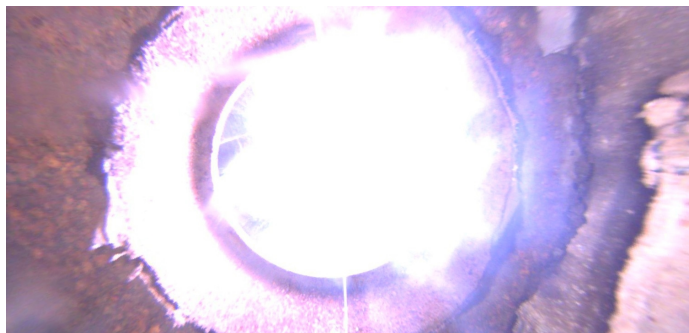
Code:	MGP
Description:	General Photo
Distance (ft):	1.9
Structural Grade:	0
O&M Grade:	0
Clock Start/From:	
Clock To:	
1st Value:	
2nd Value:	
Value Percent:	
Step:	NO
Remarks:	UNDERSIDE OF FRAME

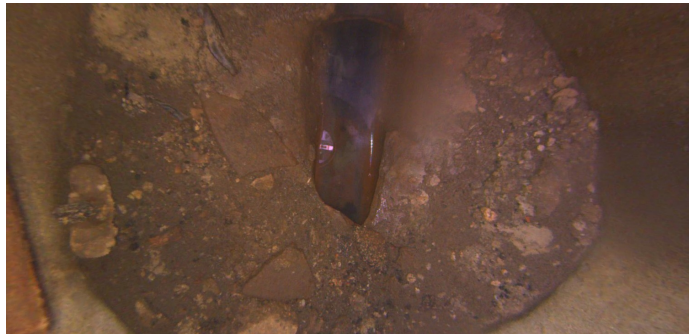
Code: **OBM**
Description: **Obstacle Pipe Material**

Distance (ft): **7.3**
Structural Grade: **0**
O&M Grade: **2**
Clock Start/From: **6**
Clock To: **9**
1st Value:
2nd Value:
Value Percent: **5.000**
Step: **NO**
Remarks:

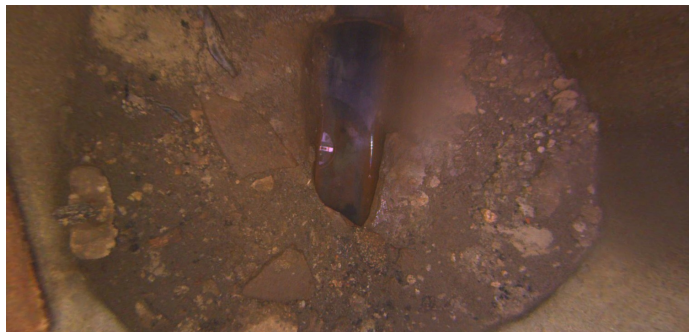
Code: **DSGV**
Description: **Deposits Settled Gravel**

Distance (ft): **7.3**
Structural Grade: **0**
O&M Grade: **2**
Clock Start/From: **12**
Clock To: **12**
1st Value:
2nd Value:
Value Percent: **5.000**
Step: **NO**
Remarks:

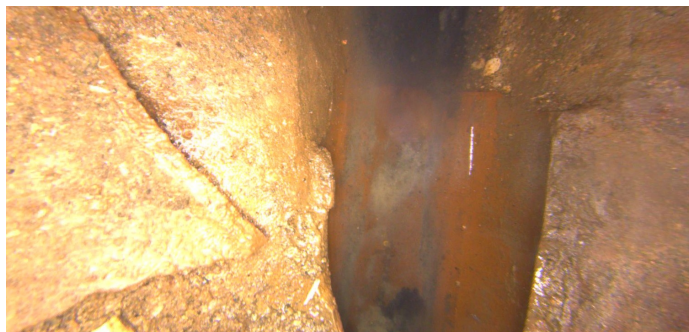
Code: **MGO**
Description: **General Observation**

Distance (ft): **9.4**
Structural Grade: **0**
O&M Grade: **0**
Clock Start/From:
Clock To:
1st Value:
2nd Value:
Value Percent:
Step: **NO**
Remarks: **END SURVEY**
