# Manhole Inspection Report

Date:	<b>04/24/2018</b>	Weather:		Coding:	<b>RZMACP</b>
MH#:	<b>M-506-013</b>	Owner:	<b>NA</b>	Len. Surveyed:	<b>4.9</b>
P.O.#:		Surveyor:	<b>Jen Costello</b>	Rim to Invert:	<b>5.6</b>
Customer:		Cert. #:	<b>U-907-5518</b>	Wall Material:	<b>Concrete (reinforced)</b>

Street:	<b>7th Pl. 407' East of Colorado St.</b>	Project:	<b>Hobart, IN</b>
City:	<b>Hobart, IN</b>	GPS Northing:	<b>2900949.647</b>
Location:		GPS Easting:	<b>2900949.647</b>
Drain Area:	<b>Southwest</b>	GPS Accuracy:	<b>Sub-Meter</b>
Cover Shape:	<b>Circular</b>	Evidence of Surcharge:	<b>No</b>
Cover Size:	<b>22.5</b>	Potential for Runoff:	<b>None</b>
Comments:

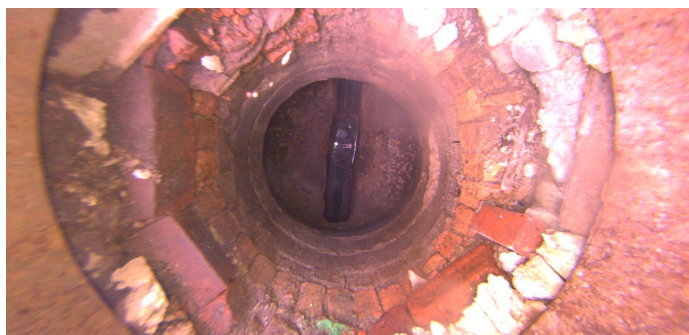
Code: **MGO**  
Description: **General Observation**

Distance (ft): **.0**  
Structural Grade: **0**  
O&M Grade: **0**  
Clock Start/From:  
Clock To:  
1st Value:  
2nd Value:  
Value Percent:  
Step: **NO**  
Remarks: **ACCESS MH**

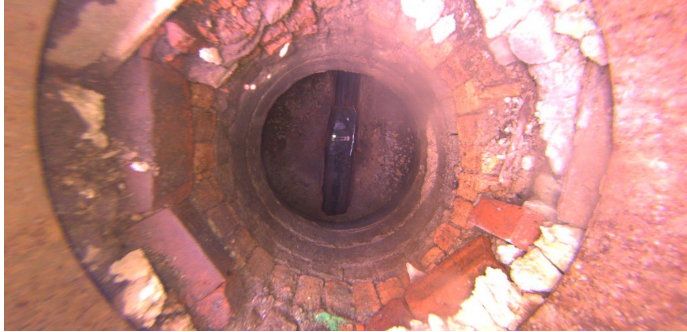
Code: **DB**  
Description: **Displaced Brick**

Distance (ft): **.0**  
Structural Grade: **3**  
O&M Grade: **0**  
Clock Start/From: **12**  
Clock To: **12**  
1st Value:  
2nd Value:  
Value Percent:  
Step: **NO**  
Remarks:

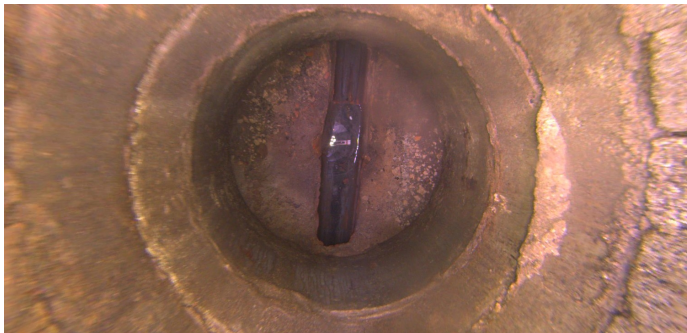
Code: **MMC**  
Description: **Material Change**

Distance (ft): **1.3**  
Structural Grade: **0**  
O&M Grade: **0**  
Clock Start/From:  
Clock To:  
1st Value:  
2nd Value:  
Value Percent:  
Step: **NO**  
Remarks: **CONCRETE**

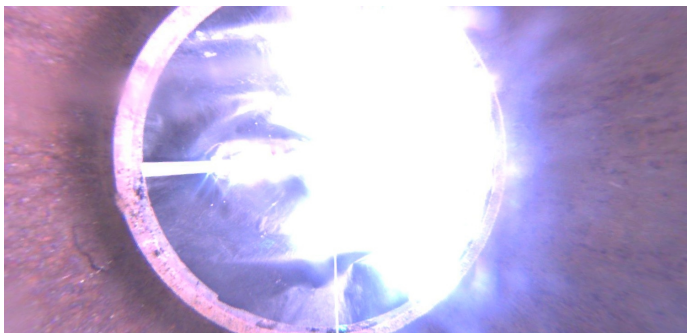
Code: **MGP**  
Description: **General Photo**

Distance (ft): **1.3**  
Structural Grade: **0**  
O&M Grade: **0**  
Clock Start/From:  
Clock To:  
1st Value:  
2nd Value:  
Value Percent:  
Step: **NO**  
Remarks: **UNDERSIDE OF FRAME**

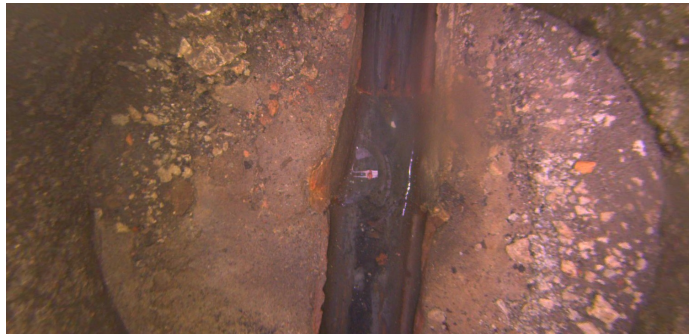
Code: **DSGV**  
Description: **Deposits Settled Gravel**

Distance (ft): **2.9**  
Structural Grade: **0**  
O&M Grade: **2**  
Clock Start/From: **12**  
Clock To: **12**  
1st Value:  
2nd Value:  
Value Percent: **5.000**  
Step: **NO**  
Remarks:

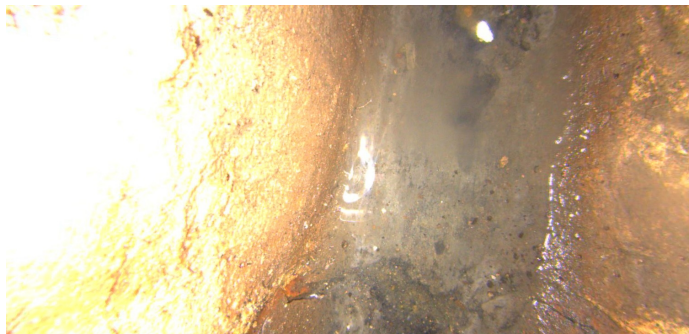
Code: **MGO**  
Description: **General Observation**

Distance (ft): **4.9**  
Structural Grade: **0**  
O&M Grade: **0**  
Clock Start/From:  
Clock To:  
1st Value:  
2nd Value:  
Value Percent:  
Step: **NO**  
Remarks: **END SURVEY**
