Manhole Inspection Report

Date:	04/24/2018	Weather:		Coding:	RZMACP
MH#:	M-506-015	Owner:	NA	Len. Surveyed:	10.0
P.O.#:		Surveyor:	John Kuglmaier	Rim to Invert:	10.9
Customer:		Cert. #:	U-1215-07002349	Wall Material:	Concrete (reinforced)

Street:	7th Pl. 507' West of Wisconsin St.	Project:	Hobart, IN
City:	Hobart, IN	GPS Northing:	2901354.303
Location:		GPS Easting:	2901354.303
Drain Area:	Southwest	GPS Accuracy:	Sub-Meter
Cover Shape:	Circular	Evidence of Surcharge:	Yes
Cover Size:	22.5	Potential for Runoff:	None
Comments:

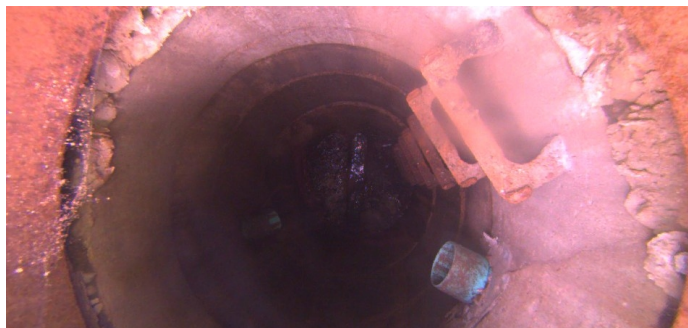
Code: **MGP**
Description: **General Photo**

Distance (ft): **.0**
Structural Grade: **0**
O&M Grade: **0**
Clock Start/From:
Clock To:
1st Value:
2nd Value:
Value Percent:
Step: **NO**
Remarks:

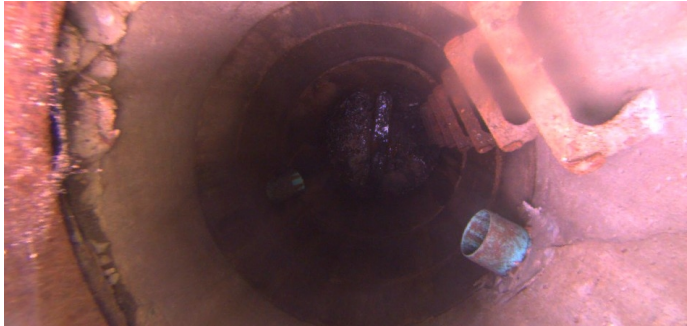
Code: **IS**
Description: **Infil Stain**

Distance (ft): **.2**
Structural Grade: **0**
O&M Grade: **0**
Clock Start/From: **12**
Clock To: **12**
1st Value:
2nd Value:
Value Percent:
Step: **NO**
Remarks:

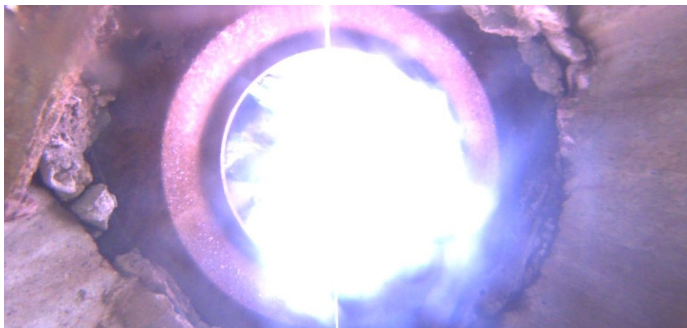
Code: **MGP**
Description: **General Photo**

Distance (ft): **2.7**
Structural Grade: **0**
O&M Grade: **0**
Clock Start/From:
Clock To:
1st Value:
2nd Value:
Value Percent:
Step: **NO**
Remarks:

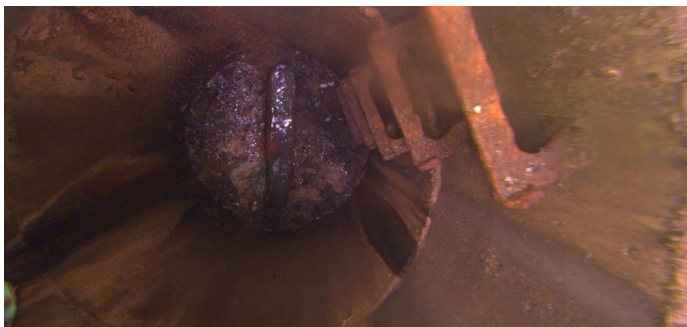
Code: **IS**
Description: **Infil Stain**

Distance (ft): **3.6**
Structural Grade: **0**
O&M Grade: **0**
Clock Start/From: **4**
Clock To:
1st Value:
2nd Value:
Value Percent:
Step: **NO**
Remarks:

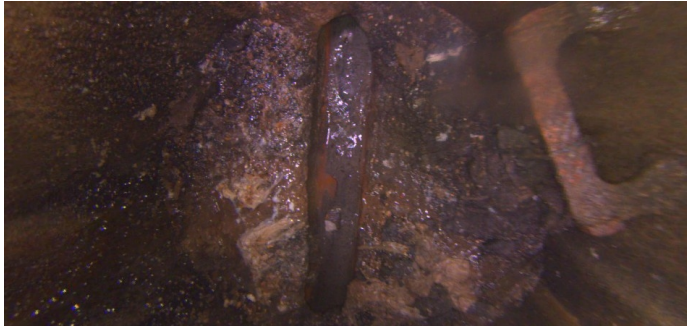
Code:	DAZ
Description:	Deposits Attached Other
Distance (ft):	7.3
Structural Grade:	0
O&M Grade:	3
Clock Start/From:	12
Clock To:	12
1st Value:	
2nd Value:	
Value Percent:	20.000
Step:	NO
Remarks:	Mixed materials

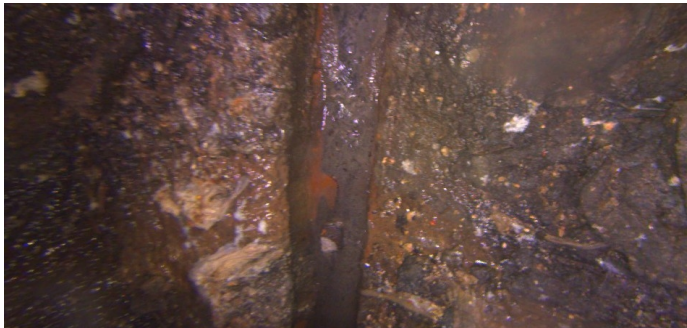
Code:	MGO
Description:	General Observation
Distance (ft):	8.7
Structural Grade:	0
O&M Grade:	0
Clock Start/From:	
Clock To:	
1st Value:	
2nd Value:	
Value Percent:	
Step:	NO
Remarks:	Ins. Comp.
