Manhole Inspection Report

Date:	04/27/2018	Weather:		Coding:	RZMACP
MH#:	M-506-016	Owner:	NA	Len. Surveyed:	16.7
P.O.#:		Surveyor:	Jen Costello	Rim to Invert:	18.1
Customer:		Cert. #:	U-907-5518	Wall Material:	Concrete (reinforced)

Street:	7th Pl. 305' West of Wisconsin St.	Project:	Hobart, IN
City:	Hobart, IN	GPS Northing:	41.52547455
Location:		GPS Easting:	-87.27026367
Drain Area:	Southwest	GPS Accuracy:	Nearest Meter
Cover Shape:	Circular	Evidence of Surcharge:	No
Cover Size:	22.5	Potential for Runoff:	None
Comments:

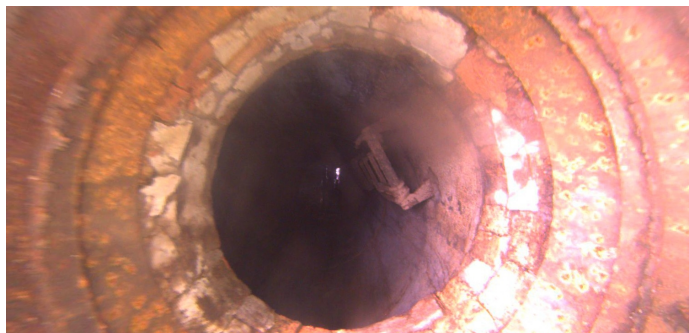
Code: **MGO**
Description: **General Observation**

Distance (ft): **.0**
Structural Grade: **0**
O&M Grade: **0**
Clock Start/From:
Clock To:
1st Value:
2nd Value:
Value Percent:
Step: **NO**
Remarks: **ACCESS MH**

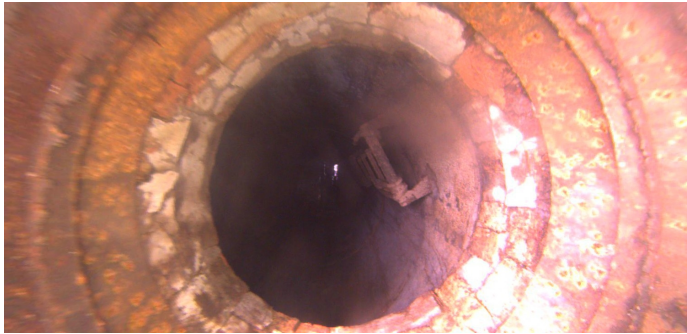
Code: **FM**
Description: **Fracture Multiple**

Distance (ft): **.0**
Structural Grade: **4**
O&M Grade: **0**
Clock Start/From: **12**
Clock To: **12**
1st Value:
2nd Value:
Value Percent:
Step: **NO**
Remarks:

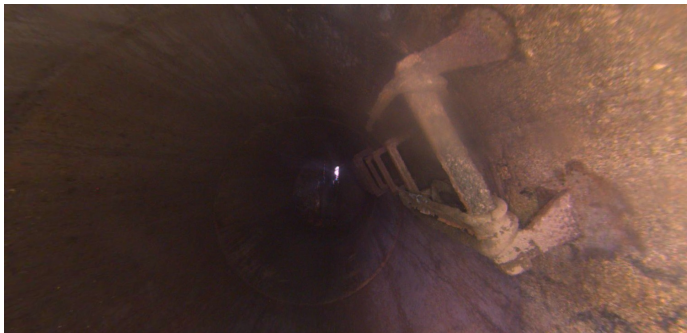
Code: **DAR**
Description: **Deposits Attached Ragging**

Distance (ft): **2.3**
Structural Grade: **0**
O&M Grade: **2**
Clock Start/From: **1**
Clock To: **3**
1st Value:
2nd Value:
Value Percent: **5.000**
Step: **YES**
Remarks:

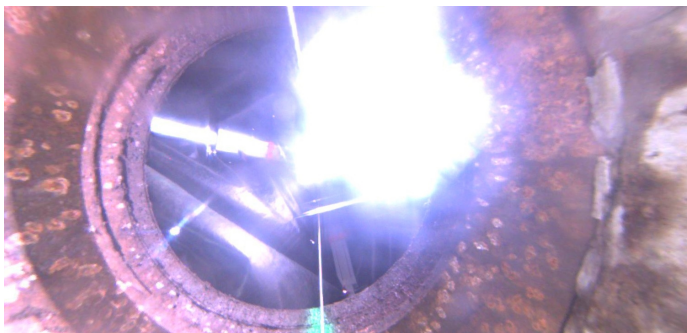
Code: **MGO**
Description: **General Observation**

Distance (ft): **2.3**
Structural Grade: **0**
O&M Grade: **0**
Clock Start/From:
Clock To:
1st Value:
2nd Value:
Value Percent:
Step: **NO**
Remarks: **UNDERSIDE OF FRAME**

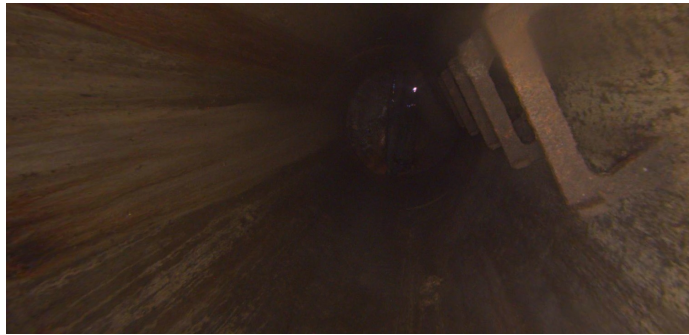
Code: **IS**
Description: **Infil Stain**

Distance (ft): **7.5**
Structural Grade: **0**
O&M Grade: **0**
Clock Start/From: **12**
Clock To: **12**
1st Value:
2nd Value:
Value Percent:
Step: **NO**
Remarks:

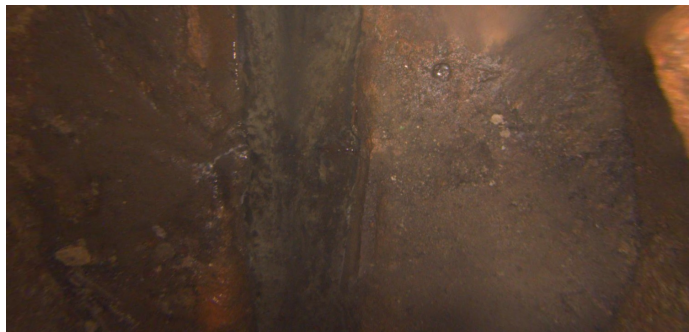
Code: **DSF**
Description: **Deposits Settled Fine**

Distance (ft): **16.2**
Structural Grade: **0**
O&M Grade: **2**
Clock Start/From: **12**
Clock To: **12**
1st Value:
2nd Value:
Value Percent: **5.000**
Step: **NO**
Remarks:

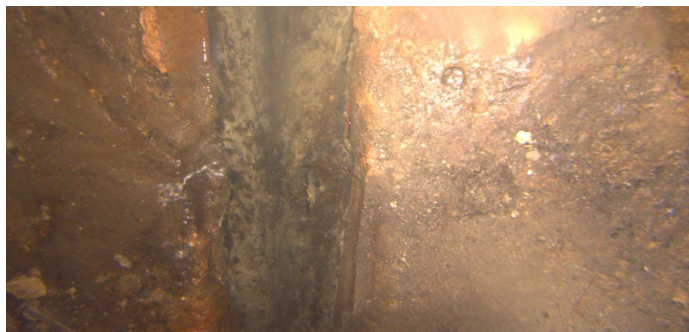
Code: **MGO**
Description: **General Observation**

Distance (ft): **16.7**
Structural Grade: **0**
O&M Grade: **0**
Clock Start/From:
Clock To:
1st Value:
2nd Value:
Value Percent:
Step: **NO**
Remarks: **END SURVEY**
