Manhole Inspection Report

Date:	04/27/2018	Weather:		Coding:	RZMACP
MH#:	M-506-016	Owner:	NA	Len. Surveyed:	9.2
P.O.#:		Surveyor:	Jen Costello	Rim to Invert:	10.4
Customer:		Cert. #:	U-907-5518	Wall Material:	Concrete (reinforced)

Street:	7th Pl. 305' West of Wisconsin St.	Project:	Hobart, IN
City:	Hobart, IN	GPS Northing:	41.52640152
Location:		GPS Easting:	-87.27033234
Drain Area:	Southwest	GPS Accuracy:	Nearest Meter
Cover Shape:	Circular	Evidence of Surcharge:	No
Cover Size:	22.5	Potential for Runoff:	None
Comments:

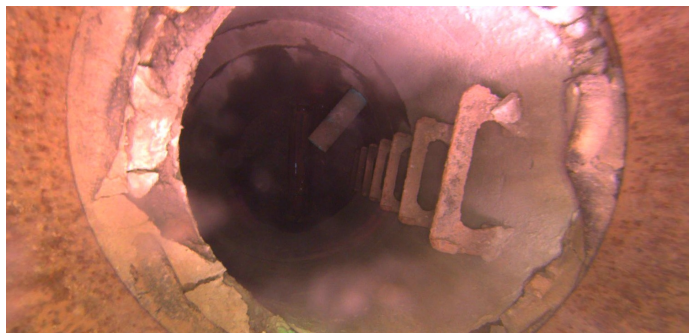
Code: **MGO**
Description: **General Observation**

Distance (ft): **.0**
Structural Grade: **0**
O&M Grade: **0**
Clock Start/From:
Clock To:
1st Value:
2nd Value:
Value Percent:
Step: **NO**
Remarks: **ACCESS MH**

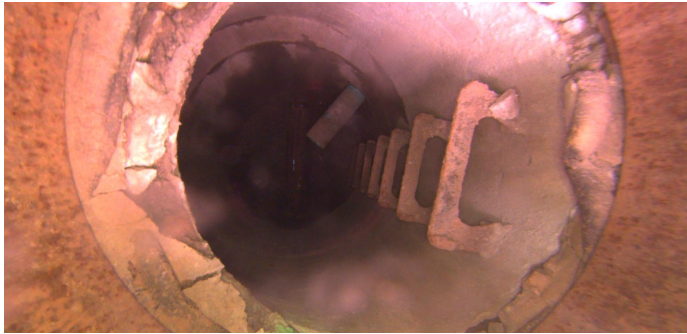
Code: **FM**
Description: **Fracture Multiple**

Distance (ft): **.0**
Structural Grade: **4**
O&M Grade: **0**
Clock Start/From: **12**
Clock To: **12**
1st Value:
2nd Value:
Value Percent:
Step: **NO**
Remarks:

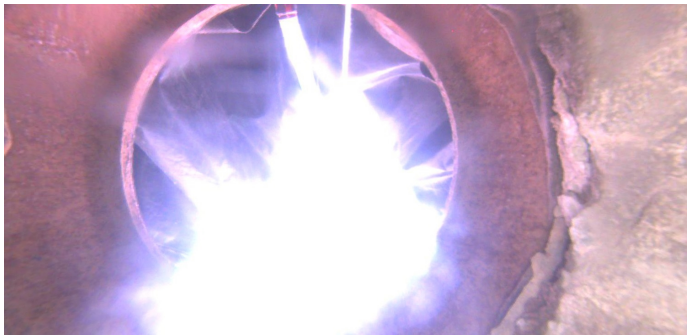
Code: **MGP**
Description: **General Photo**

Distance (ft): **2.2**
Structural Grade: **0**
O&M Grade: **0**
Clock Start/From:
Clock To:
1st Value:
2nd Value:
Value Percent:
Step: **NO**
Remarks: **UNDERSIDE OF FRAME**

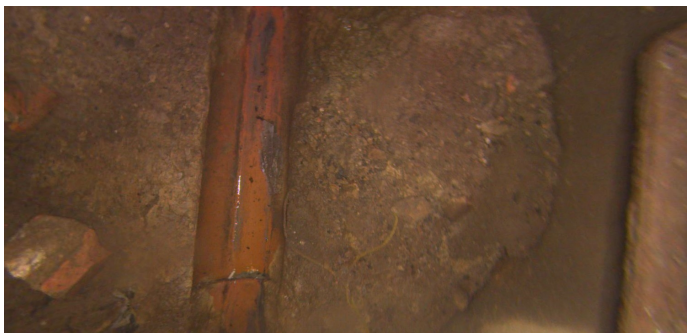
Code: **DSF**
Description: **Deposits Settled Fine**

Distance (ft): **7.3**
Structural Grade: **0**
O&M Grade: **2**
Clock Start/From: **12**
Clock To: **12**
1st Value:
2nd Value:
Value Percent: **5.000**
Step: **NO**
Remarks:

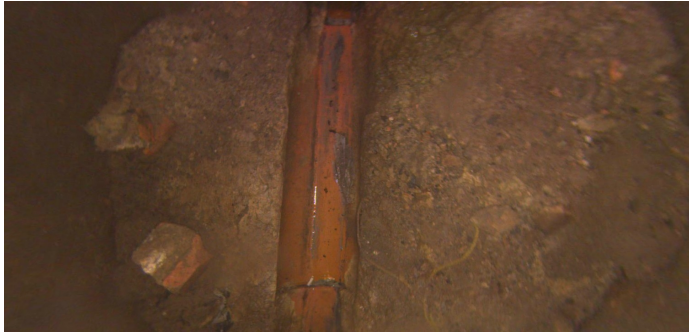
Code: **OBR**
Description: **Obstacle Rocks**

Distance (ft): **7.3**
Structural Grade: **0**
O&M Grade: **2**
Clock Start/From: **8**
Clock To: **10**
1st Value:
2nd Value:
Value Percent: **5.000**
Step: **NO**
Remarks:

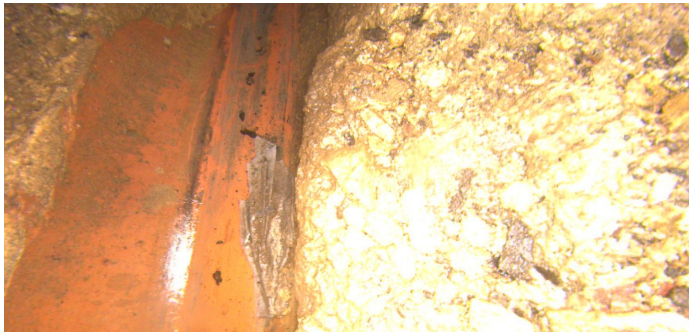
Code: **MGO**
Description: **General Observation**

Distance (ft): **9.2**
Structural Grade: **0**
O&M Grade: **0**
Clock Start/From:
Clock To:
1st Value:
2nd Value:
Value Percent:
Step: **NO**
Remarks: **END SURVEY**
