# Manhole Inspection Report

Date:	<b>09/28/2022</b>	Weather:		Coding:	<b>RZMACP</b>
MH#:	<b>M-506-024</b>	Owner:	<b>NA</b>	Len. Surveyed:	<b>10.4</b>
P.O.#:		Surveyor:	<b>Jen Costello</b>	Rim to Invert:	<b>10.8</b>
Customer:		Cert. #:	<b>U-907-5518</b>	Wall Material:	<b>Concrete (cast in place)</b>

Street:	<b>River Terrace 134' South of 7th Pl.</b>	Project:	<b>Hobart, IN</b>
City:	<b>Hobart, IN</b>	GPS Northing:	<b>2286657.099</b>
Location:	<b>Yard</b>	GPS Easting:	<b>2900161.718</b>
Drain Area:	<b>Southwest</b>	GPS Accuracy:	<b>Sub-Meter</b>
Cover Shape:	<b>Circular</b>	Evidence of Surcharge:	<b>No</b>
Cover Size:	<b>24.0</b>	Potential for Runoff:	<b>None</b>
Comments:

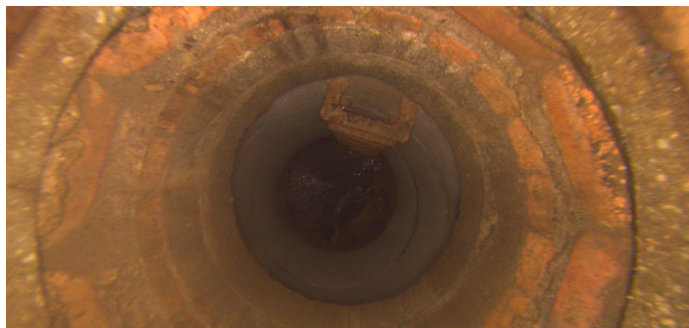
Code: **MGO**  
Description: **General Observation**

Distance (ft): **.0**  
Structural Grade: **0**  
O&M Grade: **0**  
Clock Start/From:  
Clock To:  
1st Value:  
2nd Value:  
Value Percent:  
Step: **NO**  
Remarks: **access mh**

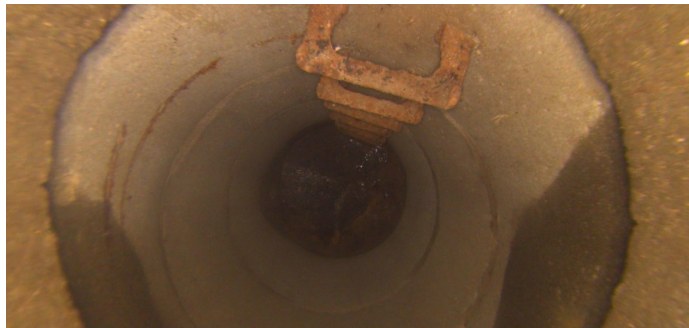
Code: **SRI**  
Description: **Surface Roughness Increased**

Distance (ft): **1.5**  
Structural Grade: **1**  
O&M Grade: **0**  
Clock Start/From: **12**  
Clock To: **12**  
1st Value:  
2nd Value:  
Value Percent:  
Step: **NO**  
Remarks:
