Manhole Inspection Report

Date:	04/24/2018	Weather:		Coding:	RZMACP
MH#:	M-506-027	Owner:	NA	Len. Surveyed:	8.3
P.O.#:		Surveyor:	John Kuglmaier	Rim to Invert:	8.7
Customer:		Cert. #:	U-1215-07002349	Wall Material:	Concrete (reinforced)

Street:	North of 7th Pl. 171' West of Colora	Project:	Hobart, IN
City:	Hobart, IN	GPS Northing:	2900360.198
Location:		GPS Easting:	2900360.198
Drain Area:	Southwest	GPS Accuracy:	Sub-Meter
Cover Shape:	Circular	Evidence of Surcharge:	No
Cover Size:	22.5	Potential for Runoff:	None
Comments:

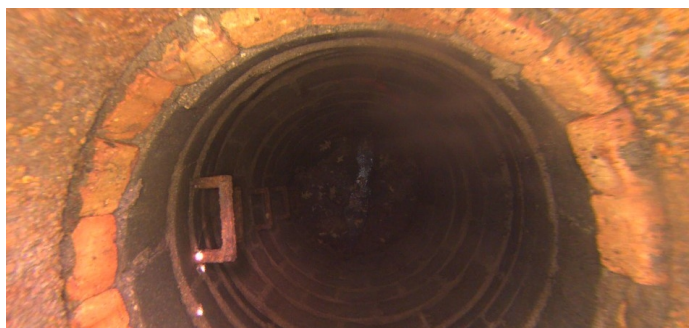
Code: **MGP**
Description: **General Photo**

Distance (ft): **.0**
Structural Grade: **0**
O&M Grade: **0**
Clock Start/From:
Clock To:
1st Value:
2nd Value:
Value Percent:
Step: **NO**
Remarks:

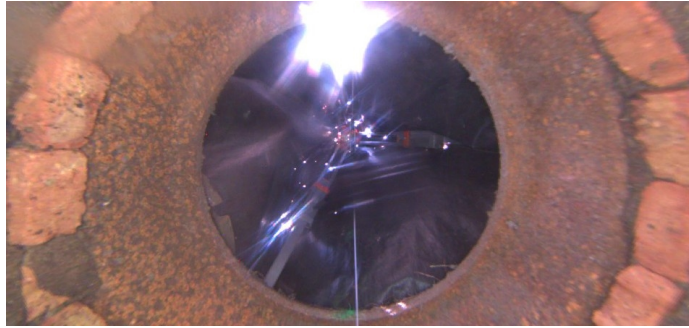
Code: **MGP**
Description: **General Photo**

Distance (ft): **2.3**
Structural Grade: **0**
O&M Grade: **0**
Clock Start/From:
Clock To:
1st Value:
2nd Value:
Value Percent:
Step: **NO**
Remarks:

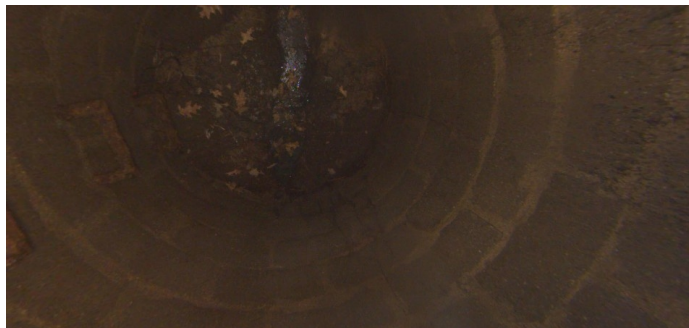
Code: **RFJ**
Description: **Roots Fine Joint**

Distance (ft): **3.5**
Structural Grade: **0**
O&M Grade: **1**
Clock Start/From: **5**
Clock To:
1st Value:
2nd Value:
Value Percent:
Step: **NO**
Remarks:

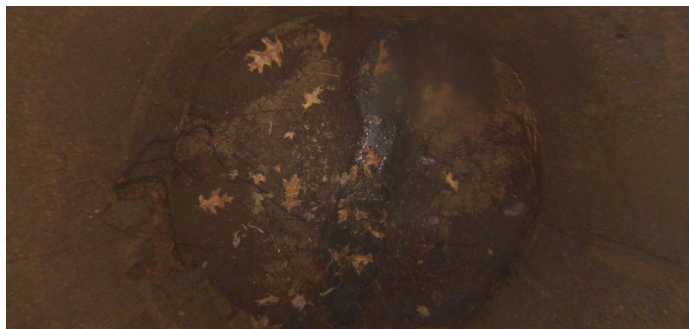
Code: **DAZ**
Description: **Deposits Attached Other**

Distance (ft): **5.7**
Structural Grade: **0**
O&M Grade: **2**
Clock Start/From: **12**
Clock To: **12**
1st Value:
2nd Value:
Value Percent: **10.000**
Step: **NO**
Remarks: **Mixed materials**

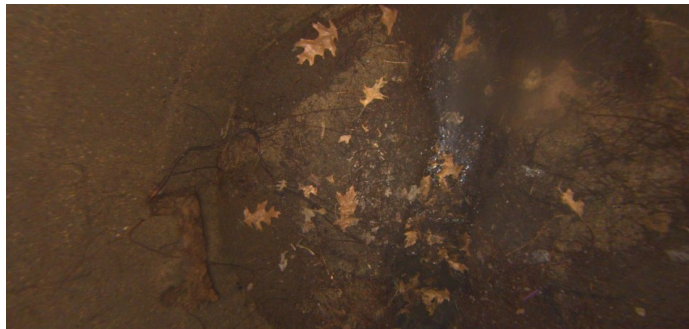
Code: **RFJ**
Description: **Roots Fine Joint**

Distance (ft): **6.4**
Structural Grade: **0**
O&M Grade: **1**
Clock Start/From: **9**
Clock To:
1st Value:
2nd Value:
Value Percent:
Step: **NO**
Remarks:

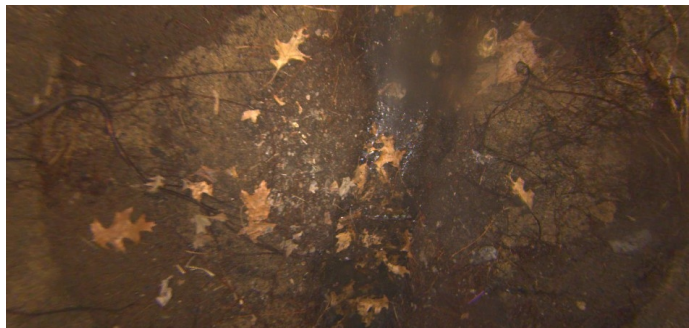
Code: **MGO**
Description: **General Observation**

Distance (ft): **7.2**
Structural Grade: **0**
O&M Grade: **0**
Clock Start/From:
Clock To:
1st Value:
2nd Value:
Value Percent:
Step: **NO**
Remarks: **Ins. Comp.**
