Manhole Inspection Report

Date:	04/25/2018	Weather:		Coding:	RZMACP
MH#:	M-506-034	Owner:	NA	Len. Surveyed:	8.7
P.O.#:		Surveyor:	John Kuglmaier	Rim to Invert:	9.1
Customer:	8.7	Cert. #:	U-1215-07002349	Wall Material:	Concrete (reinforced)

Street:	Wisconsin St. 494' North of 10th St.	Project:	Hobart, IN
City:	Hobart, IN	GPS Northing:	0.0
Location:		GPS Easting:	0.0
Drain Area:	Southwest	GPS Accuracy:	Nearest Meter
Cover Shape:	Circular	Evidence of Surcharge:	No
Cover Size:	22.5	Potential for Runoff:	None
Comments:

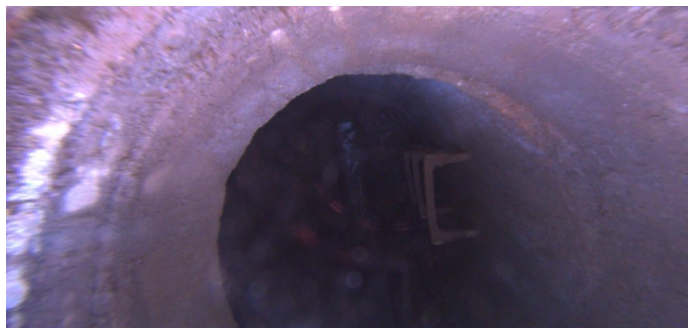
Code: **MGP**
Description: **General Photo**

Distance (ft): **.0**
Structural Grade: **0**
O&M Grade: **0**
Clock Start/From:
Clock To:
1st Value:
2nd Value:
Value Percent:
Step: **NO**
Remarks:

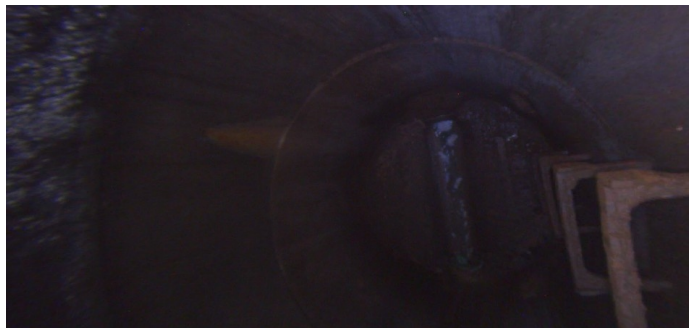
Code: **IS**
Description: **Infil Stain**

Distance (ft): **2.6**
Structural Grade: **0**
O&M Grade: **0**
Clock Start/From: **10**
Clock To:
1st Value:
2nd Value:
Value Percent:
Step: **NO**
Remarks:

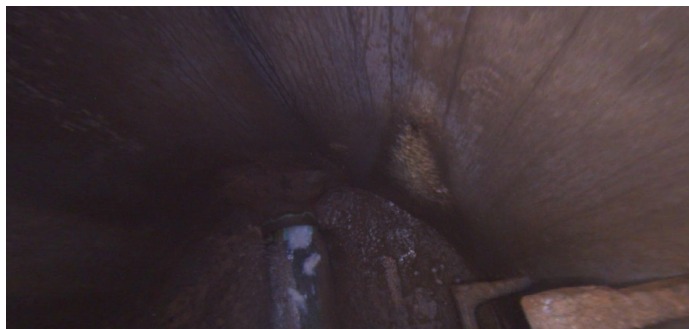
Code: **IS**
Description: **Infil Stain**

Distance (ft): **5.9**
Structural Grade: **0**
O&M Grade: **0**
Clock Start/From: **1**
Clock To:
1st Value:
2nd Value:
Value Percent:
Step: **NO**
Remarks:

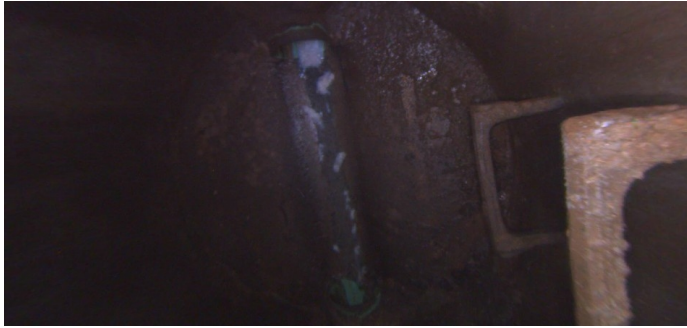
Code:	DSF
Description:	Deposits Settled Fine
Distance (ft):	6.1
Structural Grade:	0
O&M Grade:	2
Clock Start/From:	12
Clock To:	12
1st Value:	
2nd Value:	
Value Percent:	5.000
Step:	NO
Remarks:

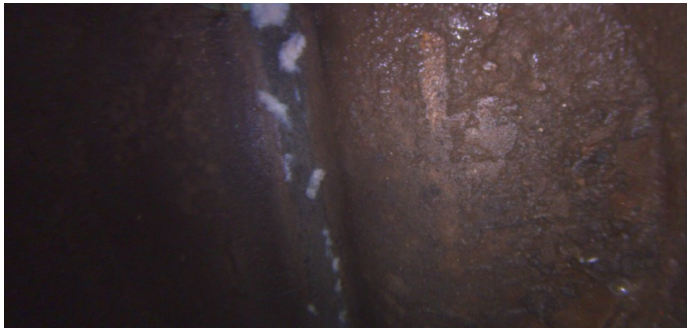
Code:	MGO
Description:	General Observation
Distance (ft):	7.8
Structural Grade:	0
O&M Grade:	0
Clock Start/From:	
Clock To:	
1st Value:	
2nd Value:	
Value Percent:	
Step:	NO
Remarks:	Ins. Comp.
