Manhole Inspection Report

Date:	04/25/2018	Weather:		Coding:	RZMACP
MH#:	M-506-034	Owner:	NA	Len. Surveyed:	9.1
P.O.#:		Surveyor:	John Kuglmaier	Rim to Invert:	9.1
Customer:	8.7	Cert. #:	U-1215-07002349	Wall Material:	Concrete (reinforced)

Street:	Wisconsin St. 494' North of 10th St.	Project:	Hobart, IN
City:	Hobart, IN	GPS Northing:	0.0
Location:		GPS Easting:	0.0
Drain Area:	Southwest	GPS Accuracy:	Nearest Meter
Cover Shape:	Circular	Evidence of Surcharge:	No
Cover Size:	22.5	Potential for Runoff:	None
Comments:

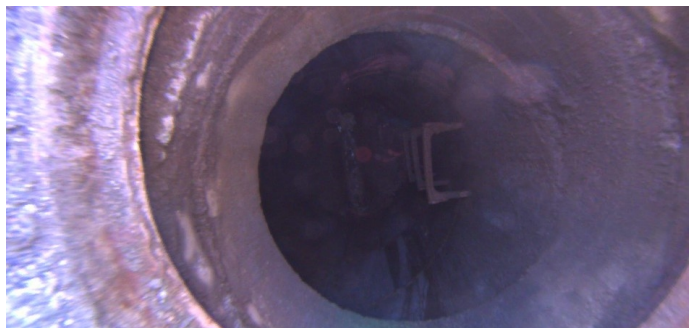
Code: **MGP**
Description: **General Photo**

Distance (ft): **.0**
Structural Grade: **0**
O&M Grade: **0**
Clock Start/From:
Clock To:
1st Value:
2nd Value:
Value Percent:
Step: **NO**
Remarks:

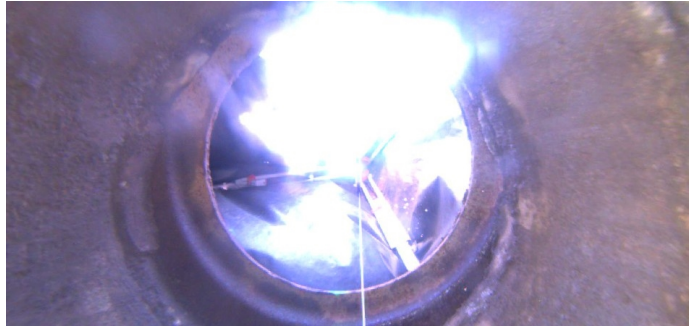
Code: **MGP**
Description: **General Photo**

Distance (ft): **2.9**
Structural Grade: **0**
O&M Grade: **0**
Clock Start/From:
Clock To:
1st Value:
2nd Value:
Value Percent:
Step: **NO**
Remarks:

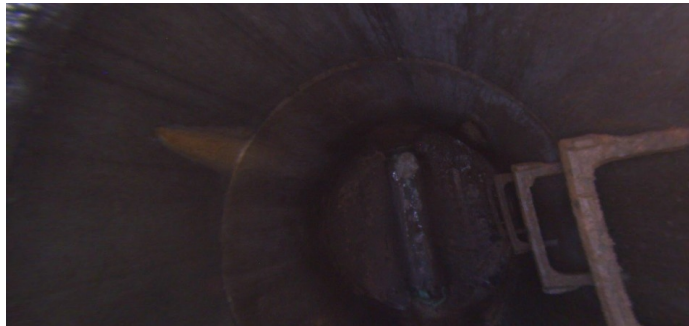
Code: **IS**
Description: **Infil Stain**

Distance (ft): **3.1**
Structural Grade: **0**
O&M Grade: **0**
Clock Start/From: **10**
Clock To:
1st Value:
2nd Value:
Value Percent:
Step: **NO**
Remarks:

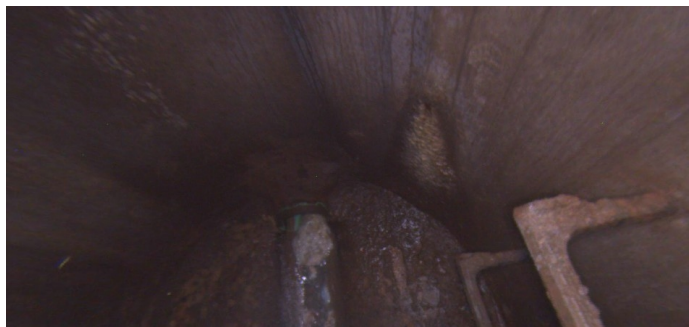
Code: **IS**
Description: **Infil Stain**

Distance (ft): **6.3**
Structural Grade: **0**
O&M Grade: **0**
Clock Start/From: **1**
Clock To:
1st Value:
2nd Value:
Value Percent:
Step: **NO**
Remarks:

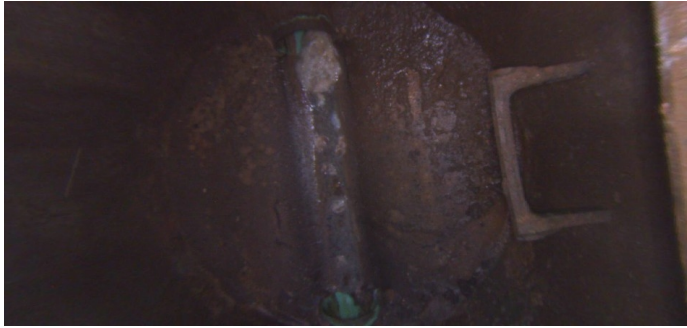
Code:	DSF
Description:	Deposits Settled Fine
Distance (ft):	6.7
Structural Grade:	0
O&M Grade:	2
Clock Start/From:	12
Clock To:	12
1st Value:	
2nd Value:	
Value Percent:	5.000
Step:	NO
Remarks:

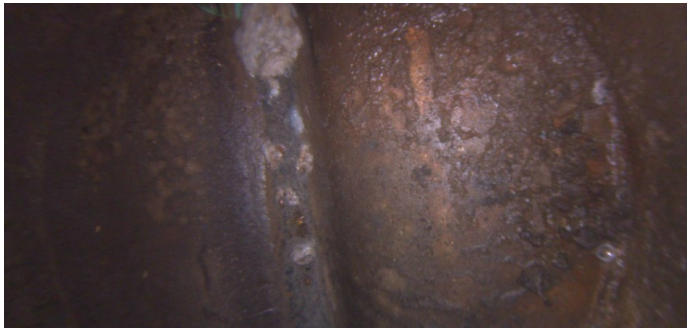
Code:	MGO
Description:	General Observation
Distance (ft):	8.0
Structural Grade:	0
O&M Grade:	0
Clock Start/From:	
Clock To:	
1st Value:	
2nd Value:	
Value Percent:	
Step:	NO
Remarks:	Ins. Comp.
