# Manhole Inspection Report

| MH#: | <b>M-506-036</b> | Owner: | <b>NA</b> | Len. Surveyed: | <b>3.3</b> |

| Street: | <b>682' Northwest of 10th St. and Deca</b> | Project: | <b>Hobart, IN</b> |

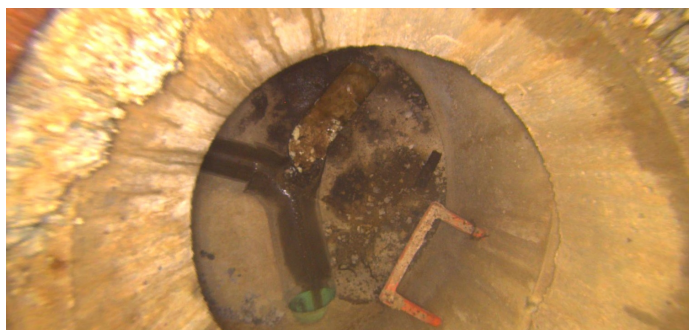
Code: **MGO**  
Description: **General Observation**

Distance (ft): **.0**  
Structural Grade: **0**  
O&M Grade: **0**  
Clock Start/From:  
Clock To:  
1st Value:  
2nd Value:  
Value Percent:  
Step: **NO**  
Remarks: **access mh**

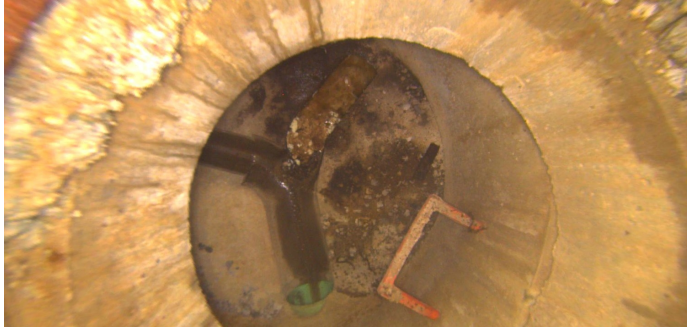
| Code: | <b>ISGT</b> |
| Description: | <b>Intruding Sealing Grout</b> |
| Distance (ft): | <b>.0</b> |
| O&M Grade: | <b>2</b> |
| Clock Start/From: | <b>9</b> |
| Clock To: | <b>3</b> |
| Value Percent: | <b>5.000</b> |

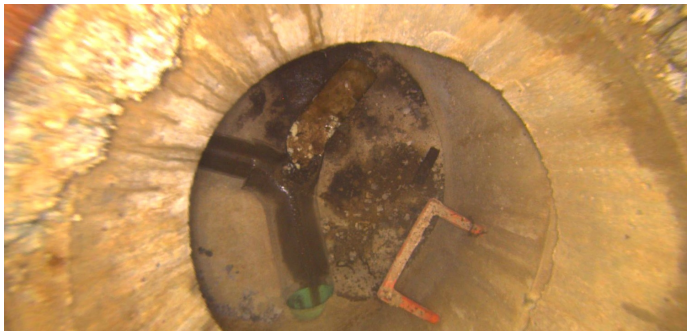
| Code: | <b>SRI</b> |
| Description: | <b>Surface Roughness Increased</b> |
| Distance (ft): | <b>.0</b> |
| Structural Grade: | <b>1</b> |

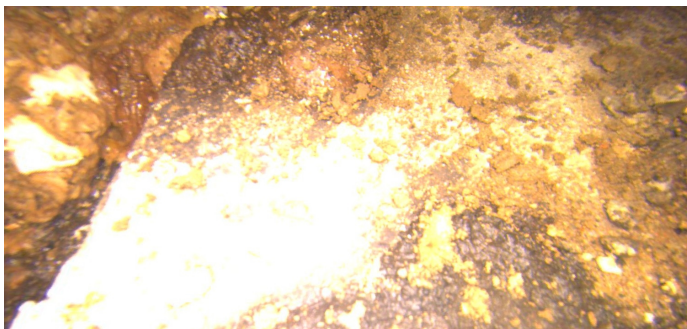
| Code: | <b>DSF</b> |
| Description: | <b>Deposits Settled Fine</b> |
| Distance (ft): | <b>3.3</b> |
| O&M Grade: | <b>2</b> |
| Value Percent: | <b>5.000</b> |

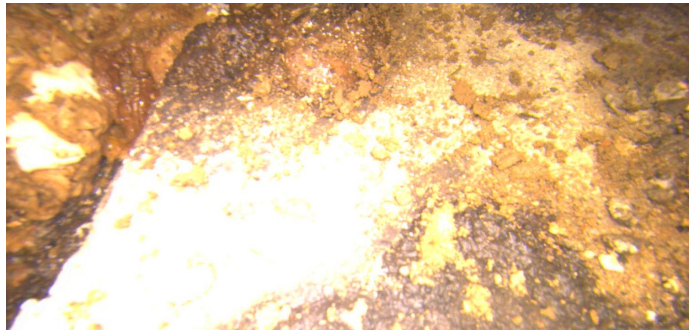
Code: **DSZ**  
Description: **Deposits Settled Other**

Distance (ft): **3.3**  
Structural Grade: **0**  
O&M Grade: **5**  
Clock Start/From: **3**  
Clock To: **9**  
1st Value:  
2nd Value:  
Value Percent: **40.000**  
Step: **NO**  
Remarks: **misc**

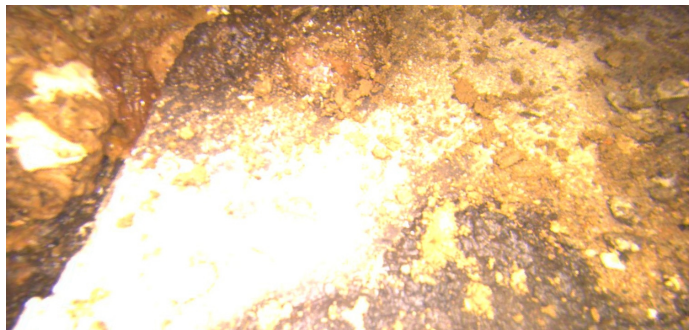
Code: **SRI**  
Description: **Surface Roughness Increased**

Distance (ft): **3.3**  
Structural Grade: **1**  
O&M Grade: **0**  
Clock Start/From: **12**  
Clock To: **12**  
1st Value:  
2nd Value:  
Value Percent:  
Step: **NO**  
Remarks:

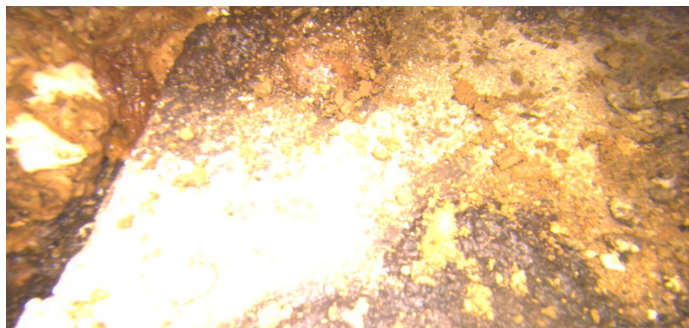
Code: **MGO**  
Description: **General Observation**

Distance (ft): **3.3**  
Structural Grade: **0**  
O&M Grade: **0**  
Clock Start/From:  
Clock To:  
1st Value:  
2nd Value:  
Value Percent:  
Step: **NO**  
Remarks: **end of survey**
