# Manhole Inspection Report

Date:	<b>04/24/2018</b>	Weather:		Coding:	<b>RZMACP</b>
MH#:	<b>M-506-037</b>	Owner:	<b>NA</b>	Len. Surveyed:	<b>5.7</b>
P.O.#:		Surveyor:	<b>John Kuglmaier</b>	Rim to Invert:	<b>6.0</b>
Customer:		Cert. #:	<b>U-1215-07002349</b>	Wall Material:	<b>Concrete (reinforced)</b>

Street:	<b>500' Northwest of 10th St. and Deca</b>	Project:	<b>Hobart, IN</b>
City:	<b>Hobart, IN</b>	GPS Northing:	<b>2899862.944</b>
Location:		GPS Easting:	<b>2899862.944</b>
Drain Area:	<b>Southwest</b>	GPS Accuracy:	<b>Sub-Meter</b>
Cover Shape:	<b>Circular</b>	Evidence of Surcharge:	<b>No</b>
Cover Size:	<b>22.5</b>	Potential for Runoff:	<b>None</b>
Comments:

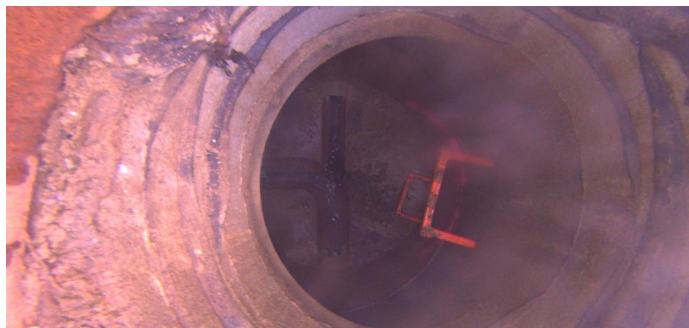
Code: **MGP**  
Description: **General Photo**

Distance (ft): **.0**  
Structural Grade: **0**  
O&M Grade: **0**  
Clock Start/From:  
Clock To:  
1st Value:  
2nd Value:  
Value Percent:  
Step: **NO**  
Remarks:

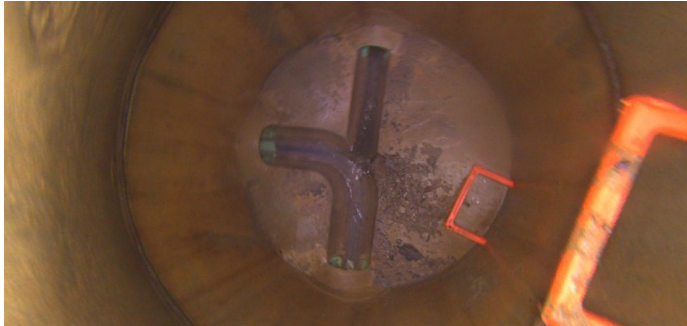
Code: **IS**  
Description: **Infil Stain**

Distance (ft): **1.8**  
Structural Grade: **0**  
O&M Grade: **0**  
Clock Start/From: **12**  
Clock To: **12**  
1st Value:  
2nd Value:  
Value Percent:  
Step: **NO**  
Remarks:

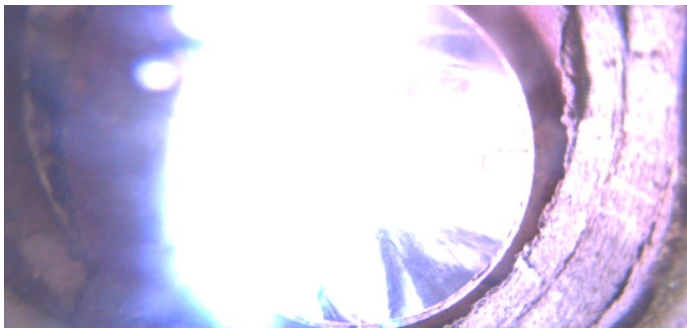
Code: **MGP**  
Description: **General Photo**

Distance (ft): **2.0**  
Structural Grade: **0**  
O&M Grade: **0**  
Clock Start/From:  
Clock To:  
1st Value:  
2nd Value:  
Value Percent:  
Step: **NO**  
Remarks:

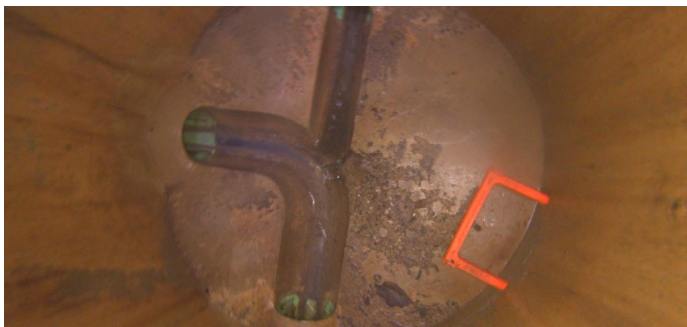
Code: **DSF**  
Description: **Deposits Settled Fine**

Distance (ft): **3.1**  
Structural Grade: **0**  
O&M Grade: **2**  
Clock Start/From: **12**  
Clock To: **12**  
1st Value:  
2nd Value:  
Value Percent: **5.000**  
Step: **NO**  
Remarks:

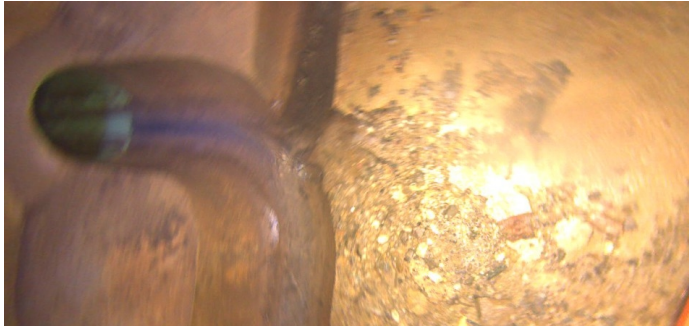
Code:	<b>MGO</b>
Description:	<b>General Observation</b>
Distance (ft):	<b>4.9</b>
Structural Grade:	<b>0</b>
O&M Grade:	<b>0</b>
Clock Start/From:	
Clock To:	
1st Value:	
2nd Value:	
Value Percent:	
Step:	<b>NO</b>
Remarks:	<b>Ins. Comp.</b>
