# Manhole Inspection Report

Date:	03/28/2018	Weather:		Coding:	RZMACP
MH#:	M-507-008	Owner:	NA	Len. Surveyed:	9.7
P.O.#:		Surveyor:	John Kuglmaier	Rim to Invert:	10.0
Customer:		Cert. #:	U-1215-07002349	Wall Material:	Concrete (reinforced)

Street:	Virginia St. 158' North of 13th Pl.	Project:	Hobart, IN
City:	Hobart, IN	GPS Northing:	0.0
Location:		GPS Easting:	0.0
Drain Area:	Southwest	GPS Accuracy:	Nearest Meter
Cover Shape:	Circular	Evidence of Surcharge:	Yes
Cover Size:	22.5	Potential for Runoff:	None
Comments:

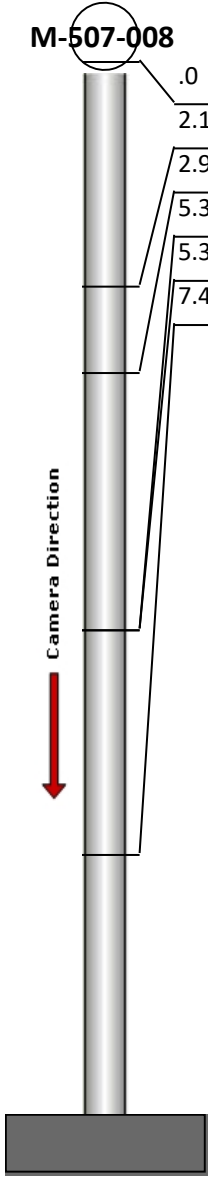
.0	MGP	General Photo	10	NA
	2.1	IS	Infil Stain	26	NA
	2.9	MGP	General Photo	41	NA
	5.3	IS	Infil Stain	60	NA
	5.3	DAE	Deposits Attached Encrustation	71	M 2
	7.4	DSF	Deposits Settled Fine	86	M 3

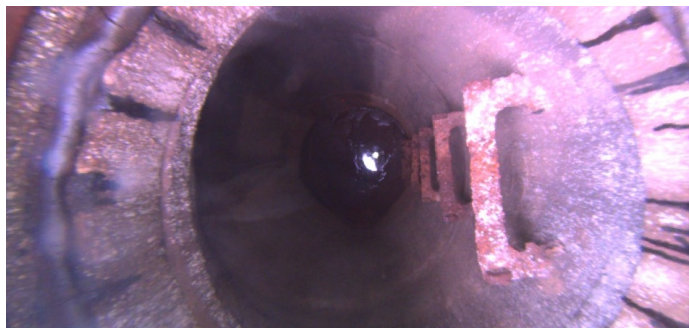
Code: **MGP**  
Description: **General Photo**

Distance (ft): **.0**  
Structural Grade: **0**  
O&M Grade: **0**  
Clock Start/From:  
Clock To:  
1st Value:  
2nd Value:  
Value Percent:  
Step: **NO**  
Remarks:

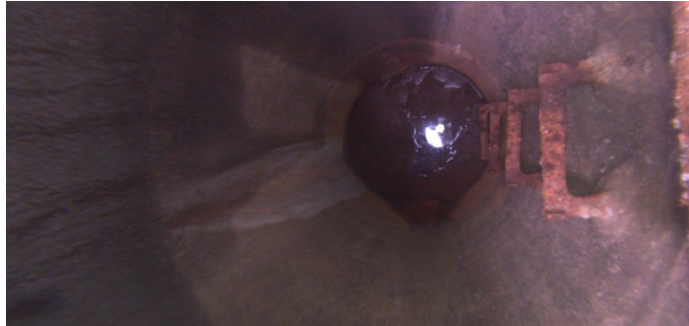
Code: **IS**  
Description: **Infil Stain**

Distance (ft): **2.1**  
Structural Grade: **0**  
O&M Grade: **0**  
Clock Start/From: **8**  
Clock To:  
1st Value:  
2nd Value:  
Value Percent:  
Step: **NO**  
Remarks:

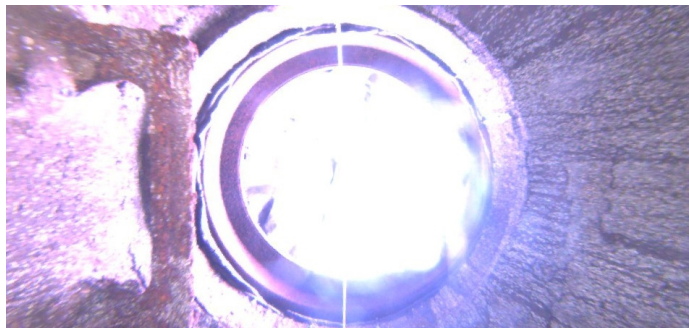
Code: **MGP**  
Description: **General Photo**

Distance (ft): **2.9**  
Structural Grade: **0**  
O&M Grade: **0**  
Clock Start/From:  
Clock To:  
1st Value:  
2nd Value:  
Value Percent:  
Step: **NO**  
Remarks:

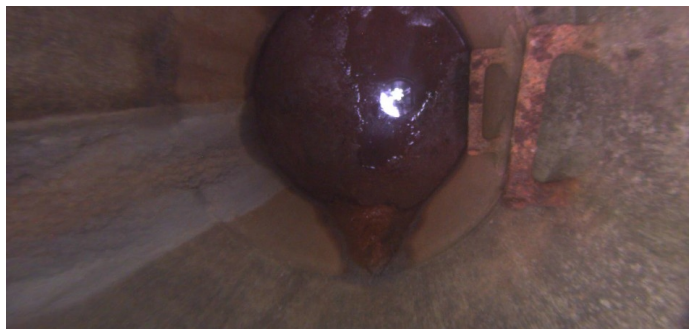
Code: **IS**  
Description: **Infil Stain**

Distance (ft): **5.3**  
Structural Grade: **0**  
O&M Grade: **0**  
Clock Start/From: **6**  
Clock To:  
1st Value:  
2nd Value:  
Value Percent:  
Step: **NO**  
Remarks:

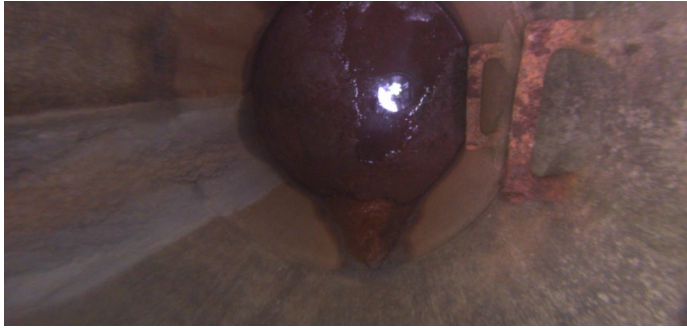
Code:	<b>DAE</b>
Description:	<b>Deposits Attached Encrustation</b>
Distance (ft):	<b>5.3</b>
Structural Grade:	<b>0</b>
O&M Grade:	<b>2</b>
Clock Start/From:	<b>6</b>
Clock To:	
1st Value:	
2nd Value:	
Value Percent:	<b>5.000</b>
Step:	<b>NO</b>
Remarks:

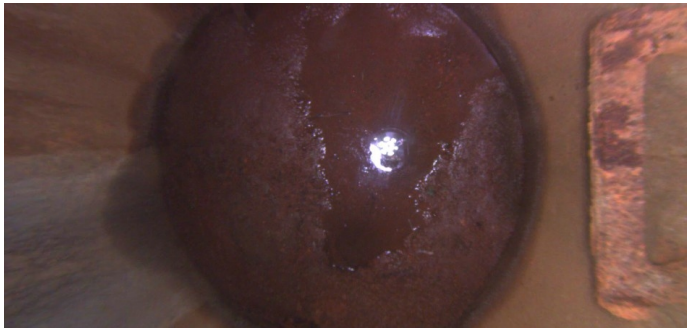
Code:	<b>DSF</b>
Description:	<b>Deposits Settled Fine</b>
Distance (ft):	<b>7.4</b>
Structural Grade:	<b>0</b>
O&M Grade:	<b>3</b>
Clock Start/From:	<b>12</b>
Clock To:	<b>12</b>
1st Value:	
2nd Value:	
Value Percent:	<b>15.000</b>
Step:	<b>NO</b>
Remarks:
