# Manhole Inspection Report

Date:	<b>03/28/2018</b>	Weather:		Coding:	<b>RZMACP</b>
MH#:	<b>M-507-010</b>	Owner:	<b>NA</b>	Len. Surveyed:	<b>7.8</b>
P.O.#:		Surveyor:	<b>John Kuglmaier</b>	Rim to Invert:	<b>8.0</b>
Customer:		Cert. #:	<b>U-1215-07002349</b>	Wall Material:	<b>Concrete (reinforced)</b>

Street:	<b>Csokasy Ln. 166' Northwest of Virgin</b>	Project:	<b>Hobart, IN</b>
City:	<b>Hobart, IN</b>	GPS Northing:	<b>0.0</b>
Location:		GPS Easting:	<b>0.0</b>
Drain Area:	<b>Southwest</b>	GPS Accuracy:	<b>Nearest Meter</b>
Cover Shape:	<b>Circular</b>	Evidence of Surcharge:	<b>No</b>
Cover Size:	<b>22.5</b>	Potential for Runoff:	<b>None</b>
Comments:

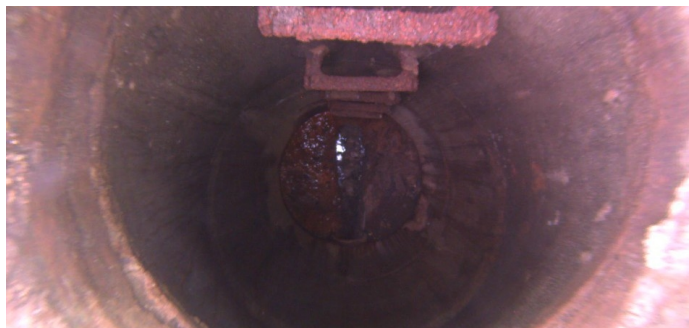
Code: **MGP**  
Description: **General Photo**

Distance (ft): **.0**  
Structural Grade: **0**  
O&M Grade: **0**  
Clock Start/From:  
Clock To:  
1st Value:  
2nd Value:  
Value Percent:  
Step: **NO**  
Remarks:

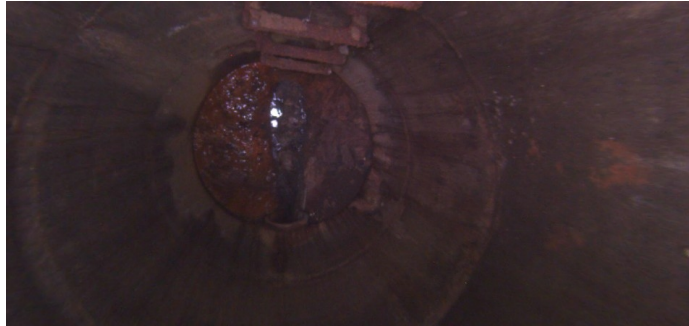
Code: **IS**  
Description: **Infil Stain**

Distance (ft): **1.3**  
Structural Grade: **0**  
O&M Grade: **0**  
Clock Start/From: **2**  
Clock To: **4**  
1st Value:  
2nd Value:  
Value Percent:  
Step: **NO**  
Remarks:

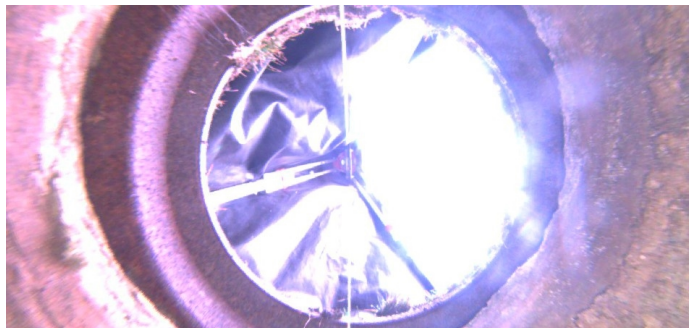
Code: **MGP**  
Description: **General Photo**

Distance (ft): **2.0**  
Structural Grade: **0**  
O&M Grade: **0**  
Clock Start/From:  
Clock To:  
1st Value:  
2nd Value:  
Value Percent:  
Step: **NO**  
Remarks:

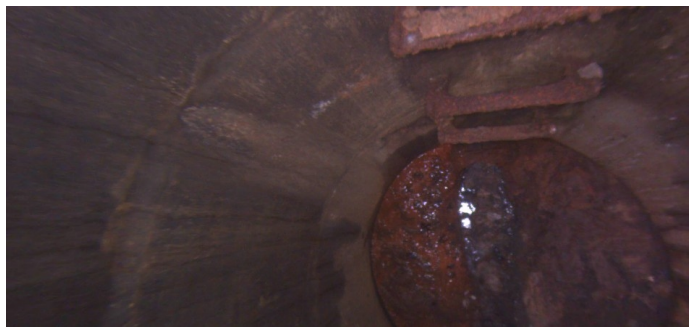
Code: **IS**  
Description: **Infil Stain**

Distance (ft): **2.9**  
Structural Grade: **0**  
O&M Grade: **0**  
Clock Start/From: **10**  
Clock To:  
1st Value:  
2nd Value:  
Value Percent:  
Step: **NO**  
Remarks:

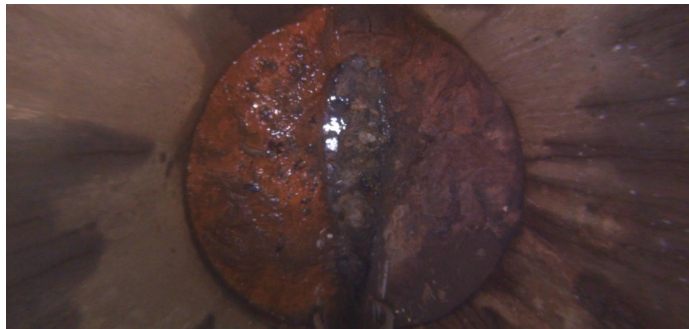
Code:	<b>DAZ</b>
Description:	<b>Deposits Attached Other</b>
Distance (ft):	<b>4.8</b>
Structural Grade:	<b>0</b>
O&M Grade:	<b>2</b>
Clock Start/From:	<b>12</b>
Clock To:	<b>12</b>
1st Value:	
2nd Value:	
Value Percent:	<b>10.000</b>
Step:	<b>NO</b>
Remarks:	<b>Mixed materials</b>

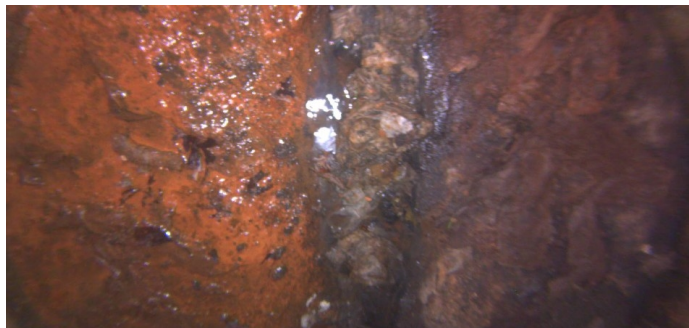
Code:	<b>MGO</b>
Description:	<b>General Observation</b>
Distance (ft):	<b>6.4</b>
Structural Grade:	<b>0</b>
O&M Grade:	<b>0</b>
Clock Start/From:	
Clock To:	
1st Value:	
2nd Value:	
Value Percent:	
Step:	<b>NO</b>
Remarks:	<b>Ins. Comp.</b>
