Manhole Inspection Report

Date:	04/05/2018	Weather:		Coding:	RZMACP
MH#:	M-507-011	Owner:	NA	Len. Surveyed:	11.7
P.O.#:		Surveyor:	John Kuglmaier	Rim to Invert:	11.9
Customer:		Cert. #:	U-1215-07002349	Wall Material:	Concrete (reinforced)

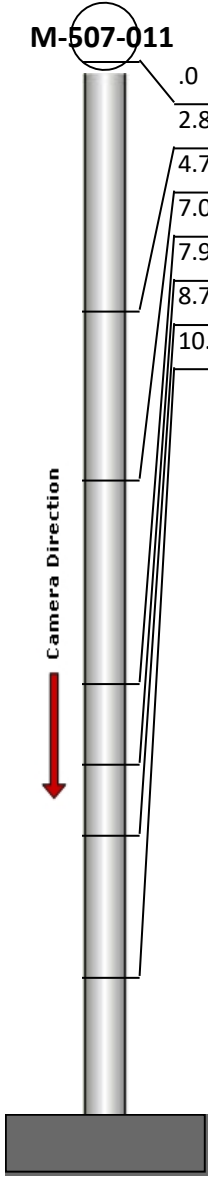
.0	MGP	General Photo	10	NA
	2.8	MGP	General Photo	29	NA
	4.7	IS	Infil Stain	47	NA
	7.0	DAGS	Deposits Attached Grease	64	M 2
	7.9	RFB	Roots Fine Barrel	78	M 2
	8.7	DAZ	Deposits Attached Other	91	M 3
	10.3	MGO	General Observation	106	NA

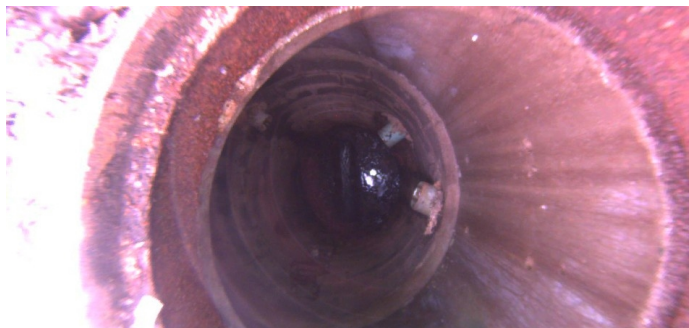
Code: **MGP**
Description: **General Photo**

Distance (ft): **.0**
Structural Grade: **0**
O&M Grade: **0**
Clock Start/From:
Clock To:
1st Value:
2nd Value:
Value Percent:
Step: **NO**
Remarks:

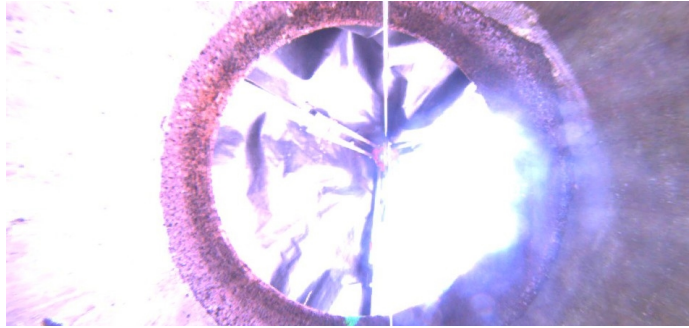
Code: **MGP**
Description: **General Photo**

Distance (ft): **2.8**
Structural Grade: **0**
O&M Grade: **0**
Clock Start/From:
Clock To:
1st Value:
2nd Value:
Value Percent:
Step: **NO**
Remarks:

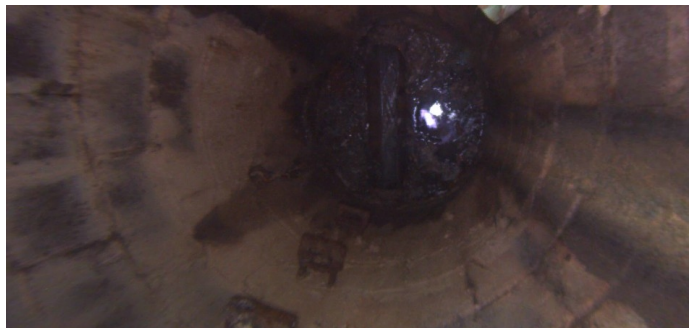
Code: **IS**
Description: **Infil Stain**

Distance (ft): **4.7**
Structural Grade: **0**
O&M Grade: **0**
Clock Start/From: **7**
Clock To:
1st Value:
2nd Value:
Value Percent:
Step: **NO**
Remarks:

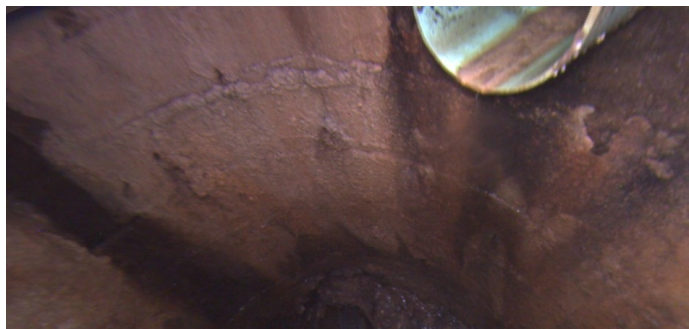
Code: **DAGS**
Description: **Deposits Attached Grease**

Distance (ft): **7.0**
Structural Grade: **0**
O&M Grade: **2**
Clock Start/From: **12**
Clock To: **12**
1st Value:
2nd Value:
Value Percent: **5.000**
Step: **NO**
Remarks:

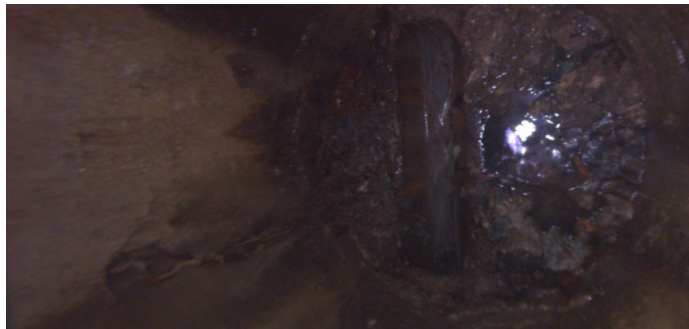
Code: **RFB**
Description: **Roots Fine Barrel**

Distance (ft): **7.9**
Structural Grade: **0**
O&M Grade: **2**
Clock Start/From: **8**
Clock To:
1st Value:
2nd Value:
Value Percent:
Step: **NO**
Remarks:

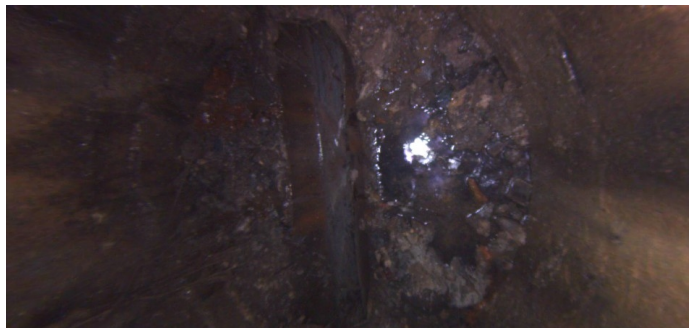
Code: **DAZ**
Description: **Deposits Attached Other**

Distance (ft): **8.7**
Structural Grade: **0**
O&M Grade: **3**
Clock Start/From: **12**
Clock To: **12**
1st Value:
2nd Value:
Value Percent: **15.000**
Step: **NO**
Remarks: **Mixed materials**

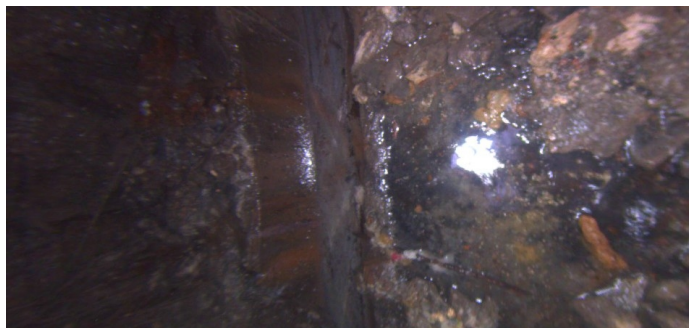
Code: **MGO**
Description: **General Observation**

Distance (ft): **10.3**
Structural Grade: **0**
O&M Grade: **0**
Clock Start/From:
Clock To:
1st Value:
2nd Value:
Value Percent:
Step: **NO**
Remarks: **Ins. Comp.**
