# Manhole Inspection Report

Date:	<b>04/05/2018</b>	Weather:		Coding:	<b>RZMACP</b>
MH#:	<b>M-507-012</b>	Owner:	<b>NA</b>	Len. Surveyed:	<b>10.7</b>
P.O.#:		Surveyor:	<b>John Kuglmaier</b>	Rim to Invert:	<b>11.9</b>
Customer:		Cert. #:	<b>U-1215-07002349</b>	Wall Material:	<b>Concrete (reinforced)</b>

Street:	<b>Southwest of Csokasy Ln. 165' South</b>	Project:	<b>Hobart, IN</b>
City:	<b>Hobart, IN</b>	GPS Northing:	<b>0.0</b>
Location:		GPS Easting:	<b>0.0</b>
Drain Area:	<b>Southwest</b>	GPS Accuracy:	<b>Nearest Meter</b>
Cover Shape:	<b>Circular</b>	Evidence of Surcharge:	<b>Yes</b>
Cover Size:	<b>22.5</b>	Potential for Runoff:	<b>None</b>
Comments:	<b>AGAINST A FENCE</b>

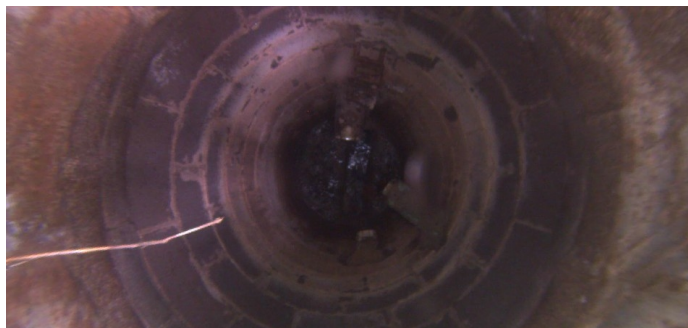
Code: **MGP**  
Description: **General Photo**

Distance (ft): **.0**  
Structural Grade: **0**  
O&M Grade: **0**  
Clock Start/From:  
Clock To:  
1st Value:  
2nd Value:  
Value Percent:  
Step: **NO**  
Remarks:

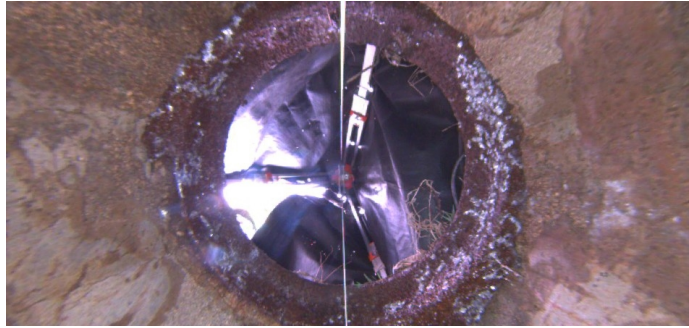
Code: **MGP**  
Description: **General Photo**

Distance (ft): **2.5**  
Structural Grade: **0**  
O&M Grade: **0**  
Clock Start/From:  
Clock To:  
1st Value:  
2nd Value:  
Value Percent:  
Step: **NO**  
Remarks:

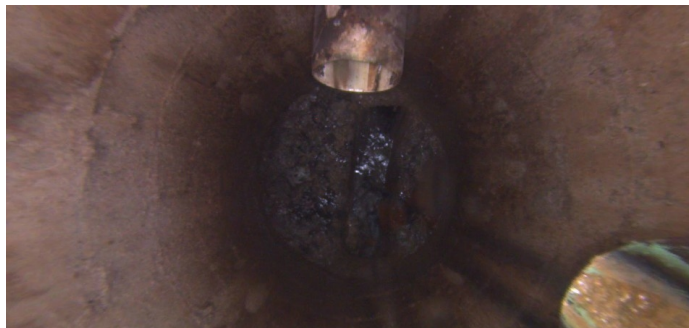
Code: **IS**  
Description: **Infil Stain**

Distance (ft): **4.8**  
Structural Grade: **0**  
O&M Grade: **0**  
Clock Start/From: **12**  
Clock To: **12**  
1st Value:  
2nd Value:  
Value Percent:  
Step: **NO**  
Remarks:

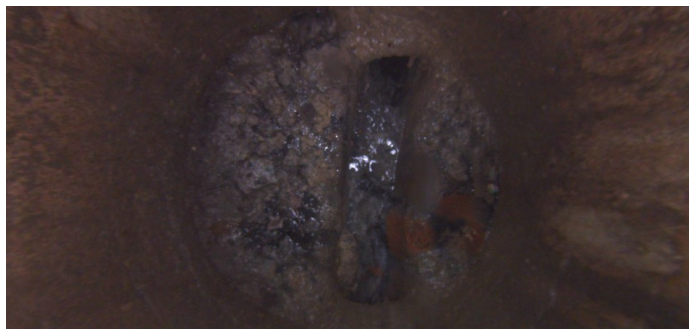
Code: **DAZ**  
Description: **Deposits Attached Other**

Distance (ft): **7.2**  
Structural Grade: **0**  
O&M Grade: **2**  
Clock Start/From: **12**  
Clock To: **12**  
1st Value:  
2nd Value:  
Value Percent: **10.000**  
Step: **NO**  
Remarks: **Mixed materials**

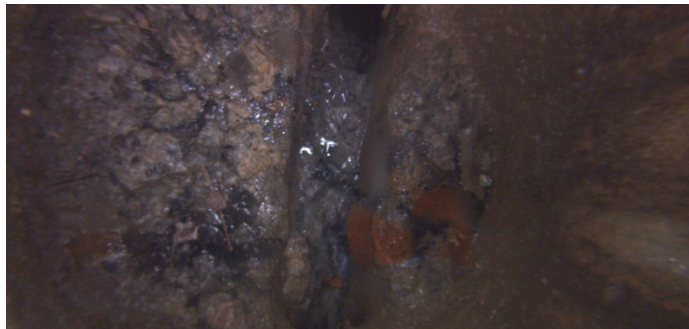
Code: **IS**  
Description: **Infil Stain**

Distance (ft): **8.5**  
Structural Grade: **0**  
O&M Grade: **0**  
Clock Start/From: **4**  
Clock To:  
1st Value:  
2nd Value:  
Value Percent:  
Step: **NO**  
Remarks:

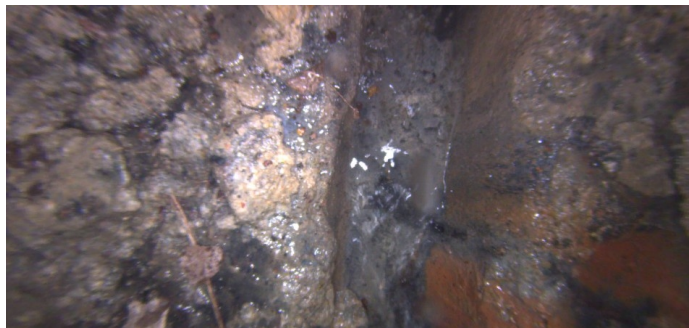
Code: **MGO**  
Description: **General Observation**

Distance (ft): **9.7**  
Structural Grade: **0**  
O&M Grade: **0**  
Clock Start/From:  
Clock To:  
1st Value:  
2nd Value:  
Value Percent:  
Step: **NO**  
Remarks: **Ins. Comp.**
