Manhole Inspection Report

Date:	04/07/2018	Weather:		Coding:	RZMACP
MH#:	M-507-019	Owner:	NA	Len. Surveyed:	10.0
P.O.#:		Surveyor:	John Kuglmaier	Rim to Invert:	10.8
Customer:		Cert. #:	U-1215-07002349	Wall Material:	Concrete (reinforced)

Street:	Colorado Ct. to the West.	Project:	Hobart, IN
City:	Hobart, IN	GPS Northing:	0.0
Location:		GPS Easting:	0.0
Drain Area:	Southwest	GPS Accuracy:	Nearest Meter
Cover Shape:	Circular	Evidence of Surcharge:	Yes
Cover Size:	22.5	Potential for Runoff:	None
Comments:

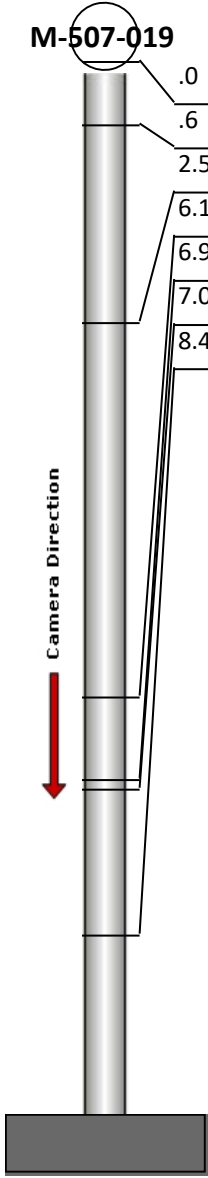
.0	MGP	General Photo	10	NA
	.6	IS	Infil Stain	23	NA
	2.5	MGP	General Photo	40	NA
	6.1	DAE	Deposits Attached Encrustation	61	M 2
	6.9	IS	Infil Stain	75	NA
	7.0	DAE	Deposits Attached Encrustation	87	M 2
	8.4	MGO	General Observation	101	NA

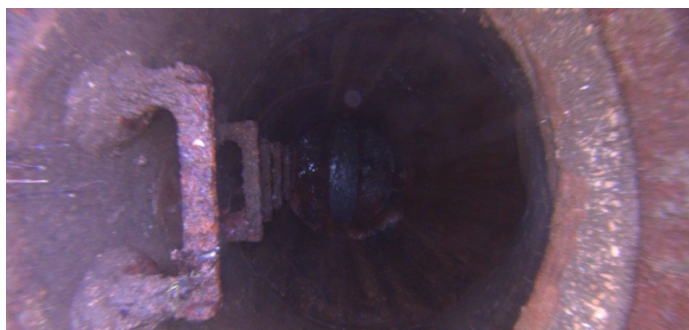
Code: **MGP**
Description: **General Photo**

Distance (ft): **.0**
Structural Grade: **0**
O&M Grade: **0**
Clock Start/From:
Clock To:
1st Value:
2nd Value:
Value Percent:
Step: **NO**
Remarks:

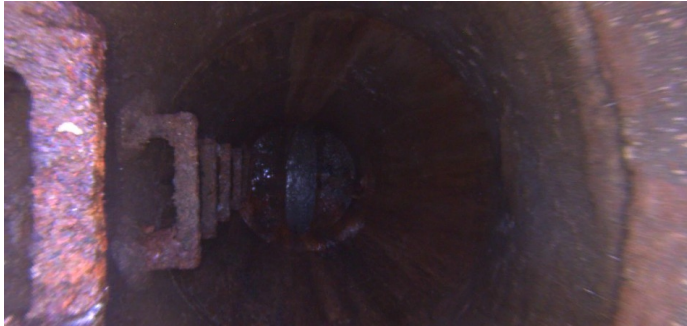
Code: **IS**
Description: **Infil Stain**

Distance (ft): **.6**
Structural Grade: **0**
O&M Grade: **0**
Clock Start/From: **12**
Clock To: **12**
1st Value:
2nd Value:
Value Percent:
Step: **NO**
Remarks:

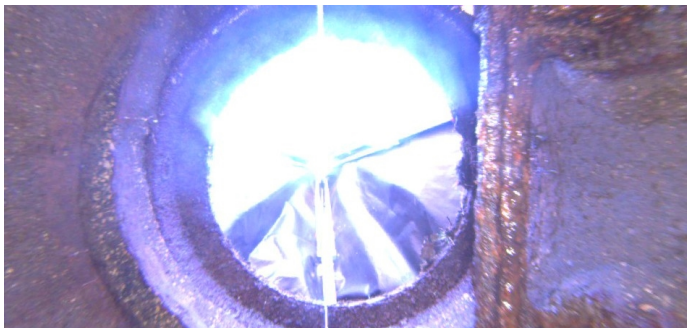
Code: **MGP**
Description: **General Photo**

Distance (ft): **2.5**
Structural Grade: **0**
O&M Grade: **0**
Clock Start/From:
Clock To:
1st Value:
2nd Value:
Value Percent:
Step: **NO**
Remarks:

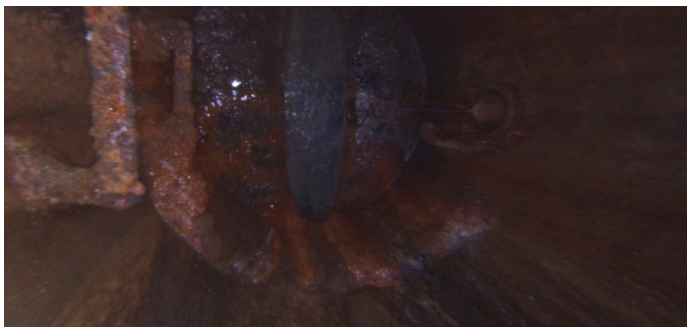
Code: **DAE**
Description: **Deposits Attached Encrustation**

Distance (ft): **6.1**
Structural Grade: **0**
O&M Grade: **2**
Clock Start/From: **4**
Clock To: **9**
1st Value:
2nd Value:
Value Percent: **5.000**
Step: **NO**
Remarks:

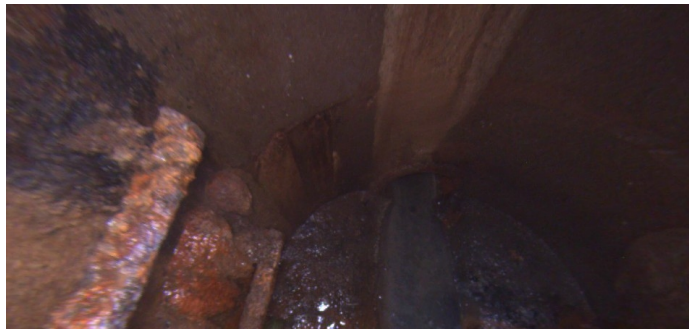
Code: **IS**
Description: **Infil Stain**

Distance (ft): **6.9**
Structural Grade: **0**
O&M Grade: **0**
Clock Start/From: **10**
Clock To: **11**
1st Value:
2nd Value:
Value Percent:
Step: **NO**
Remarks:

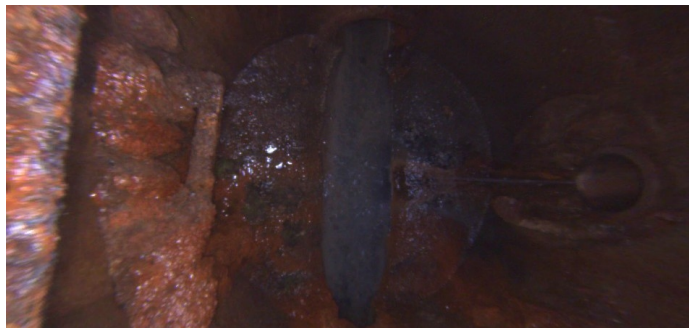
Code: **DAE**
Description: **Deposits Attached Encrustation**

Distance (ft): **7.0**
Structural Grade: **0**
O&M Grade: **2**
Clock Start/From: **12**
Clock To: **12**
1st Value:
2nd Value:
Value Percent: **5.000**
Step: **NO**
Remarks:

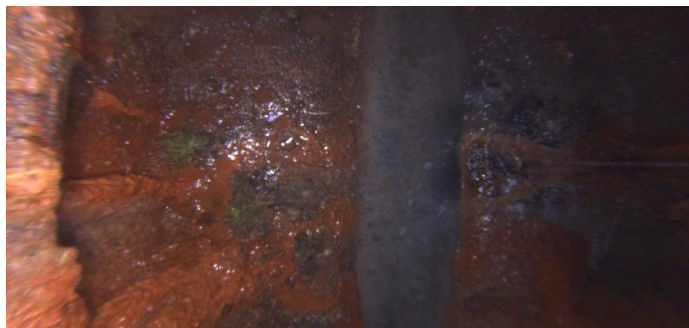
Code: **MGO**
Description: **General Observation**

Distance (ft): **8.4**
Structural Grade: **0**
O&M Grade: **0**
Clock Start/From:
Clock To:
1st Value:
2nd Value:
Value Percent:
Step: **NO**
Remarks: **Ins. Comp.**
