Manhole Inspection Report

Date:	03/27/2018	Weather:		Coding:	RZMACP
MH#:	M-507-020	Owner:	NA	Len. Surveyed:	10.5
P.O.#:		Surveyor:	John Kuglmaier	Rim to Invert:	10.4
Customer:		Cert. #:	U-1215-07002349	Wall Material:	Concrete (reinforced)

Street:	North of Colorado St. 215' South of	Project:	Hobart, IN
City:	Hobart, IN	GPS Northing:	0.0
Location:		GPS Easting:	0.0
Drain Area:	Southwest	GPS Accuracy:	Nearest Meter
Cover Shape:	Circular	Evidence of Surcharge:	No
Cover Size:	22.5	Potential for Runoff:	None
Comments:

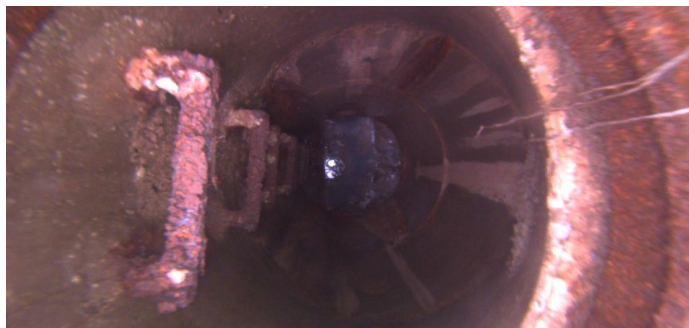
Code: **MGP**
Description: **General Photo**

Distance (ft): **.0**
Structural Grade: **0**
O&M Grade: **0**
Clock Start/From:
Clock To:
1st Value:
2nd Value:
Value Percent:
Step: **NO**
Remarks:

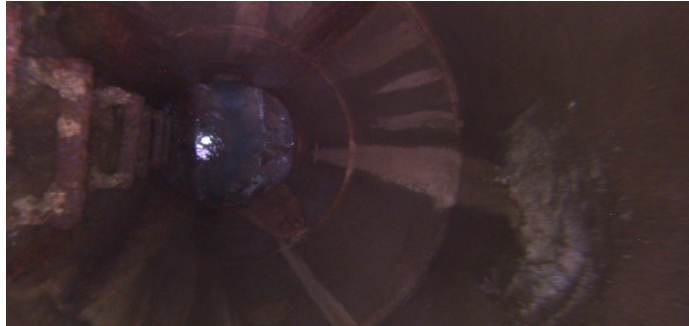
Code: **IS**
Description: **Infil Stain**

Distance (ft): **1.4**
Structural Grade: **0**
O&M Grade: **0**
Clock Start/From: **4**
Clock To:
1st Value:
2nd Value:
Value Percent:
Step: **NO**
Remarks:

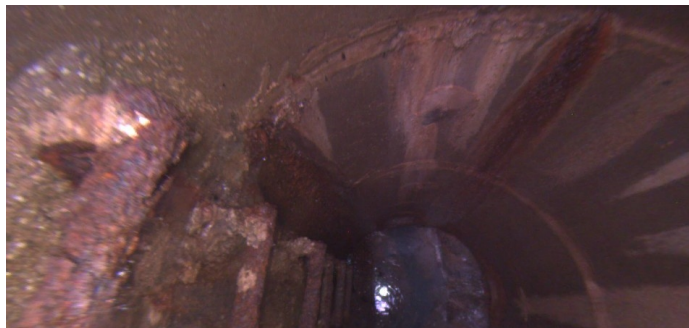
Code: **IS**
Description: **Infil Stain**

Distance (ft): **2.2**
Structural Grade: **0**
O&M Grade: **0**
Clock Start/From: **10**
Clock To:
1st Value:
2nd Value:
Value Percent:
Step: **NO**
Remarks:

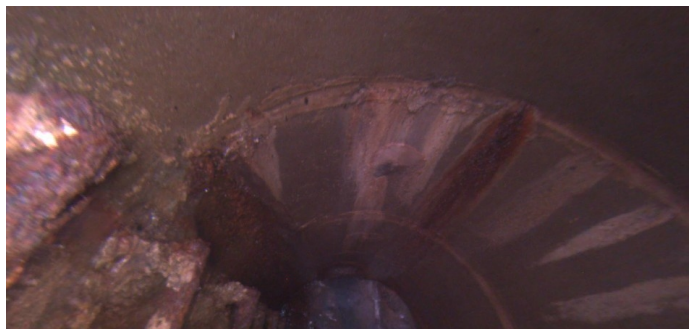
Code: **IS**
Description: **Infil Stain**

Distance (ft): **2.2**
Structural Grade: **0**
O&M Grade: **0**
Clock Start/From: **1**
Clock To:
1st Value:
2nd Value:
Value Percent:
Step: **NO**
Remarks:

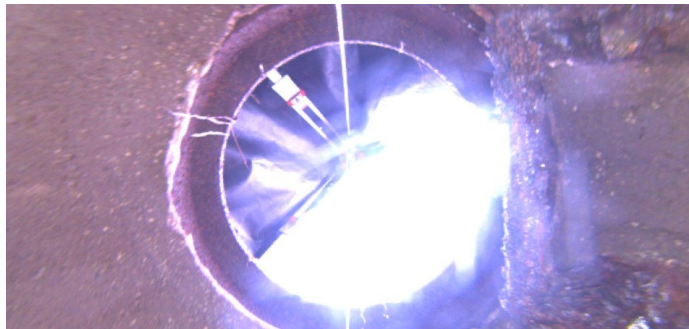
Code: **MGP**
Description: **General Photo**

Distance (ft): **2.7**
Structural Grade: **0**
O&M Grade: **0**
Clock Start/From:
Clock To:
1st Value:
2nd Value:
Value Percent:
Step: **NO**
Remarks:

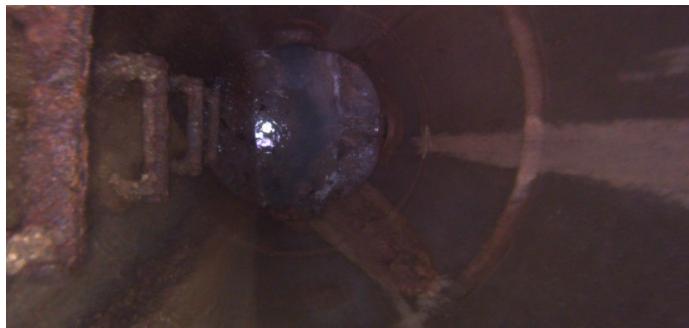
Code: **IS**
Description: **Infil Stain**

Distance (ft): **4.2**
Structural Grade: **0**
O&M Grade: **0**
Clock Start/From: **5**
Clock To:
1st Value:
2nd Value:
Value Percent:
Step: **NO**
Remarks:

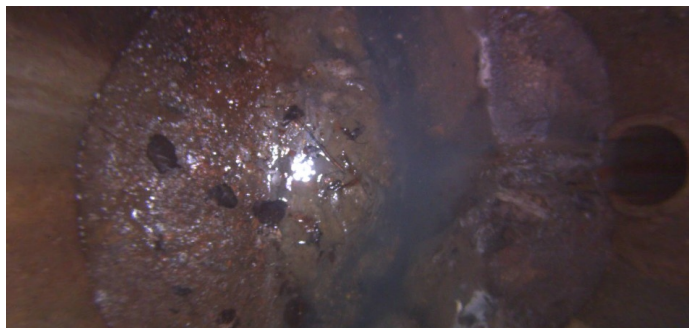
Code: **MGO**
Description: **General Observation**

Distance (ft): **8.8**
Structural Grade: **0**
O&M Grade: **0**
Clock Start/From:
Clock To:
1st Value:
2nd Value:
Value Percent:
Step: **NO**
Remarks: **Ins. Comp.**
