Manhole Inspection Report

Date:	04/05/2018	Weather:		Coding:	RZMACP
MH#:	M-507-022	Owner:	NA	Len. Surveyed:	8.4
P.O.#:		Surveyor:	John Kuglmaier	Rim to Invert:	8.8
Customer:		Cert. #:	U-1215-07002349	Wall Material:	Concrete (reinforced)

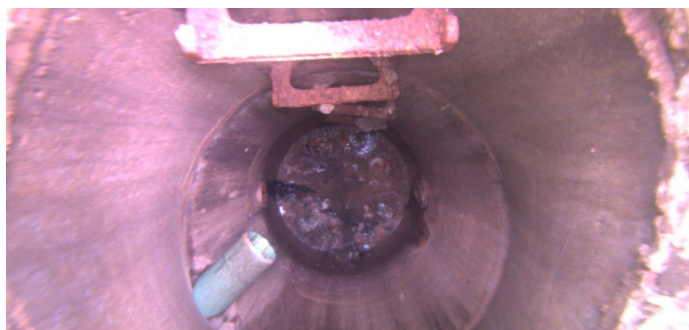
Code: **MGP**
Description: **General Photo**

Distance (ft): **.0**
Structural Grade: **0**
O&M Grade: **0**
Clock Start/From:
Clock To:
1st Value:
2nd Value:
Value Percent:
Step: **NO**
Remarks:

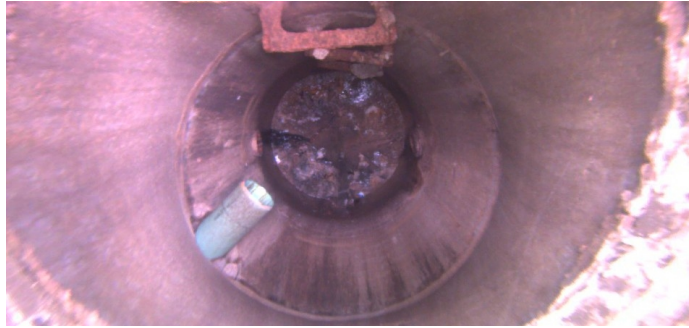
Code: **IS**
Description: **Infil Stain**

Distance (ft): **.0**
Structural Grade: **0**
O&M Grade: **0**
Clock Start/From: **12**
Clock To: **12**
1st Value:
2nd Value:
Value Percent:
Step: **NO**
Remarks:

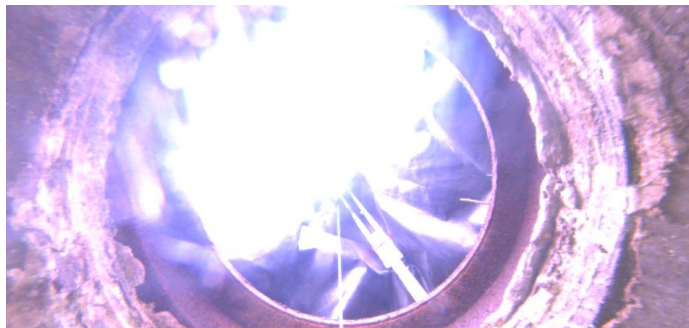
Code: **MGP**
Description: **General Photo**

Distance (ft): **2.1**
Structural Grade: **0**
O&M Grade: **0**
Clock Start/From:
Clock To:
1st Value:
2nd Value:
Value Percent:
Step: **NO**
Remarks:

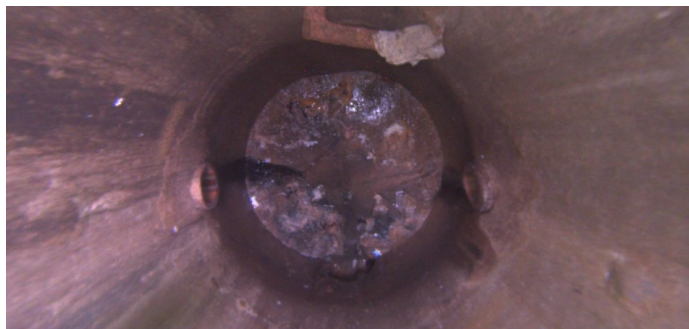
Code: **IS**
Description: **Infil Stain**

Distance (ft): **3.1**
Structural Grade: **0**
O&M Grade: **0**
Clock Start/From: **12**
Clock To: **12**
1st Value:
2nd Value:
Value Percent:
Step: **NO**
Remarks:

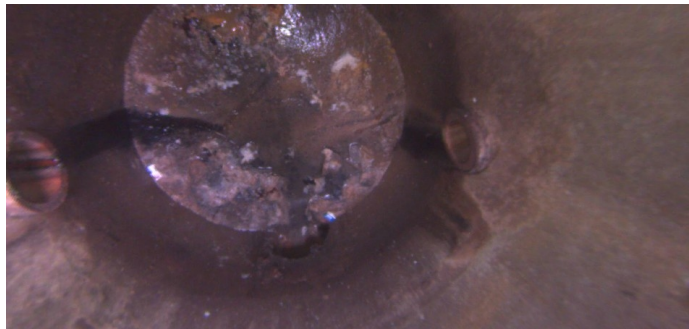
Code: **IS**
Description: **Infil Stain**

Distance (ft): **4.2**
Structural Grade: **0**
O&M Grade: **0**
Clock Start/From: **4**
Clock To:
1st Value:
2nd Value:
Value Percent:
Step: **NO**
Remarks:

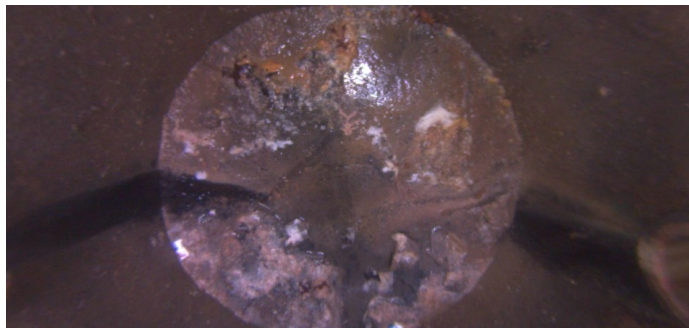
Code: **DAZ**
Description: **Deposits Attached Other**

Distance (ft): **5.7**
Structural Grade: **0**
O&M Grade: **2**
Clock Start/From: **12**
Clock To: **12**
1st Value:
2nd Value:
Value Percent: **5.000**
Step: **NO**
Remarks: **Mixed materials**

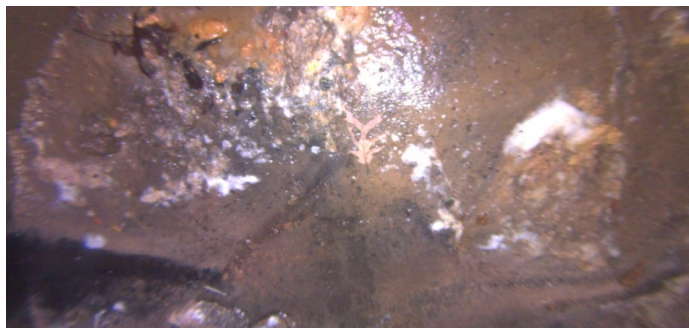
Code: **MGO**
Description: **General Observation**

Distance (ft): **7.3**
Structural Grade: **0**
O&M Grade: **0**
Clock Start/From:
Clock To:
1st Value:
2nd Value:
Value Percent:
Step: **NO**
Remarks: **Ins. Comp.**
