# Manhole Inspection Report

| MH#: | M-507-026 | Owner: | NA | Len. Surveyed: | 6.9 |

| Street: | West of Colorado St. 379' South of 1 | Project: | Hobart, IN |

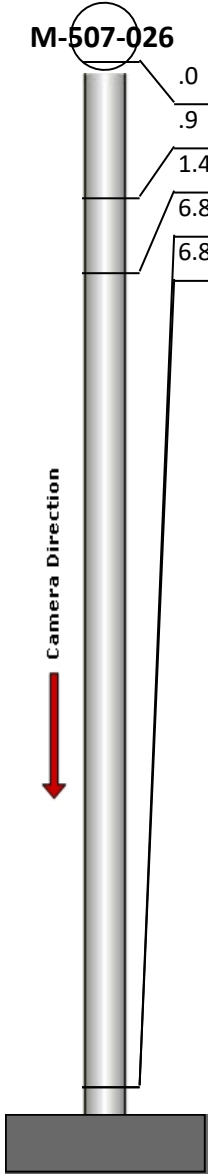
| | Position | Code | Observation | Video (sec) | Grade |
|--|---|---|---|---|---|
| | M-507-026 | | | | |

| | Position | Code | Observation | Video (sec) | Grade |
|--|---|---|---|---|---|
| | .0 | MGO | General Observation | 10 | NA |
| | .9 | SAV | Surface Aggregate Visible | 23 | S 3 |
| | 1.4 | MGP | General Photo | 36 | NA |
| | 6.8 | MGO | General Observation | 60 | NA |
| | 6.8 | SAV | Surface Aggregate Visible | 70 | S 3 |

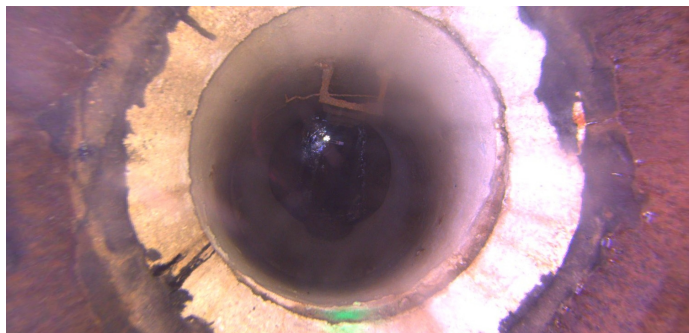
| Code: | <b>MGO</b> |
| Description: | <b>General Observation</b> |
| Distance (ft): | <b>.0</b> |
| Remarks: | <b>access MH</b> |

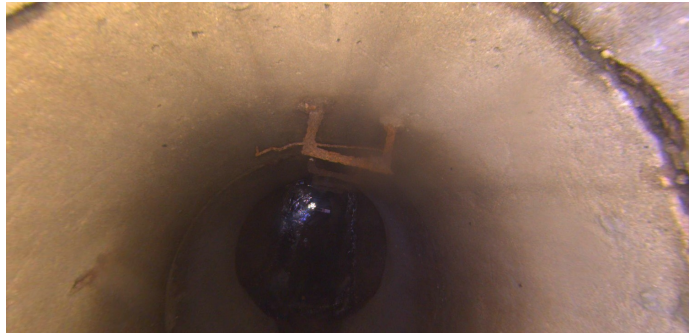
Code: **SAV**  
Description: **Surface Aggregate Visible**

Distance (ft): **.9**  
Structural Grade: **3**  
O&M Grade: **0**  
Clock Start/From: **12**  
Clock To: **12**  
1st Value:  
2nd Value:  
Value Percent:  
Step: **NO**  
Remarks:

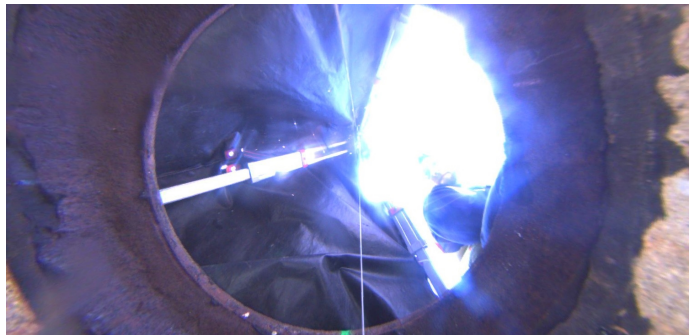
Code: **MGP**  
Description: **General Photo**

Distance (ft): **1.4**  
Structural Grade: **0**  
O&M Grade: **0**  
Clock Start/From:  
Clock To:  
1st Value:  
2nd Value:  
Value Percent:  
Step: **NO**  
Remarks: **UNDERSIDE OF FRAME**

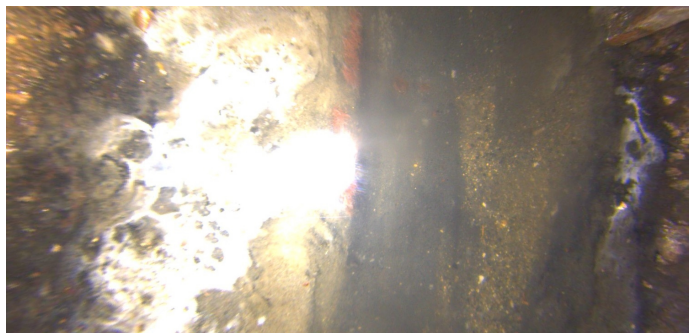
Code: **MGO**  
Description: **General Observation**

Distance (ft): **6.8**  
Structural Grade: **0**  
O&M Grade: **0**  
Clock Start/From:  
Clock To:  
1st Value:  
2nd Value:  
Value Percent:  
Step: **NO**  
Remarks: **END SURVEY**

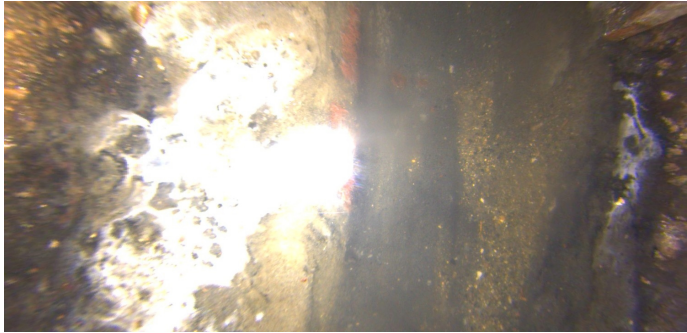
| Code: | <b>SAV</b> |
| Description: | <b>Surface Aggregate Visible</b> |
| Distance (ft): | <b>6.8</b> |
| Structural Grade: | <b>3</b> |
