Manhole Inspection Report

Date:	03/27/2018	Weather:		Coding:	RZMACP
MH#:	M-507-032	Owner:	NA	Len. Surveyed:	8.3
P.O.#:		Surveyor:	John Kuglmaier	Rim to Invert:	7.8
Customer:		Cert. #:	U-1215-07002349	Wall Material:	Concrete (reinforced)

Street:	West of Dekalb St. 199' North of Cso	Project:	Hobart, IN
City:	Hobart, IN	GPS Northing:	0.0
Location:		GPS Easting:	0.0
Drain Area:	Southwest	GPS Accuracy:	Nearest Meter
Cover Shape:	Circular	Evidence of Surcharge:	No
Cover Size:	22.5	Potential for Runoff:	None
Comments:

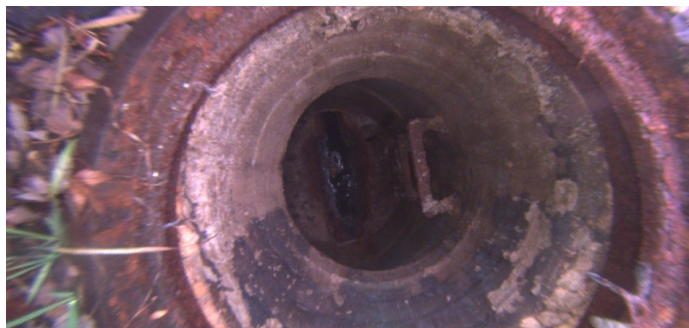
Code: **MGP**
Description: **General Photo**

Distance (ft): **.0**
Structural Grade: **0**
O&M Grade: **0**
Clock Start/From:
Clock To:
1st Value:
2nd Value:
Value Percent:
Step: **NO**
Remarks:

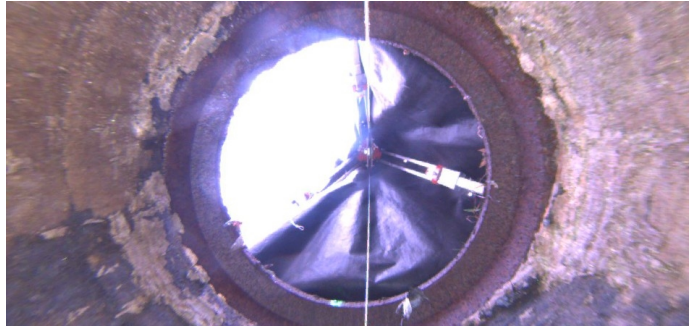
Code: **MGP**
Description: **General Photo**

Distance (ft): **3.0**
Structural Grade: **0**
O&M Grade: **0**
Clock Start/From:
Clock To:
1st Value:
2nd Value:
Value Percent:
Step: **NO**
Remarks:

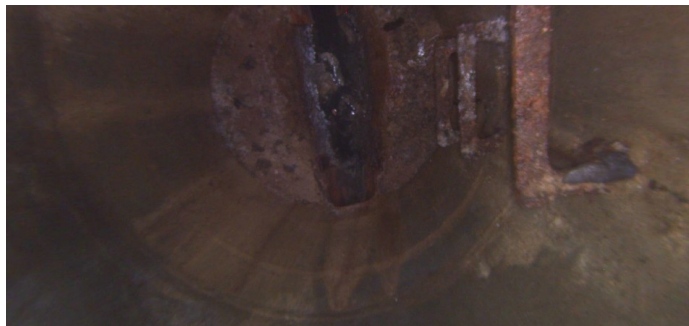
Code: **IS**
Description: **Infil Stain**

Distance (ft): **3.6**
Structural Grade: **0**
O&M Grade: **0**
Clock Start/From: **5**
Clock To: **8**
1st Value:
2nd Value:
Value Percent:
Step: **NO**
Remarks:

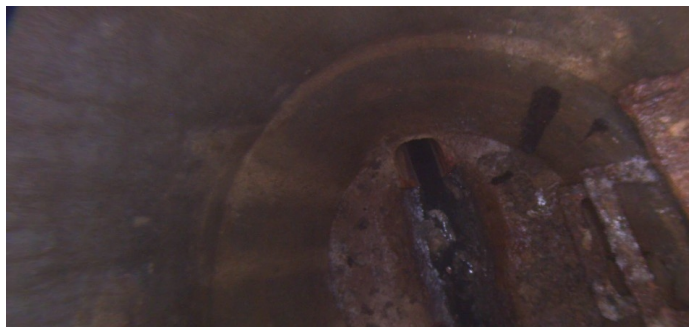
Code: **IS**
Description: **Infil Stain**

Distance (ft): **3.6**
Structural Grade: **0**
O&M Grade: **0**
Clock Start/From: **9**
Clock To: **10**
1st Value:
2nd Value:
Value Percent:
Step: **NO**
Remarks:

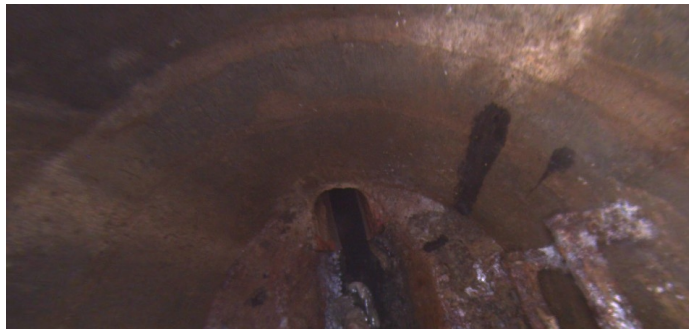
Code: **IS**
Description: **Infil Stain**

Distance (ft): **4.6**
Structural Grade: **0**
O&M Grade: **0**
Clock Start/From: **2**
Clock To:
1st Value:
2nd Value:
Value Percent:
Step: **NO**
Remarks:

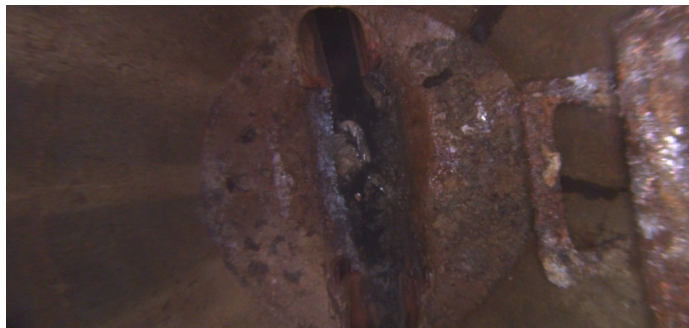
Code: **DAZ**
Description: **Deposits Attached Other**

Distance (ft): **5.2**
Structural Grade: **0**
O&M Grade: **2**
Clock Start/From: **12**
Clock To: **12**
1st Value:
2nd Value:
Value Percent: **5.000**
Step: **NO**
Remarks: **Mixed materials**

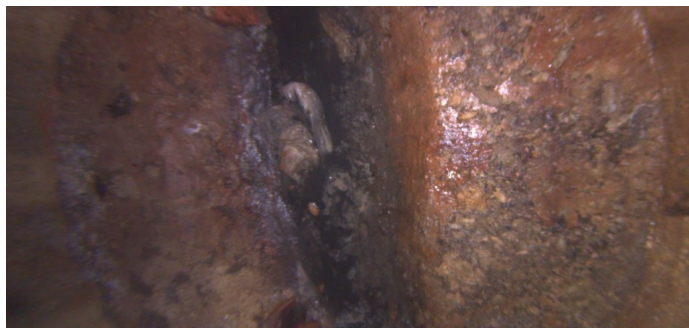
Code: **MGO**
Description: **General Observation**

Distance (ft): **6.6**
Structural Grade: **0**
O&M Grade: **0**
Clock Start/From:
Clock To:
1st Value:
2nd Value:
Value Percent:
Step: **NO**
Remarks: **Ins. Comp.**
