Manhole Inspection Report

Date:	03/28/2018	Weather:		Coding:	RZMACP
MH#:	M-507-036	Owner:	NA	Len. Surveyed:	7.2
P.O.#:		Surveyor:	John Kuglmaier	Rim to Invert:	7.9
Customer:		Cert. #:	U-1215-07002349	Wall Material:	Concrete (reinforced)

Street:	Dekalb Ct. and Csokasy Ln.	Project:	Hobart, IN
City:	Hobart, IN	GPS Northing:	0.0
Location:		GPS Easting:	0.0
Drain Area:	Southwest	GPS Accuracy:	Nearest Meter
Cover Shape:	Circular	Evidence of Surcharge:	No
Cover Size:	22.5	Potential for Runoff:	None
Comments:

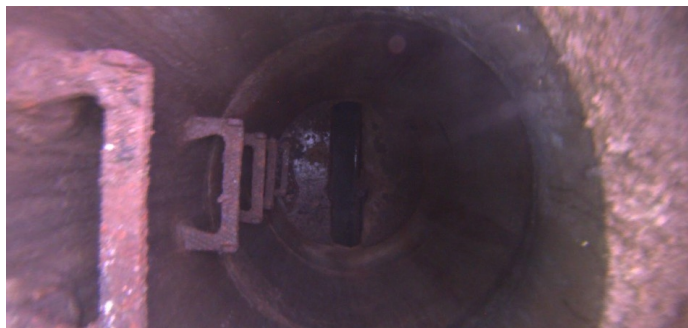
Code: **MGP**
Description: **General Photo**

Distance (ft): **.0**
Structural Grade: **0**
O&M Grade: **0**
Clock Start/From:
Clock To:
1st Value:
2nd Value:
Value Percent:
Step: **NO**
Remarks:

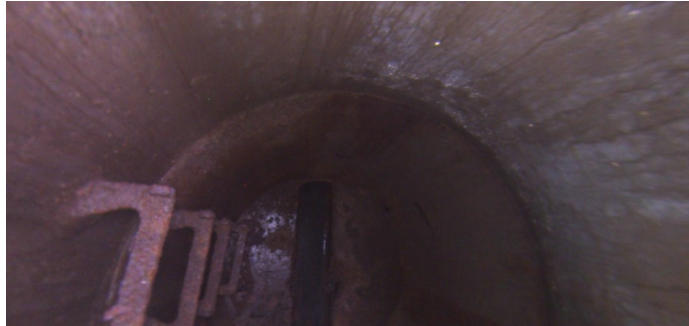
Code: **IS**
Description: **Infil Stain**

Distance (ft): **.8**
Structural Grade: **0**
O&M Grade: **0**
Clock Start/From: **1**
Clock To: **2**
1st Value:
2nd Value:
Value Percent:
Step: **NO**
Remarks:

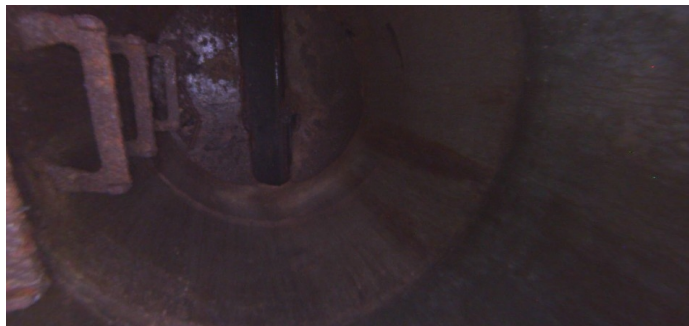
Code: **IS**
Description: **Infil Stain**

Distance (ft): **1.5**
Structural Grade: **0**
O&M Grade: **0**
Clock Start/From: **4**
Clock To: **5**
1st Value:
2nd Value:
Value Percent:
Step: **NO**
Remarks:

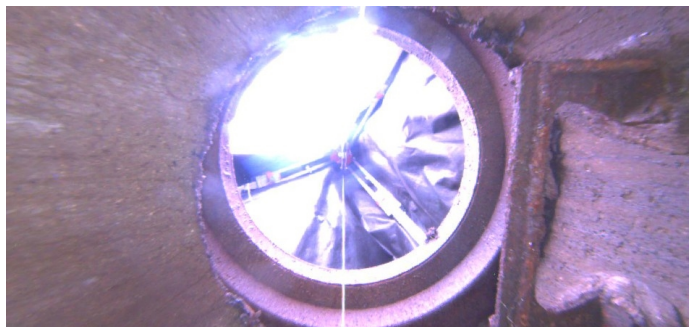
Code: **MGP**
Description: **General Photo**

Distance (ft): **2.5**
Structural Grade: **0**
O&M Grade: **0**
Clock Start/From:
Clock To:
1st Value:
2nd Value:
Value Percent:
Step: **NO**
Remarks:

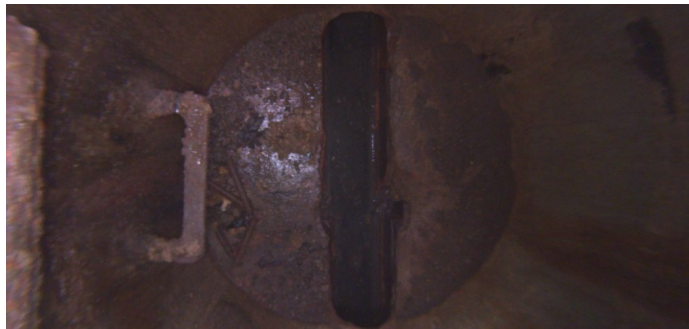
Code: **DSF**
Description: **Deposits Settled Fine**

Distance (ft): **4.0**
Structural Grade: **0**
O&M Grade: **2**
Clock Start/From: **12**
Clock To: **12**
1st Value:
2nd Value:
Value Percent: **5.000**
Step: **NO**
Remarks:

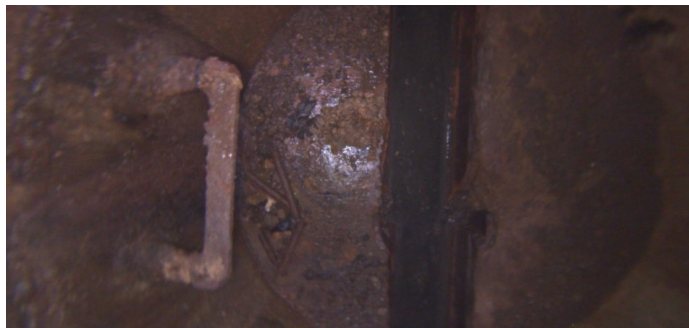
Code: **OBZ**
Description: **Obstacle Other**

Distance (ft): **4.7**
Structural Grade: **0**
O&M Grade: **2**
Clock Start/From: **8**
Clock To: **9**
1st Value:
2nd Value:
Value Percent: **5.000**
Step: **NO**
Remarks: **Metal rods**

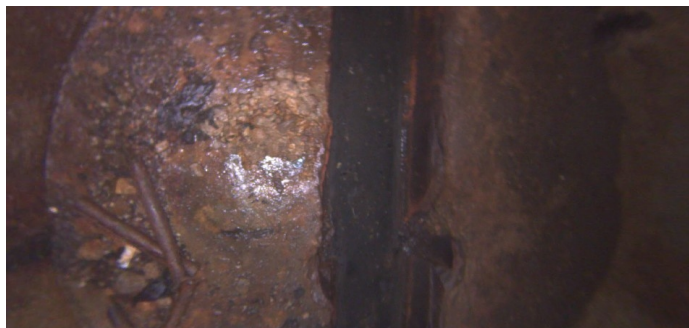
Code: **MGO**
Description: **General Observation**

Distance (ft): **5.6**
Structural Grade: **0**
O&M Grade: **0**
Clock Start/From:
Clock To:
1st Value:
2nd Value:
Value Percent:
Step: **NO**
Remarks: **Ins. Comp.**
