# Manhole Inspection Report

Date:	04/26/2018	Weather:		Coding:	RZMACP
MH#:	M-507-039.1	Owner:	NA	Len. Surveyed:	7.6
P.O.#:		Surveyor:	Jen Costello	Rim to Invert:	8.3
Customer:		Cert. #:	U-907-5518	Wall Material:	Concrete (reinforced)

Street:	10th St. 179' West of Virginia St.	Project:	Hobart, IN
City:	Hobart, IN	GPS Northing:	2901210.267
Location:		GPS Easting:	2901210.267
Drain Area:	Southwest	GPS Accuracy:	Sub-Meter
Cover Shape:	Circular	Evidence of Surcharge:	No
Cover Size:	22.5	Potential for Runoff:	None
Comments:

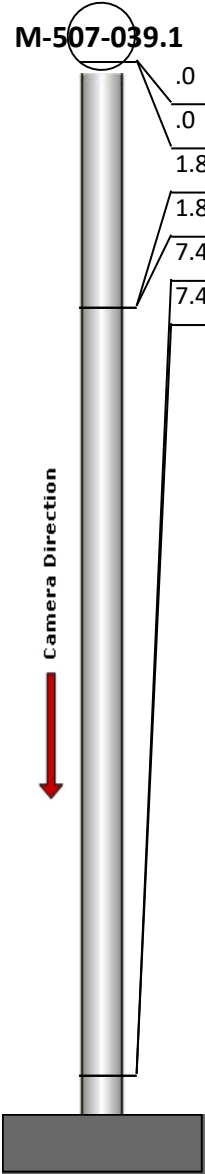
M-507-039.1				
	.0	MGO	General Observation	10	NA
	.0	B	Broken	21	S 4
	1.8	SAV	Surface Aggregate Visible	36	S 3
	1.8	MGO	General Observation	50	NA
	7.4	SAP	Surface Aggregate Projecting	74	S 3
	7.4	MGO	General Observation	86	NA

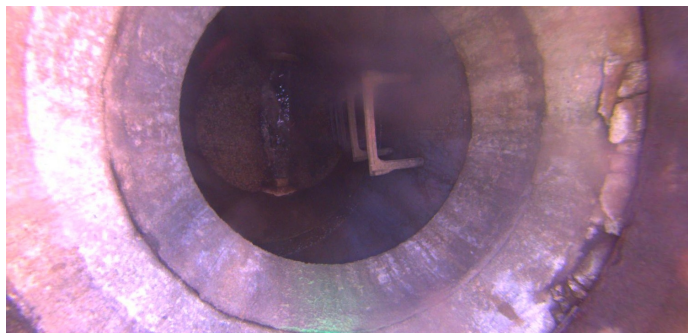
Code: **MGO**  
Description: **General Observation**

Distance (ft): **.0**  
Structural Grade: **0**  
O&M Grade: **0**  
Clock Start/From:  
Clock To:  
1st Value:  
2nd Value:  
Value Percent:  
Step: **NO**  
Remarks: **ACCESS MH**

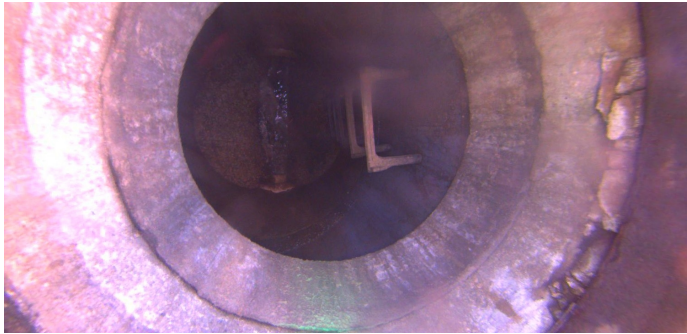
Code: **B**  
Description: **Broken**

Distance (ft): **.0**  
Structural Grade: **4**  
O&M Grade: **0**  
Clock Start/From: **3**  
Clock To: **4**  
1st Value:  
2nd Value:  
Value Percent:  
Step: **NO**  
Remarks:

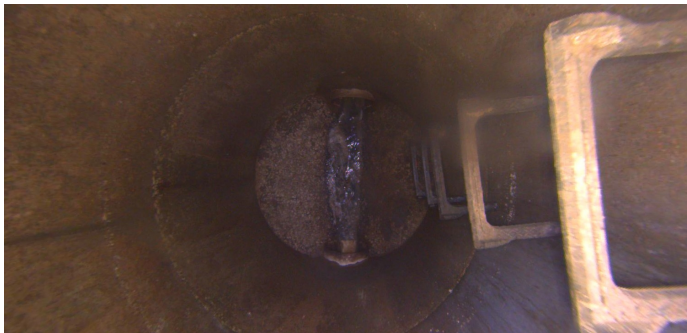
Code: **SAV**  
Description: **Surface Aggregate Visible**

Distance (ft): **1.8**  
Structural Grade: **3**  
O&M Grade: **0**  
Clock Start/From: **12**  
Clock To: **12**  
1st Value:  
2nd Value:  
Value Percent:  
Step: **NO**  
Remarks:

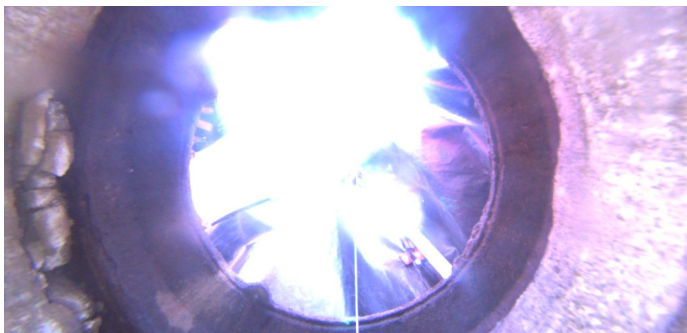
Code: **MGO**  
Description: **General Observation**

Distance (ft): **1.8**  
Structural Grade: **0**  
O&M Grade: **0**  
Clock Start/From:  
Clock To:  
1st Value:  
2nd Value:  
Value Percent:  
Step: **NO**  
Remarks: **UNDERSIDE OF FRAME**

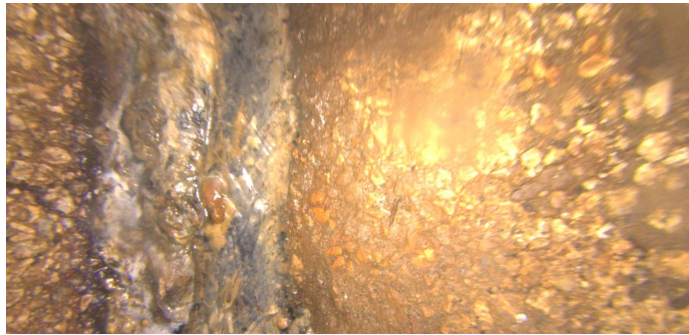
Code:	<b>SAP</b>
Description:	<b>Surface Aggregate Projecting</b>
Distance (ft):	<b>7.4</b>
Structural Grade:	<b>3</b>
O&M Grade:	<b>0</b>
Clock Start/From:	<b>12</b>
Clock To:	<b>12</b>
1st Value:	
2nd Value:	
Value Percent:	
Step:	<b>NO</b>
Remarks:

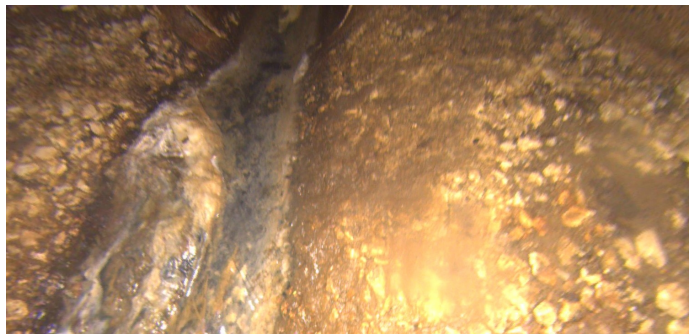
Code:	<b>MGO</b>
Description:	<b>General Observation</b>
Distance (ft):	<b>7.4</b>
Structural Grade:	<b>0</b>
O&M Grade:	<b>0</b>
Clock Start/From:	
Clock To:	
1st Value:	
2nd Value:	
Value Percent:	
Step:	<b>NO</b>
Remarks:	<b>END SURVEY</b>
