# Manhole Inspection Report

Date:	<b>04/24/2018</b>	Weather:		Coding:	<b>RZMACP</b>
MH#:	<b>M-507-039.5</b>	Owner:	<b>NA</b>	Len. Surveyed:	<b>5.9</b>
P.O.#:		Surveyor:	<b>John Kuglmaier</b>	Rim to Invert:	<b>6.0</b>
Customer:		Cert. #:	<b>U-1215-07002349</b>	Wall Material:	<b>Concrete (reinforced)</b>

Street:	<b>10th Pl. and 170' West of Colorado S</b>	Project:	<b>Hobart, IN</b>
City:	<b>Hobart, IN</b>	GPS Northing:	<b>41.52108383</b>
Location:		GPS Easting:	<b>-87.27368164</b>
Drain Area:	<b>Southwest</b>	GPS Accuracy:	<b>Nearest Meter</b>
Cover Shape:	<b>Circular</b>	Evidence of Surcharge:	<b>Yes</b>
Cover Size:	<b>22.5</b>	Potential for Runoff:	<b>None</b>
Comments:

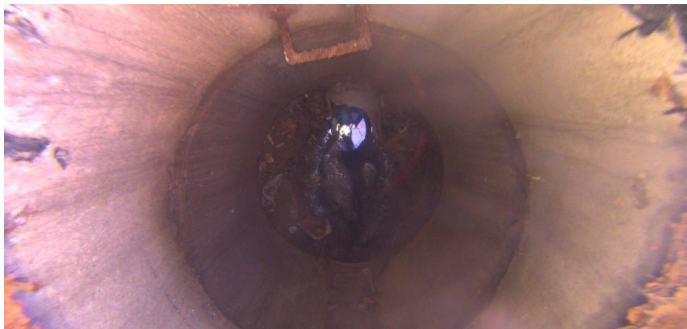
Code:	<b>MGP</b>
Description:	<b>General Photo</b>

Distance (ft):	.0
Structural Grade:	0
O&M Grade:	0
Clock Start/From:	
Clock To:	
1st Value:	
2nd Value:	
Value Percent:	
Step:	NO
Remarks:

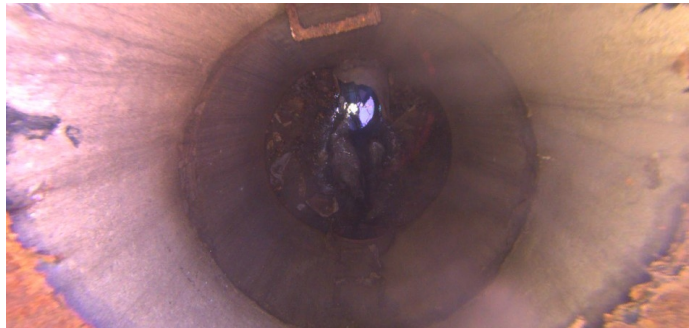
Code: **IS**  
Description: **Infil Stain**

Distance (ft): **.0**  
Structural Grade: **0**  
O&M Grade: **0**  
Clock Start/From: **12**  
Clock To: **12**  
1st Value:  
2nd Value:  
Value Percent:  
Step: **NO**  
Remarks:

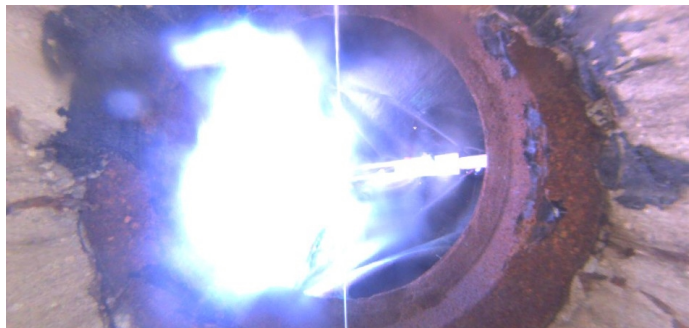
Code: **MGP**  
Description: **General Photo**

Distance (ft): **2.4**  
Structural Grade: **0**  
O&M Grade: **0**  
Clock Start/From:  
Clock To:  
1st Value:  
2nd Value:  
Value Percent:  
Step: **NO**  
Remarks:

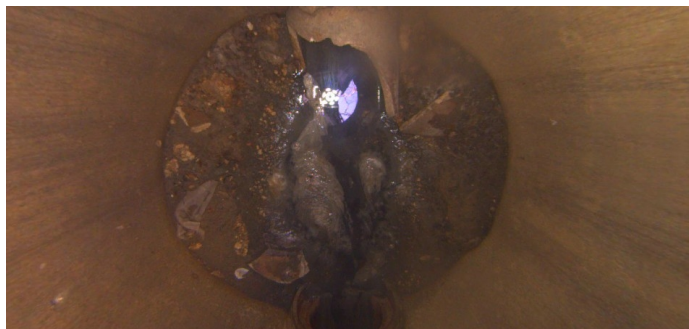
Code: **DAZ**  
Description: **Deposits Attached Other**

Distance (ft): **2.9**  
Structural Grade: **0**  
O&M Grade: **3**  
Clock Start/From: **12**  
Clock To: **12**  
1st Value:  
2nd Value:  
Value Percent: **15.000**  
Step: **NO**  
Remarks: **Mixed materials**

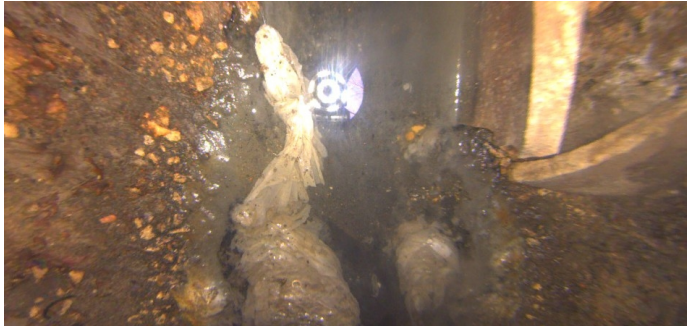
Code:	<b>MGO</b>
Description:	<b>General Observation</b>
Distance (ft):	<b>5.0</b>
Structural Grade:	<b>0</b>
O&M Grade:	<b>0</b>
Clock Start/From:	
Clock To:	
1st Value:	
2nd Value:	
Value Percent:	
Step:	<b>NO</b>
Remarks:	<b>Ins. Comp.</b>
