Manhole Inspection Report

Date:	04/24/2018	Weather:		Coding:	RZMACP
MH#:	M-507-039.7	Owner:	NA	Len. Surveyed:	5.4
P.O.#:		Surveyor:	Jen Costello	Rim to Invert:	5.8
Customer:		Cert. #:	U-907-5518	Wall Material:	Concrete (reinforced)

Street:	231' East of Decatur St. North of 10t	Project:	Hobart, IN
City:	Hobart, IN	GPS Northing:	2900428.633
Location:		GPS Easting:	2900428.633
Drain Area:	Southwest	GPS Accuracy:	Sub-Meter
Cover Shape:	Circular	Evidence of Surcharge:	No
Cover Size:	26.0	Potential for Runoff:	None
Comments:

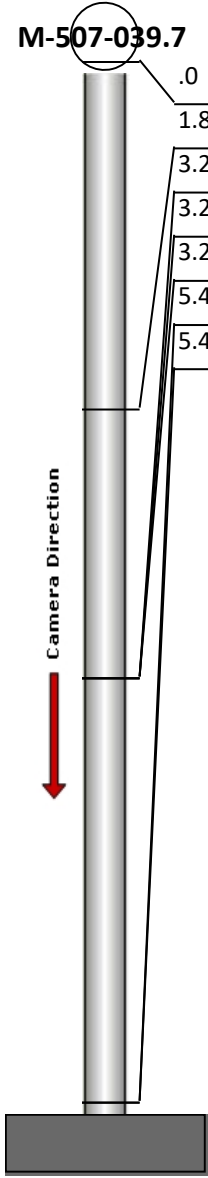
.0	MGO	General Observation	10	NA
	1.8	MGO	General Observation	26	NA
	3.2	RFJ	Roots Fine Joint	43	M 1
	3.2	SAP	Surface Aggregate Projecting	54	S 3
	3.2	DAR	Deposits Attached Ragging	66	M 2
	5.4	DSZ	Deposits Settled Other	82	M 2
	5.4	MGO	General Observation	93	NA

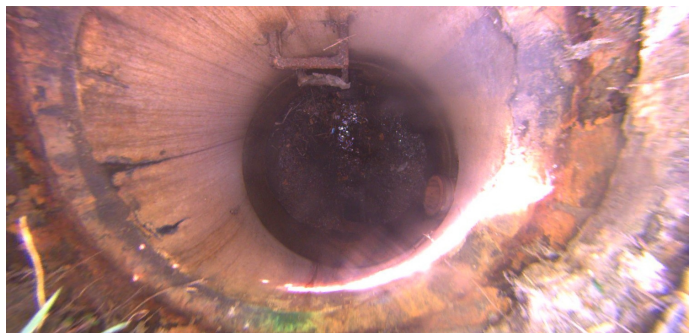
Code: **MGO**
Description: **General Observation**

Distance (ft): **.0**
Structural Grade: **0**
O&M Grade: **0**
Clock Start/From:
Clock To:
1st Value:
2nd Value:
Value Percent:
Step: **NO**
Remarks: **ACCESS MH**

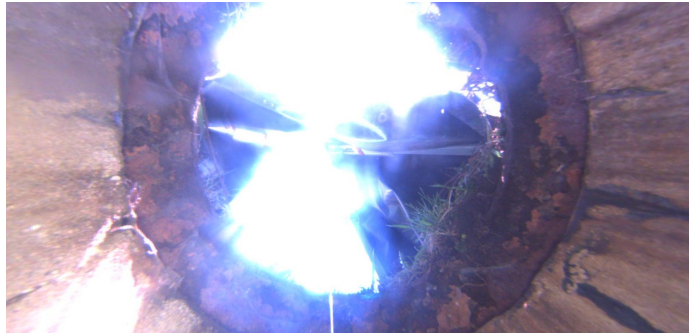
Code:	MGO
Description:	General Observation
Distance (ft):	1.8
Structural Grade:	0
O&M Grade:	0
Clock Start/From:	
Clock To:	
1st Value:	
2nd Value:	
Value Percent:	
Step:	NO
Remarks:	UNDERSIDE OF FRAME

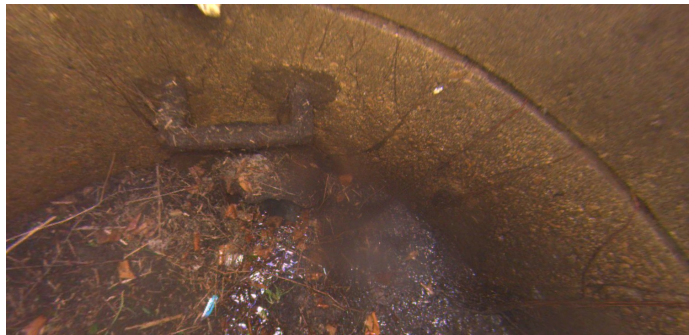
Code:	RFJ
Description:	Roots Fine Joint
Distance (ft):	3.2
Structural Grade:	0
O&M Grade:	1
Clock Start/From:	10
Clock To:	3
1st Value:	
2nd Value:	
Value Percent:	
Step:	NO
Remarks:

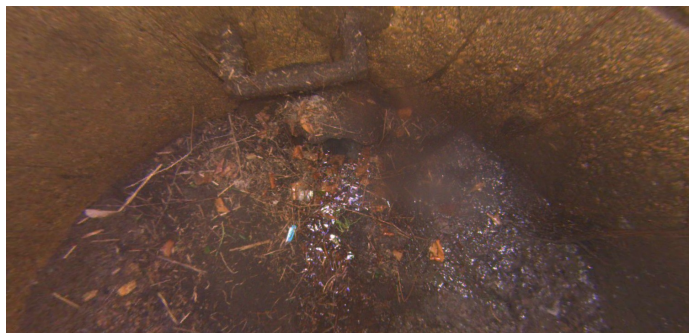
Code:	SAP
Description:	Surface Aggregate Projecting
Distance (ft):	3.2
Structural Grade:	3
O&M Grade:	0
Clock Start/From:	12
Clock To:	12
1st Value:	
2nd Value:	
Value Percent:	
Step:	NO
Remarks:

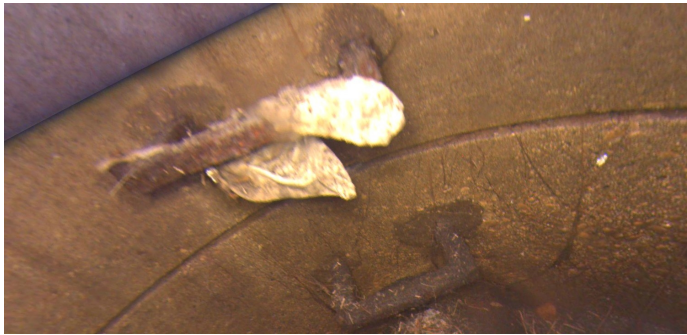
Code:	DAR
Description:	Deposits Attached Ragging
Distance (ft):	3.2
Structural Grade:	0
O&M Grade:	2
Clock Start/From:	12
Clock To:	
1st Value:	
2nd Value:	
Value Percent:	5.000
Step:	YES
Remarks:

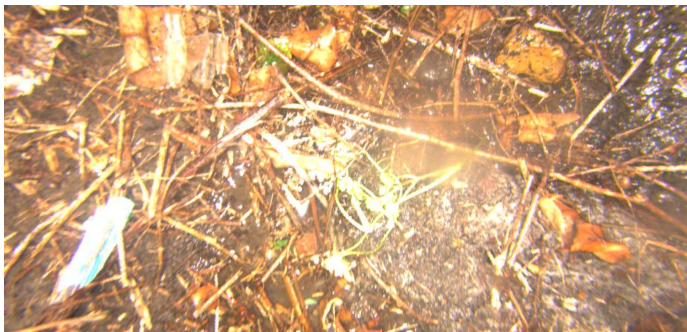
Code:	DSZ
Description:	Deposits Settled Other
Distance (ft):	5.4
Structural Grade:	0
O&M Grade:	2
Clock Start/From:	12
Clock To:	12
1st Value:	
2nd Value:	
Value Percent:	10.000
Step:	NO
Remarks:	MISC

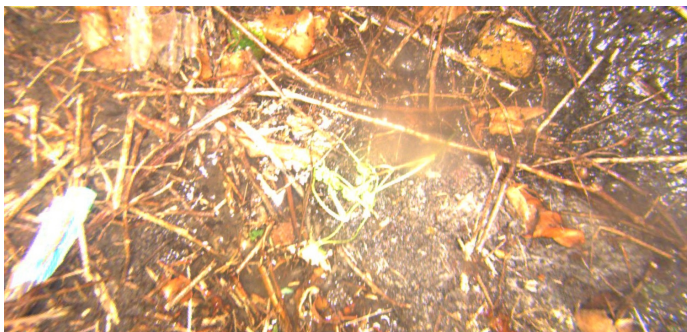
Code:	MGO
Description:	General Observation
Distance (ft):	5.4
Structural Grade:	0
O&M Grade:	0
Clock Start/From:	
Clock To:	
1st Value:	
2nd Value:	
Value Percent:	
Step:	NO
Remarks:	END SURVEY
