# Manhole Inspection Report

Date:	<b>04/26/2018</b>	Weather:		Coding:	<b>RZMACP</b>
MH#:	<b>M-507-039</b>	Owner:	<b>NA</b>	Len. Surveyed:	<b>5.1</b>
P.O.#:		Surveyor:	<b>Jen Costello</b>	Rim to Invert:	<b>9.1</b>
Customer:		Cert. #:	<b>U-907-5518</b>	Wall Material:	<b>Concrete (reinforced)</b>

Street:	<b>Virginia St. and 10th St.</b>	Project:	<b>Hobart, IN</b>
City:	<b>Hobart, IN</b>	GPS Northing:	<b>2901388.758</b>
Location:		GPS Easting:	<b>2901388.758</b>
Drain Area:	<b>Southwest</b>	GPS Accuracy:	<b>Sub-Meter</b>
Cover Shape:	<b>Circular</b>	Evidence of Surcharge:	<b>No</b>
Cover Size:	<b>22.5</b>	Potential for Runoff:	<b>None</b>
Comments:

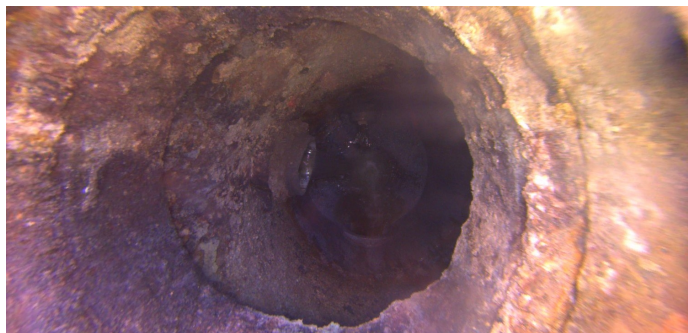
Code: **MGO**  
Description: **General Observation**

Distance (ft): **.0**  
Structural Grade: **0**  
O&M Grade: **0**  
Clock Start/From:  
Clock To:  
1st Value:  
2nd Value:  
Value Percent:  
Step: **NO**  
Remarks: **ACCESS MH**

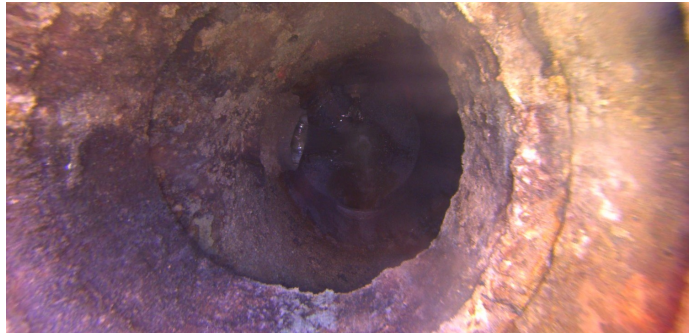
Code: **SAP**  
Description: **Surface Aggregate Projecting**

Distance (ft): **.0**  
Structural Grade: **3**  
O&M Grade: **0**  
Clock Start/From: **12**  
Clock To: **12**  
1st Value:  
2nd Value:  
Value Percent:  
Step: **NO**  
Remarks:

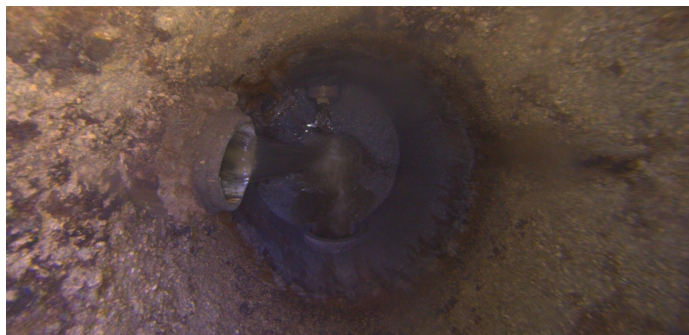
Code: **SAP**  
Description: **Surface Aggregate Projecting**

Distance (ft): **1.7**  
Structural Grade: **3**  
O&M Grade: **0**  
Clock Start/From: **12**  
Clock To: **12**  
1st Value:  
2nd Value:  
Value Percent:  
Step: **NO**  
Remarks:

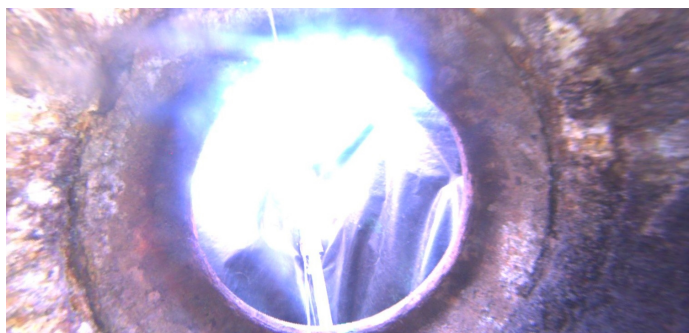
Code: **MGO**  
Description: **General Observation**

Distance (ft): **1.7**  
Structural Grade: **0**  
O&M Grade: **0**  
Clock Start/From:  
Clock To:  
1st Value:  
2nd Value:  
Value Percent:  
Step: **NO**  
Remarks: **END SURVEY**

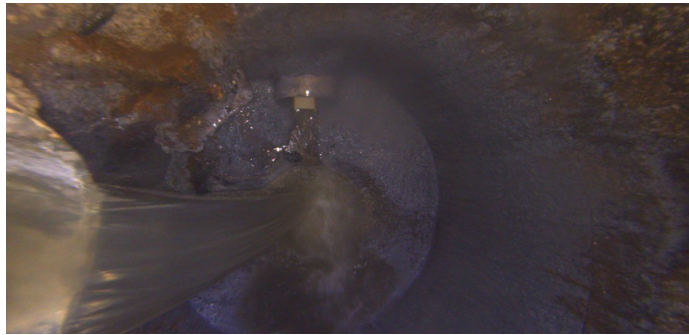
Code: **IW**  
Description: **Infil Weeper**

Distance (ft): **3.8**  
Structural Grade: **0**  
O&M Grade: **2**  
Clock Start/From: **12**  
Clock To: **12**  
1st Value:  
2nd Value:  
Value Percent:  
Step: **NO**  
Remarks:

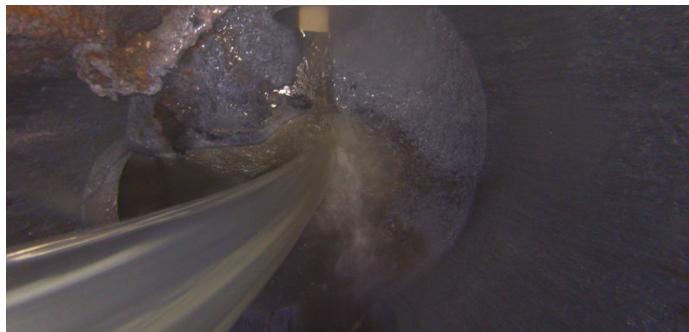
Code: **SAP**  
Description: **Surface Aggregate Projecting**

Distance (ft): **5.1**  
Structural Grade: **3**  
O&M Grade: **0**  
Clock Start/From: **12**  
Clock To: **12**  
1st Value:  
2nd Value:  
Value Percent:  
Step: **NO**  
Remarks:

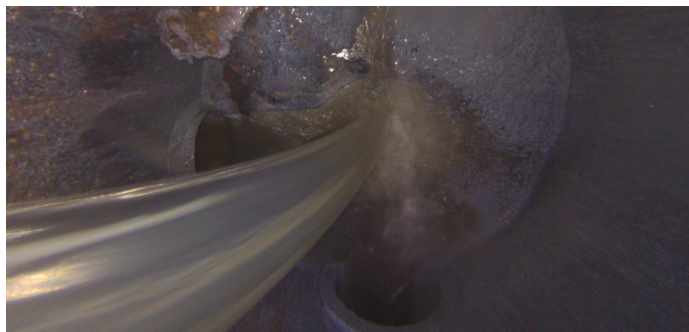
Code: **MSA**  
Description: **Abandoned Survey**

Distance (ft): **5.1**  
Structural Grade: **0**  
O&M Grade: **0**  
Clock Start/From:  
Clock To:  
1st Value:  
2nd Value:  
Value Percent:  
Step: **NO**  
Remarks: **UNKNOWN**
